CATONSVILLE ELEMENTARY SCHOOL EXISTING CONDITIONS ASSESSMENT REPORT

**615 Frederick Road
Catonsville, Maryland 21228**

Prepared For:
Baltimore County
Department of Property Management

Submitted:
September 1, 2016

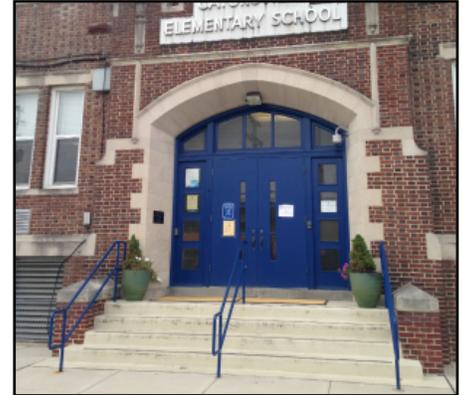
Main entrance is only accessed via stairs and is therefore, non-ADA compliant.

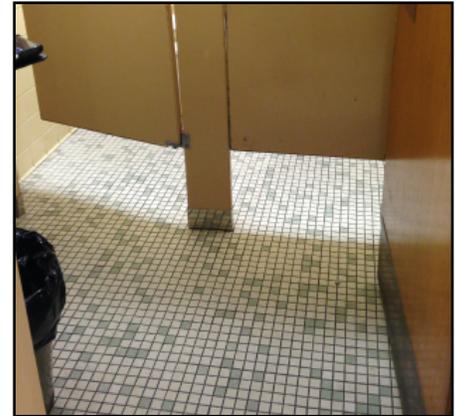
Currently, no toilet rooms in the building meet ADA accessibility requirements. Issues documented include, but are not limited to: inadequate toilet stall clearances, no ADA stall provided, inadequate fixture clearances, noncompliant accessory placement, and unsatisfied turn-radius requirements. A renovation will require at least one accessible toilet fixture for both sexes be provided on each floor for each use area. For example, it would not be acceptable for those who may be in the "Cafeteria" area to traverse into the "Gymnasium" area toilet.

Inadequate ADA turn radius.

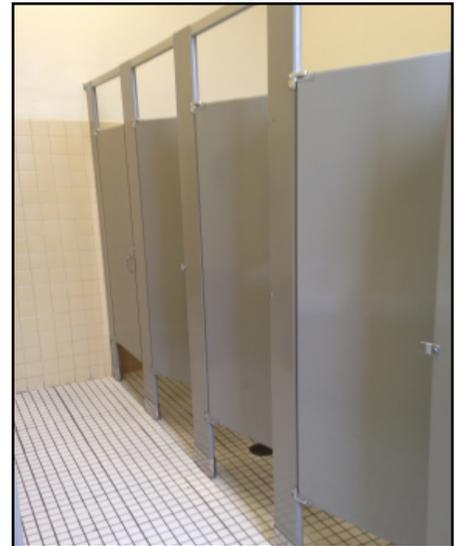
No ADA stall provided.

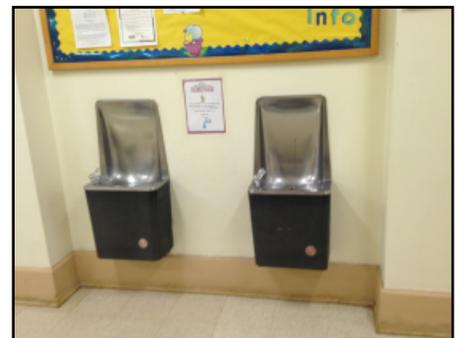
No knee clearances provided.

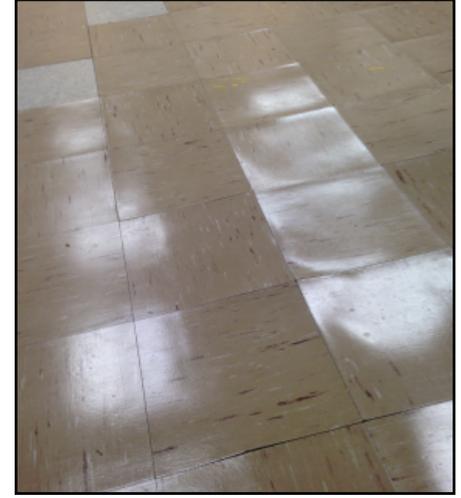
Based upon existing building drawings, it appears that the foundation system is a slab on grade. Due to the age of the building, any vapor barrier that was originally installed (which is unlikely) would have eroded by this time and the noticeable delamination of VCT may be an indicator of the resultant moisture infiltration.

Delaminating floor finishes may indicate moisture infiltration.

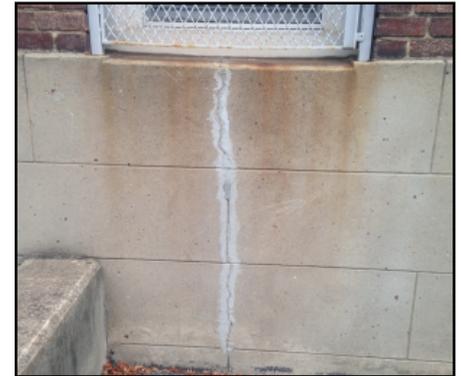
The stress cracks observed on the exterior walls raises some question as to the suitable nature of the soils beneath the foundation and the foundation condition itself. Any possible solution will include excavation of soils in areas showing distress to reveal the nature of the surrounding soil and footing conditions. In addition to subterranean site work, any new work beyond the existing footprint will require a surface storm water management facility to comply with current codes.

Stress cracks may indicate uneven settling of footings or moisture infiltration.

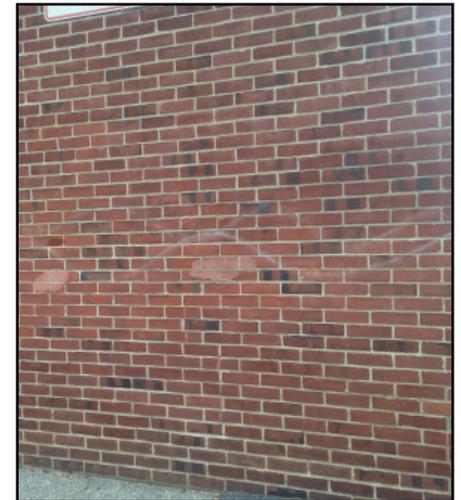
Based upon field observation and review of the construction drawings, the entire exterior envelope appears to be 4" brick veneer backed by CMU. There is no air space between the brick and concrete block, rendering it prone to moisture infiltration. Little to no efflorescence was observed while on site which would indicate that the wall is performing surprisingly well for its age. The exterior mortar joints on brick veneer have been excessively weathered and are crumbling in some locations at the original portion of the building. At the gymnasium, joints and brick veneer appear to be in good condition. Certain spots in the building have thru wall cracks at the sills of windows and, while probably not structural in nature, should be repaired to prevent further water infiltration. Spray painted vandalism was observed in several places.

Vandalism.

All brick and cast stone joints should be repointed. Testing on existing mortar and brick should be done prior to selecting new mortar type as some types of older bricks can quickly deteriorate when paired with new type-N mortars. Due to the prevalence of graffiti, the whole building should be washed clean and coated with an anti-graffiti coating.

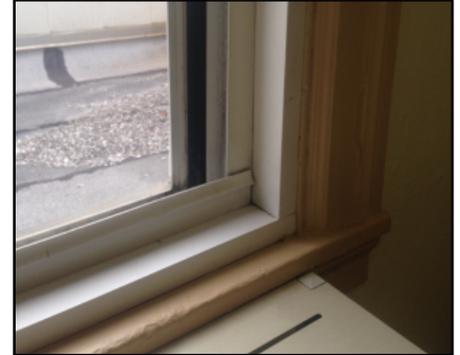
Most of the fenestration is made of hollow metal windows that were replaced in 2000. The units are likely constructed of thermally broken aluminum frames and insulated glazing. Most do not operate properly and require a stick to prop them open. This indicates that the windows were not properly hung and balanced when originally installed. No locking hardware was present on the windows which poses a significant security problem. Sill flashing at windows in the addition portion of the building is in poor condition and requires replacing. There are also AC window units supported by rusted, make-shift supports which do not appear to be in an acceptable condition to leave unattended.

Typical window condition.

Primarily due to being improperly hung and because of the lack of locks, all window units should be updated. Additionally, due to the historic nature of the building, it is recommended that the replacement windows be of the simulated divided lite type. The AC window units and supports would not be required with an updated MEP system.

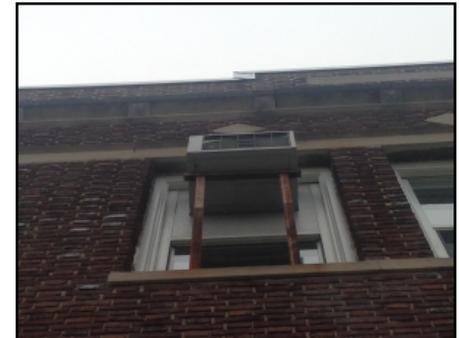
AC window units.

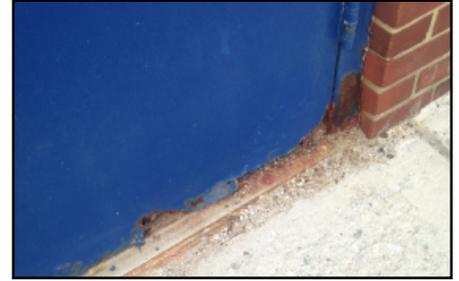
Exterior doors are hollow metal and most have hollow metal frames. Door panels are dented and have started to rust. In general, most frames are salvageable providing they could accommodate the hinging of new door panels. Around the main entry, the door frame is wood and appears to have begun to rot and deteriorate.

Condition of hollow metal doors.

Any type of renovation will require the owner to contribute 20% of the budget to accessibility upgrades. Anticipate replacing all door panels and fitting them with ADA-compliant latch/lever style hardware. All door frames should be ground and repainted. The main entry assembly should be replaced completely.

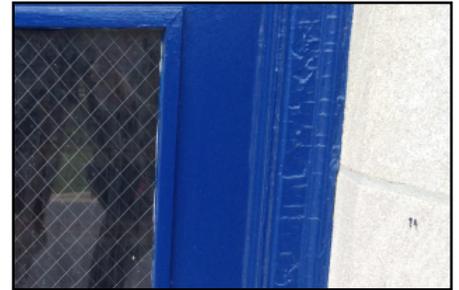
Wood frame around entry door has started to rot.

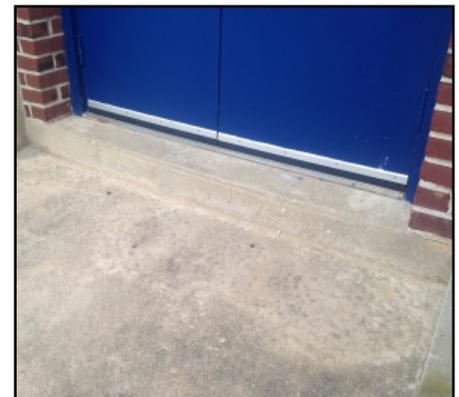
Non-ADA compliant threshold.

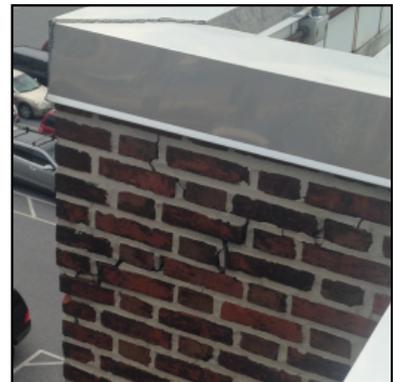
Flashing and parapet coping are stainless steel. The flashing appears to be in good condition; however, the sealant at coping joints is failing. The resultant water infiltration has caused the brick veneer to crack to the point where failure is potentially eminent. Some cast stone pieces have also begun to detach from the building in certain areas.

Failing brick parapet.

The failing brick veneer should be replaced immediately or risk it falling 40' to the ground below. Loose cast stone pieces should either be properly anchored or replaced with new units. Limited portions of coping should be replaced as required to create permanent seals to stop further water infiltration. If the roof is replaced to accommodate addition insulation then all copings would require replacement. Alternate drainage methods need to be created to direct water away from the overwhelmed internal drains.

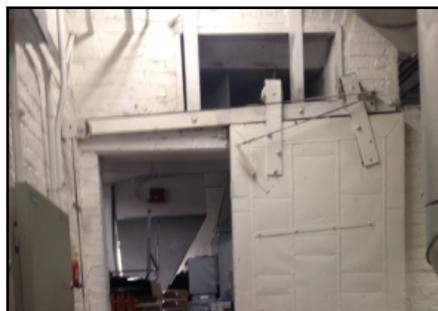
Inadequate door width at Mechanical Room. Fire rating lost because of wall penetrations.

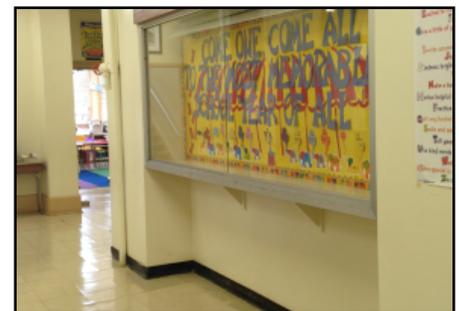
- Lobby: The display case in the lobby is offset from the ground and will require a cane-warning device underneath of it.
- IT Room: The IT room is not secured. If required, the door needs to be repaired so that the gate is no longer needed.
- Mechanical Room: The door to the Mechanical Room is neither wide enough to remove the existing mechanical equipment nor wide enough to install new equipment. Selective demolition of the wall will be required and a double door permanently installed to accommodate large pieces of equipment. Additionally, wall penetrations have voided the fire rating inherent in the wall which is required to surround mechanical areas.

Cane-warning device required.

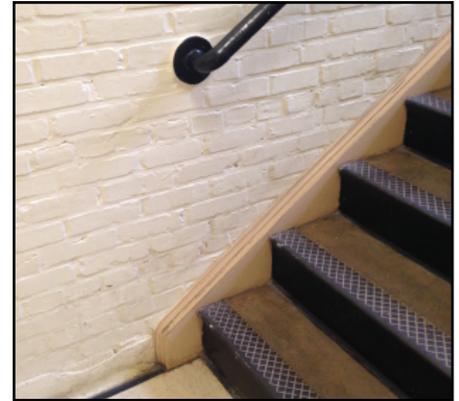
Handrail diameter size and extensions not met.

Other exterior stairs are in average condition. Railings will require the handrail to extend past the top and bottom tread and require picket or rail spacing to be such that nothing 4" in diameter or larger can be passed through them.

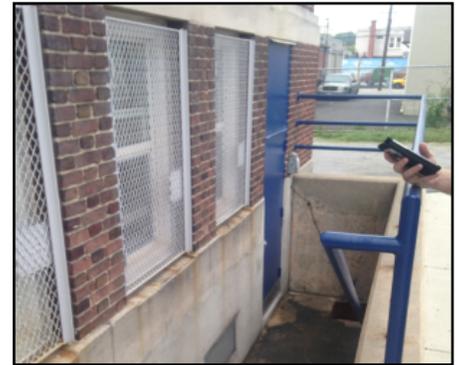
Inadequate handrail extension, spacing between rails, and fall protection.

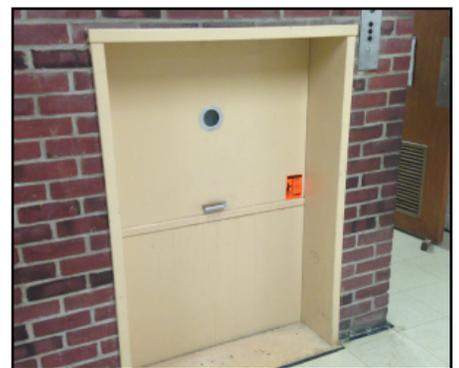
Non-ADA compliant dumbwaiter.

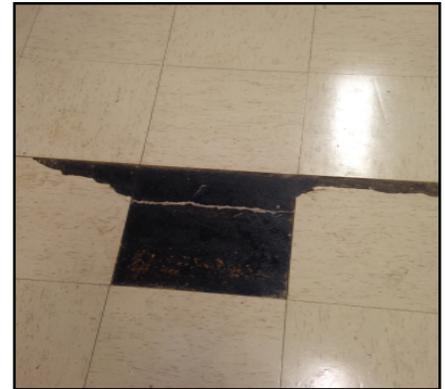
The finishes are showing a large degree of use and wear. The plaster was not sanded to a smooth finish which leaves the walls looking rough. VCT tiles are missing, peeling up, and mastic has been left uncovered in areas. This mastic and any other such materials should be tested by a licensed hazardous materials contractor for asbestos. The peeling may be due to moisture infiltration because the moisture barrier has degraded below the slab. Tiles in the bathrooms are dated looking and with the required reconfiguration for ADA compliance, will need to be replaced. Cracking and peeling wall finishes were noted in multiple rooms. Acoustical ceiling tiles are dirty, cracked, and patched in areas.

Missing VCT and exposed mastic.

With the poor and inconsistent state of the VCT, all tiles should be removed and replaced. An option may be to install a light weight topping slab to create a level floor system and provide a moisture barrier between the floor finish and slab on grade. Plaster should be removed and GWB over furring studs should be used over all walls. Ceiling tiles in the whole building should be replaced and tiles in the bathrooms should be replaced with vinyl-coated tiles for sanitary and maintenance reasons. Tiles in the bathrooms will need to be removed and replaced after ADA renovations take place. All areas with cracked paint should have the paint scraped off and repainted. Test all paint for hazardous materials before removing.

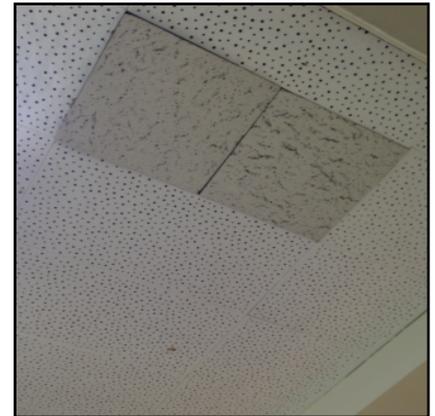
Patched ceiling tile.

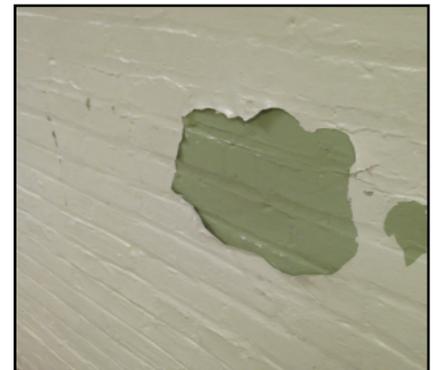
Peeling paint finish.

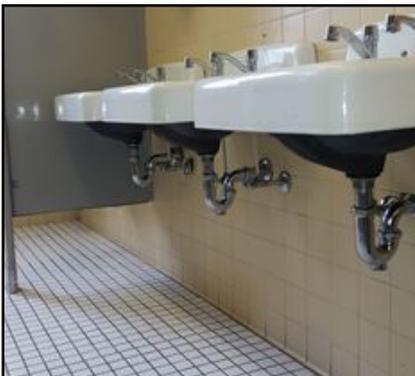
Photograph 16 - Typical bathroom lavatory. Missing pipe guard required by code.

Install vinyl PVC under sink pipe guards on all exposed lavatory waste piping per plumbing code. None were observed as seen in Photograph #38. A sample is shown to the right.
