# Spring Branch Subwatershed - Small Watershed Action Plan

(Addendum to the Water Quality Management Plan for Loch Raven Watershed)

Prepared by  
**Baltimore County**  
Department of Environmental Protection and Resource Management  
401 Bosley Avenue, Suite 416, Towson, MD 21204

**March 17, 2008**

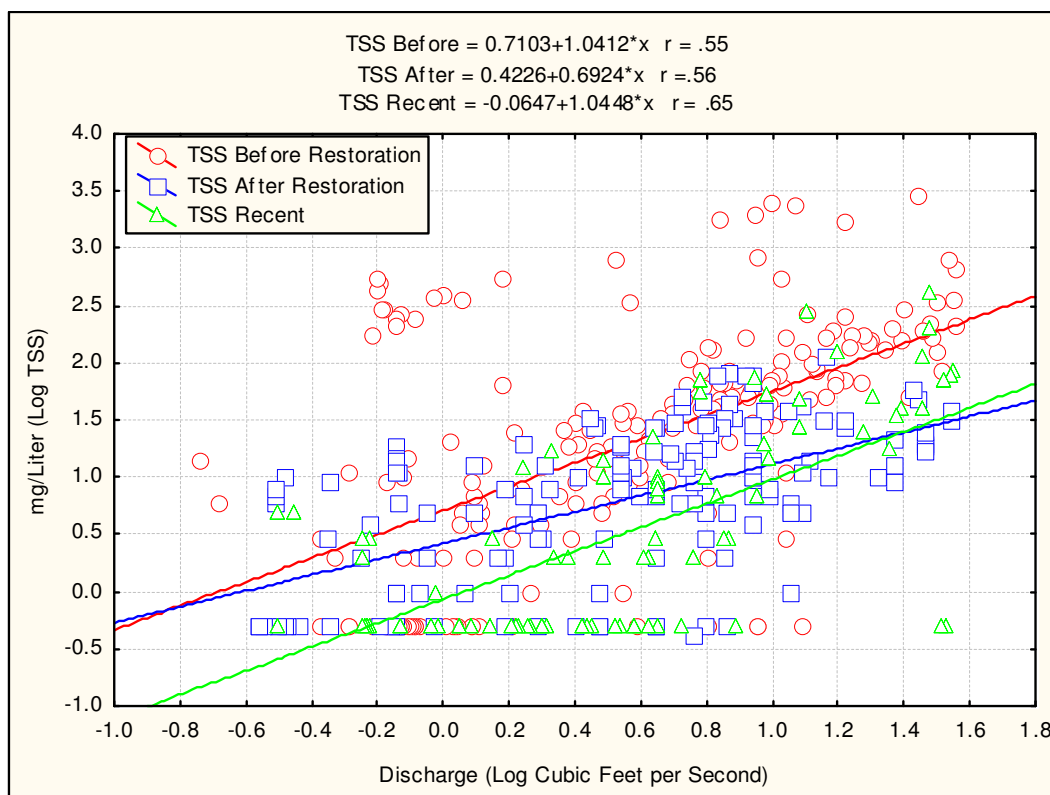
Figure 2-13: Total Suspended Solids (TSS) Data and Regressions for the Three Time Periods.

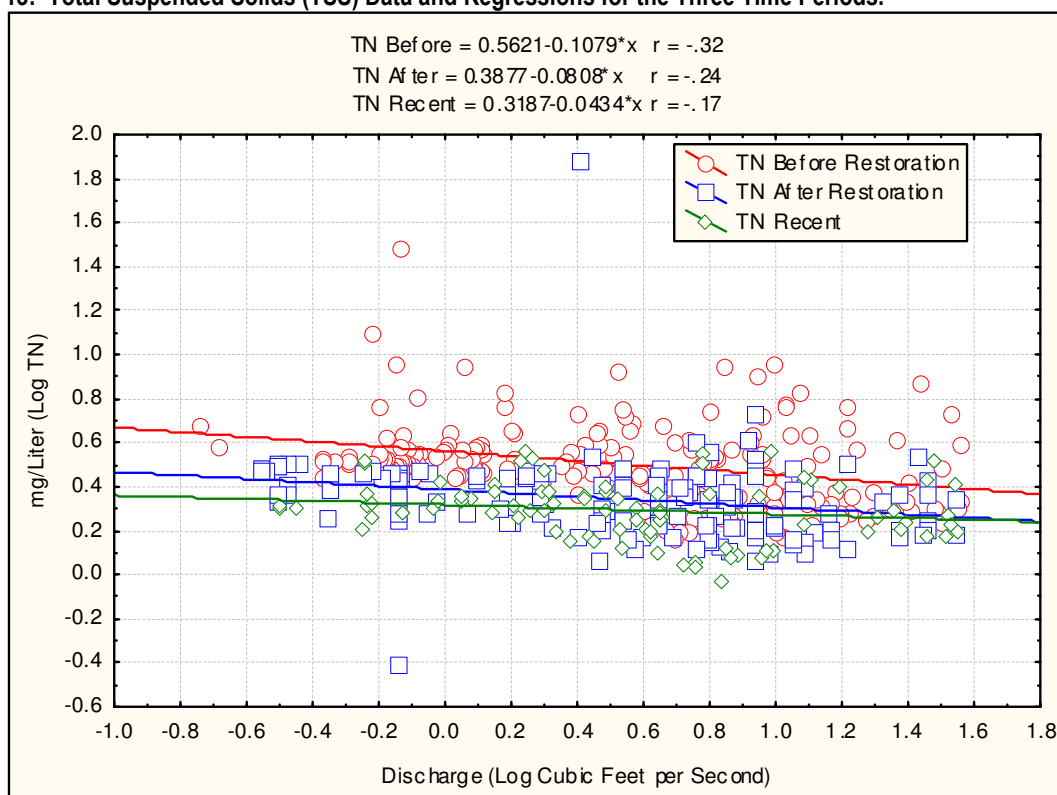
Figure 2-15: Total Nitrogen (TN) Data and Regressions for the Three Time Periods

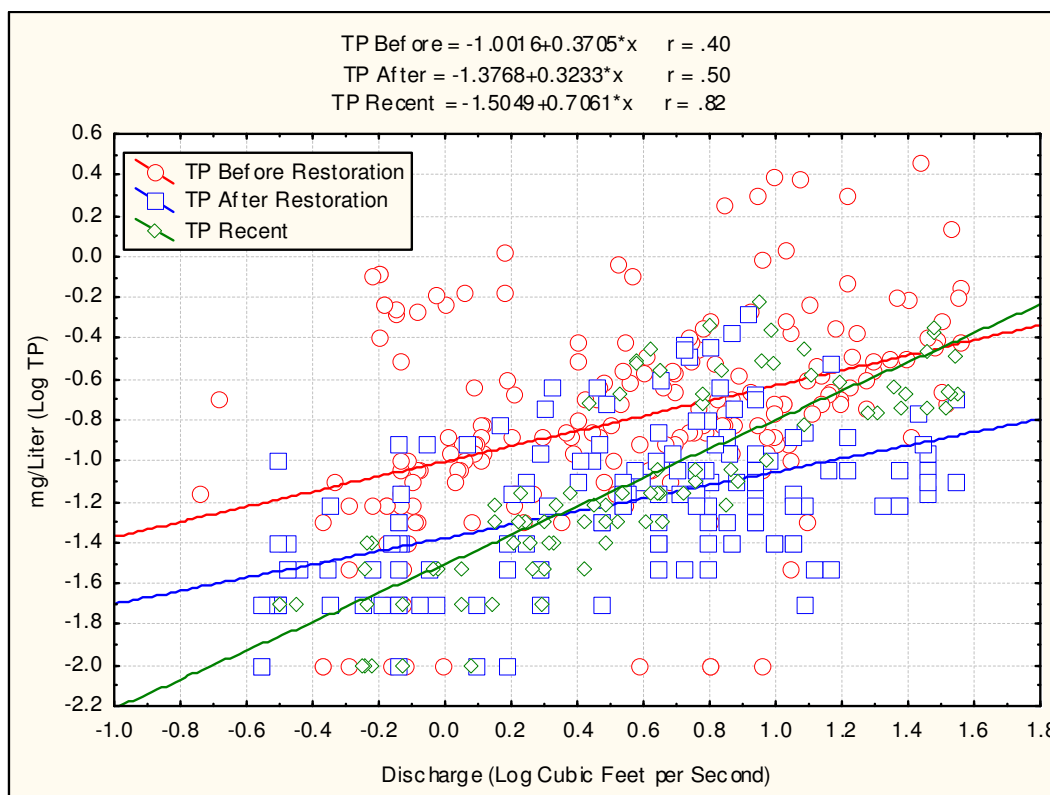
**Figure 2-14: Total Phosphorus (TP) Data and Regressions for the Three Time Periods.**

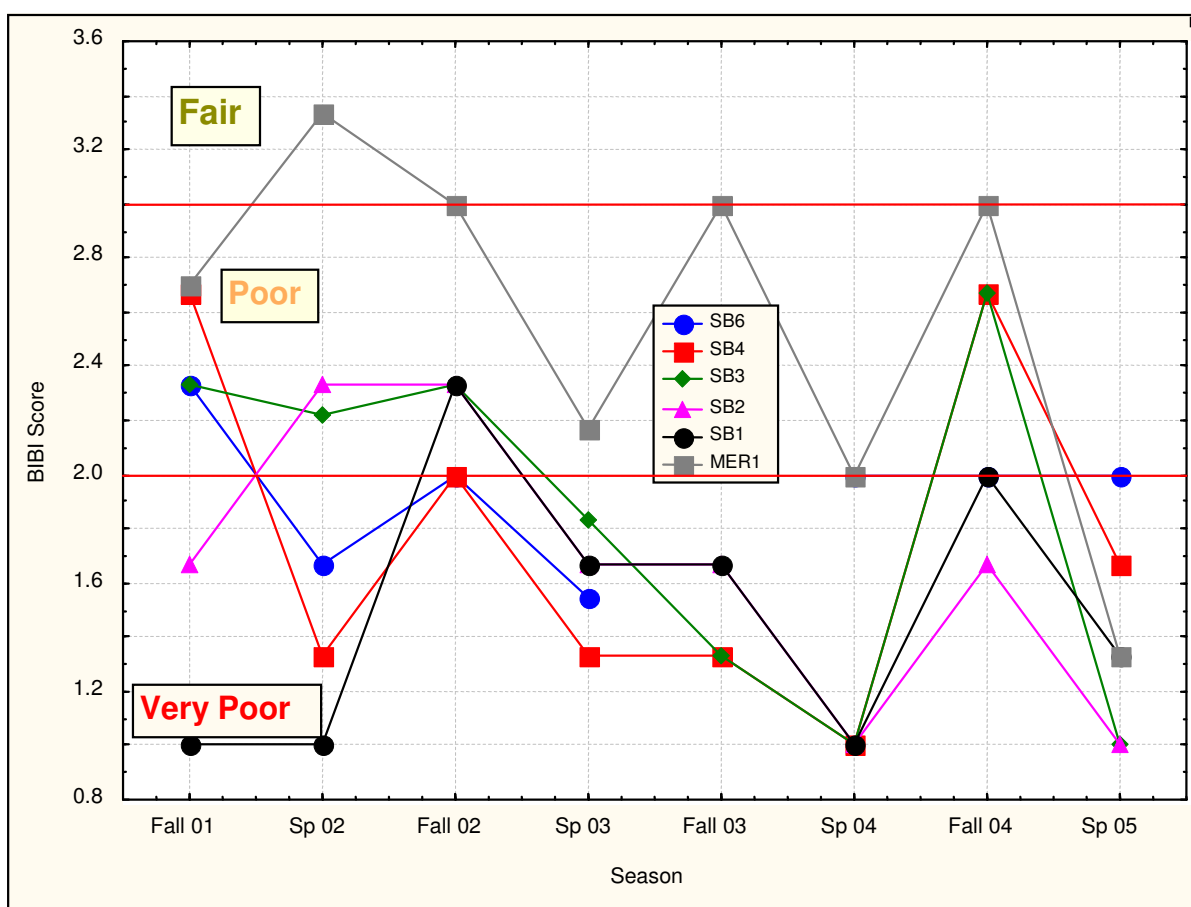
Figure 2-18: Spring Branch BIBI Scores, Site by Season.

Figure 2-18 shows BIBI results for each station by the sampling season. The figure shows that there is no consistent pattern of improvement at any of the sites. Merryman's Branch, the reference site is the only site to achieve a fair rating during the monitoring period, but even that site had excursions into poor ratings. The drought of 2001 and 2002 followed by the third wettest year on record in 2003 could have masked any recovery in the biological community due to stream restoration. The samples from the spring of 2005 were all in the very poor range.

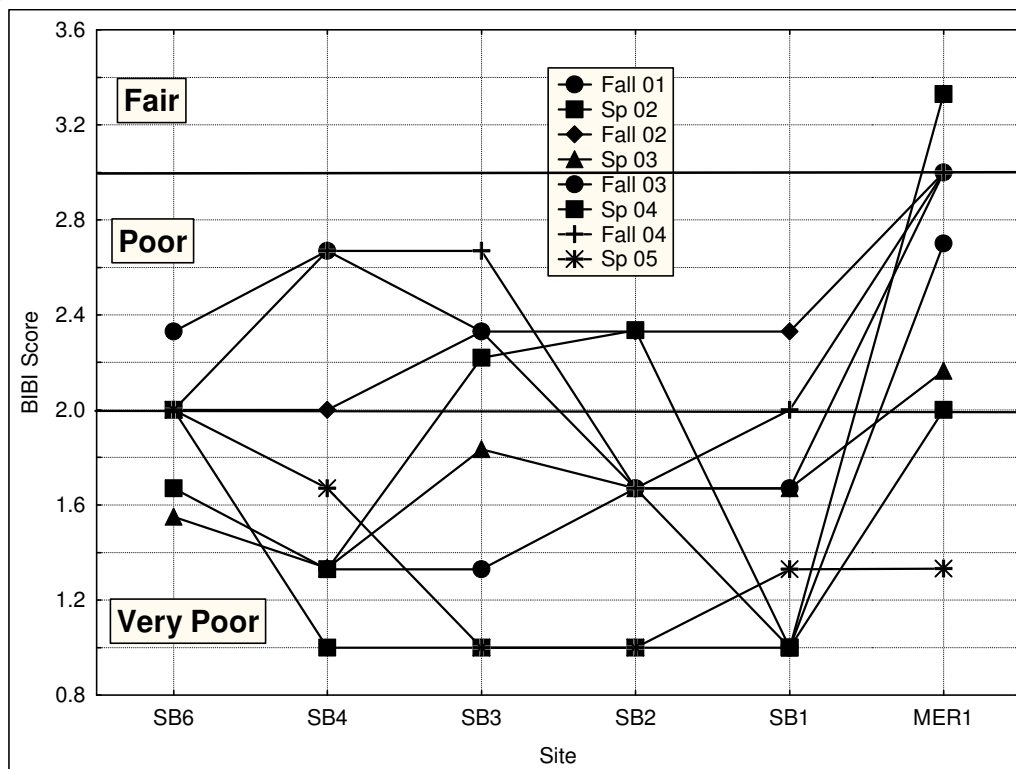
Figure 2-19 displays the changes at each site over the sampling period. SB1, the site below the restored reach was consistently rated as very poor by the BIBI scores. Sites within the restored reach ranged from poor to very poor, but scored better than SB1 with the exception of spring 2003. Merryman's Branch was rated higher during most seasons, but was below SB6 in the fall of 2001.

Figure 2-19: Spring Branch BIBI Scores, Season by Site.

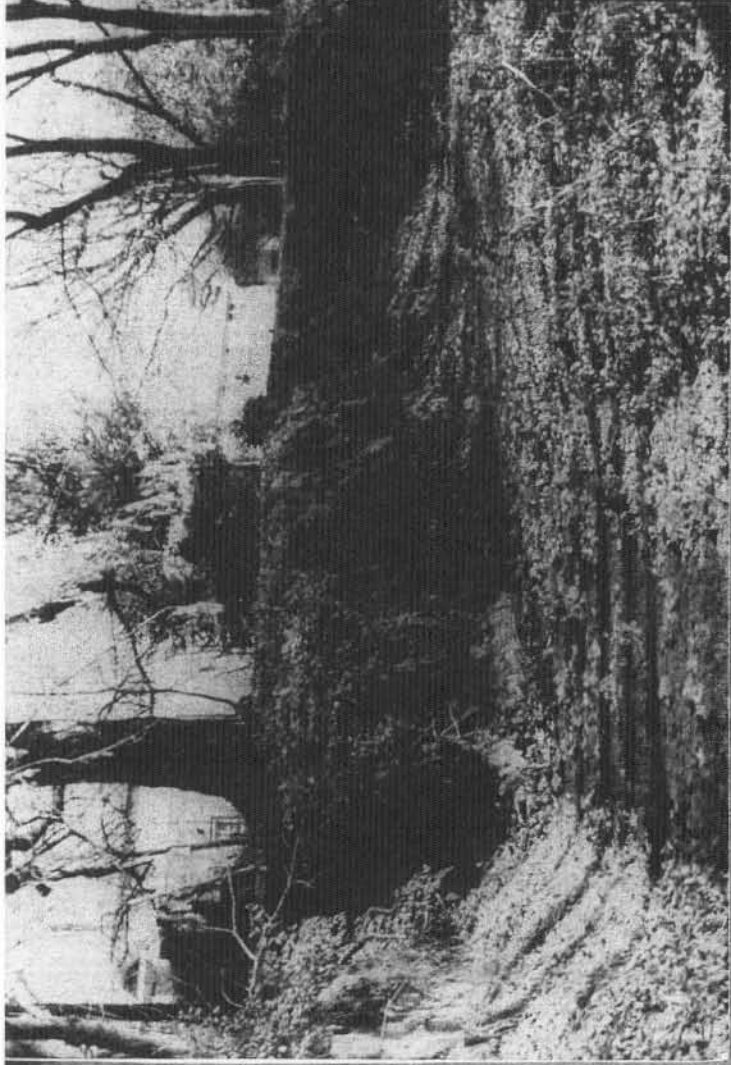
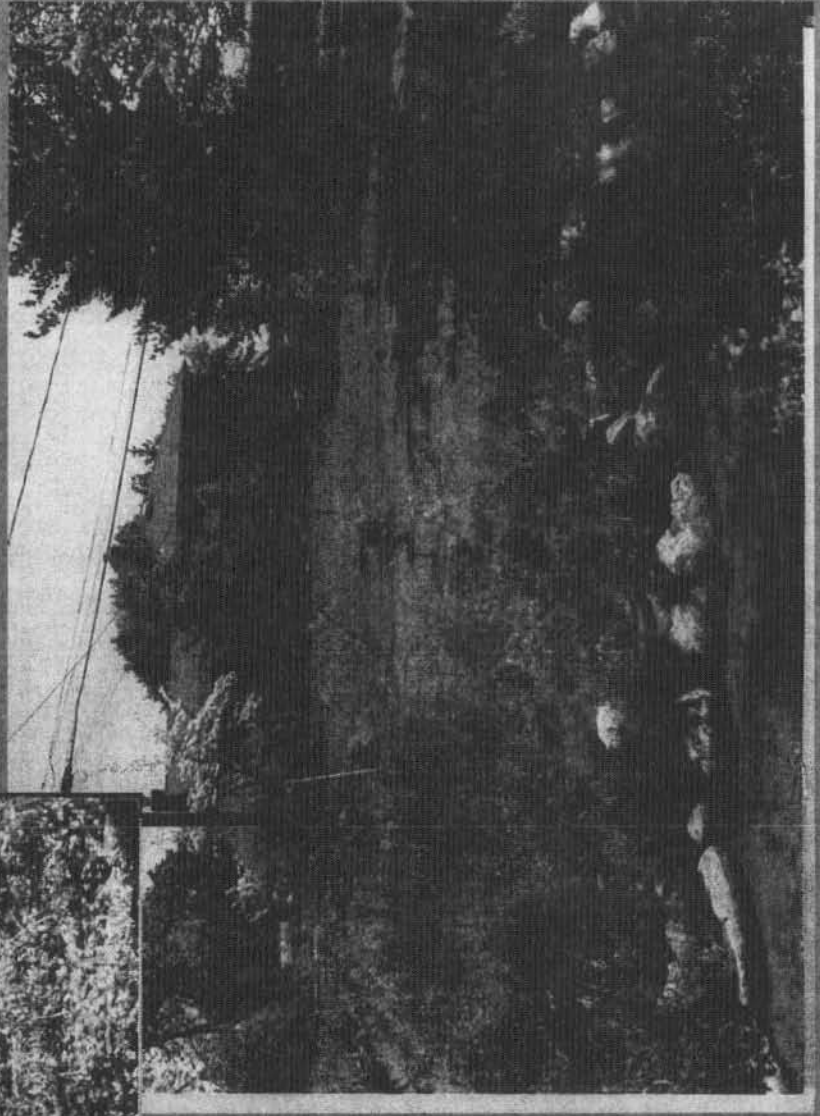
MAIN STEM AT  
CONFLUENCE

BEFORE AND AFTER

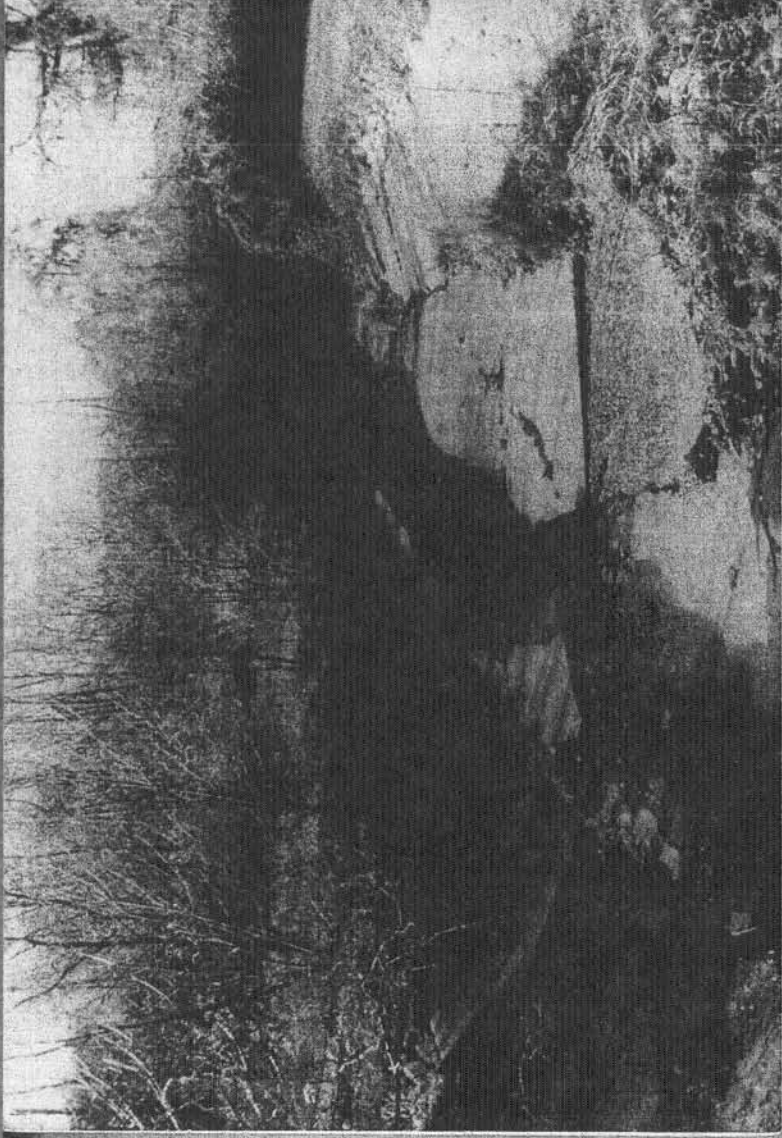
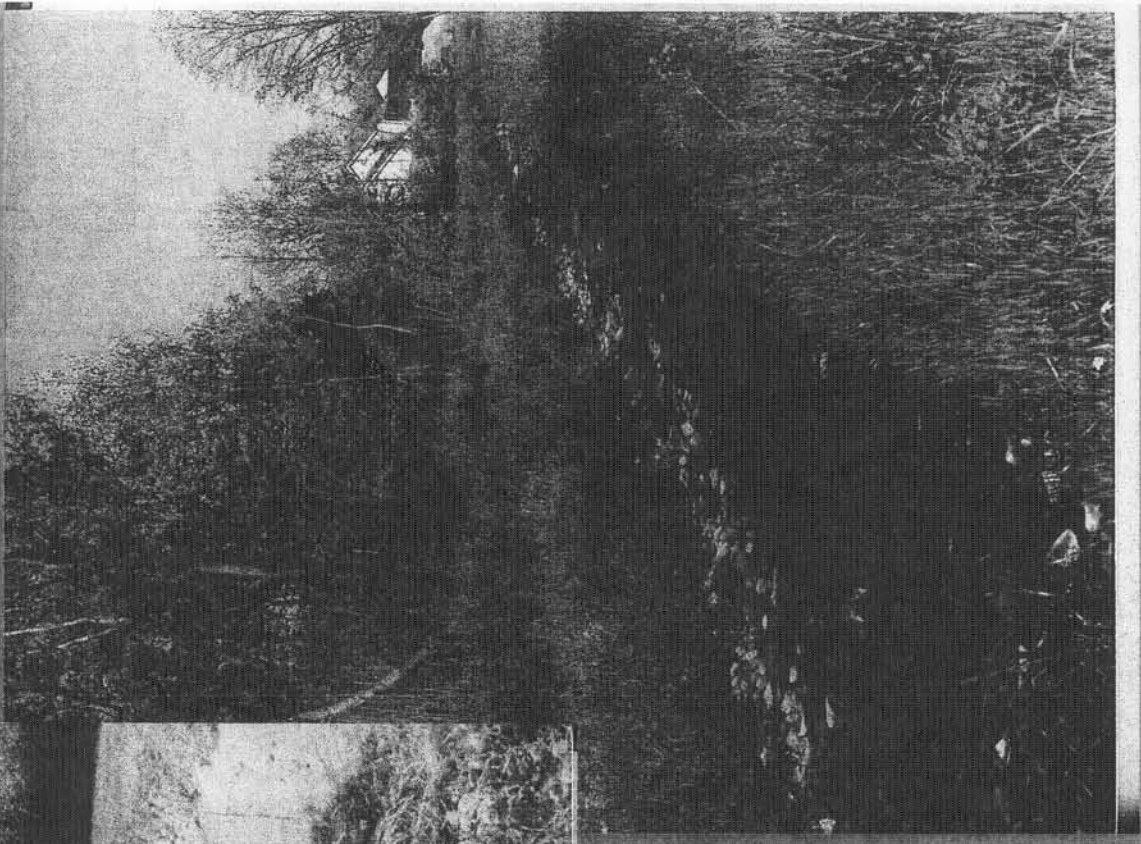
MAIN STEM AT POT  
SPRING ROAD  
BEFORE AND AFTER
