Spring Branch Subwatershed - Small Watershed Action Plan

Volume 2: Appendices D Through G

Spring Branch Stream Restoration – Conceptual Plan Report (Biohabitats, 1995)

Spring Branch Stream Restoration Project

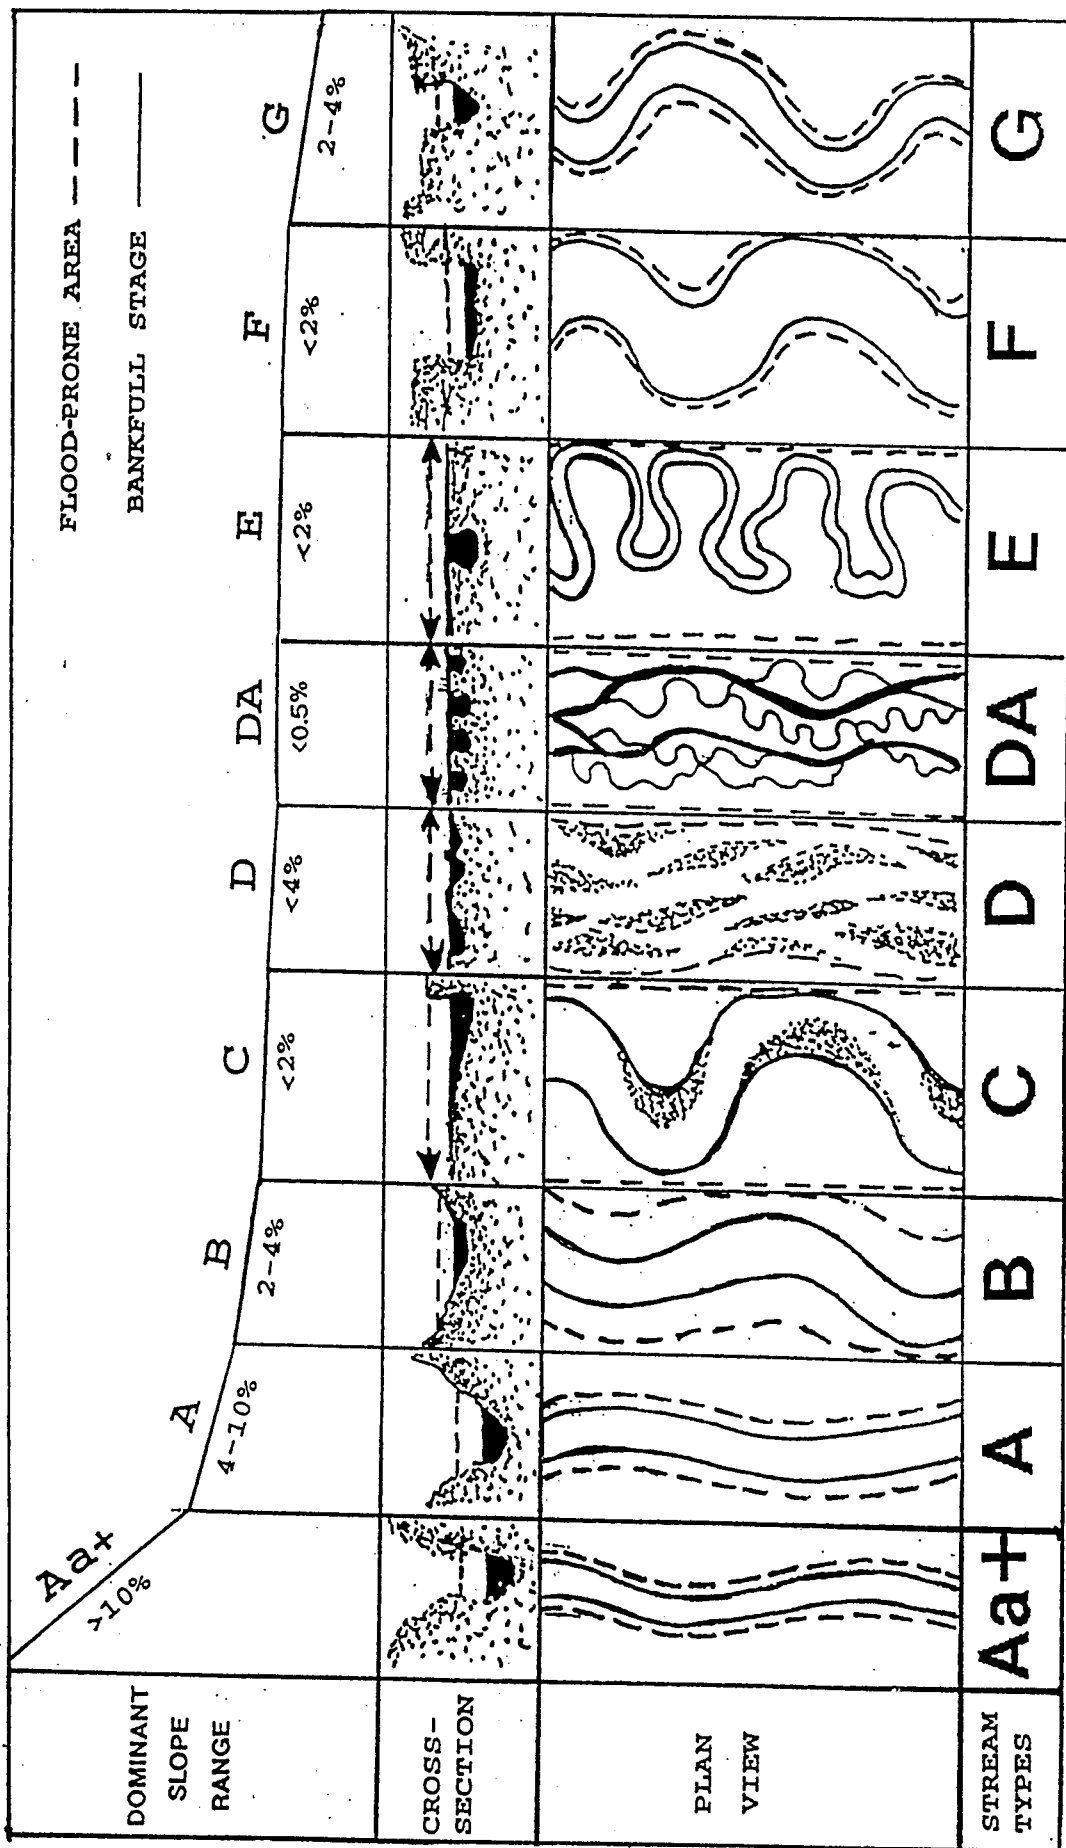
STREAM CHANNEL TYPES

The Wolman Pebble Count Method was used to determine dominant particle size of the bed material.

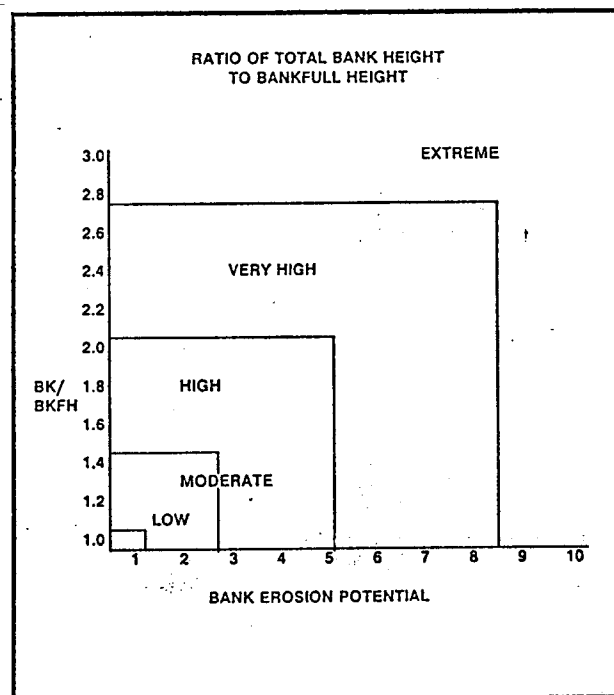
FIGURE 3.2 - EROSION POTENTIAL RATINGS

Channel banks are high with steep bank angles, a result of deliberate channelization or the channel enlargement response to perturbations in the watershed. Rosgen (1993) has developed a relationship between the bank height to bankfull height ratio and erosion potential (refer to Figure 3.2). Applying this relationship to measurements of bank conditions made in the field, the majority of the channel banks area rated as having a very high to

extreme potential for erosion. In most cases the bank erosion is a predominantly the result of slumping and lack of riparian cover. Figure 3.3 illustrates a typical sequence of channel bank adjustment following channel enlargement. Spring Branch exhibits all stages of channel adjustment at various different locations; however stages 3 and 4 are most representative of current conditions.

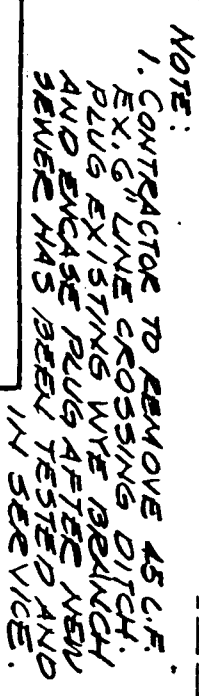
BALTIMORE COUNTY, MARYLAND
DEPARTMENT OF PUBLIC
WORKS
JOB ORDER NO. 21-7
SPRING BRANCH
STREAM RESTORATION
UTILITIES

Temporary shoring of the lateral should be performed immediately to eliminate further waste discharge into the stream. A permanent solution should be coordinated with stream restoration activities. Two approaches for correcting the broken sewer lateral have been submitted to DEPRM and DPW for review. These include encasing the lateral in concrete or relocating the lateral at the clean out and reconnecting to the main trunk line at Manhole 34857. The County has indicated that relocation is the preferred approach. A preliminary relocation design is shown in Figure 4.1.

An existing sanitary lateral connection serving Stratford Lot #32, 108 Westdale Court, is located between sanitary manholes 34857 and 34858. This sanitary lateral connection is an aerial crossing which impedes the stream flow by catching storm debris. The force of the stream acting on the lateral connection has caused several pipe joints to open, resulting in sanitary discharge to the stream. Temporary shoring of this line is required to eliminate the discharge. Permanent solutions are proposed in Section 4.0.

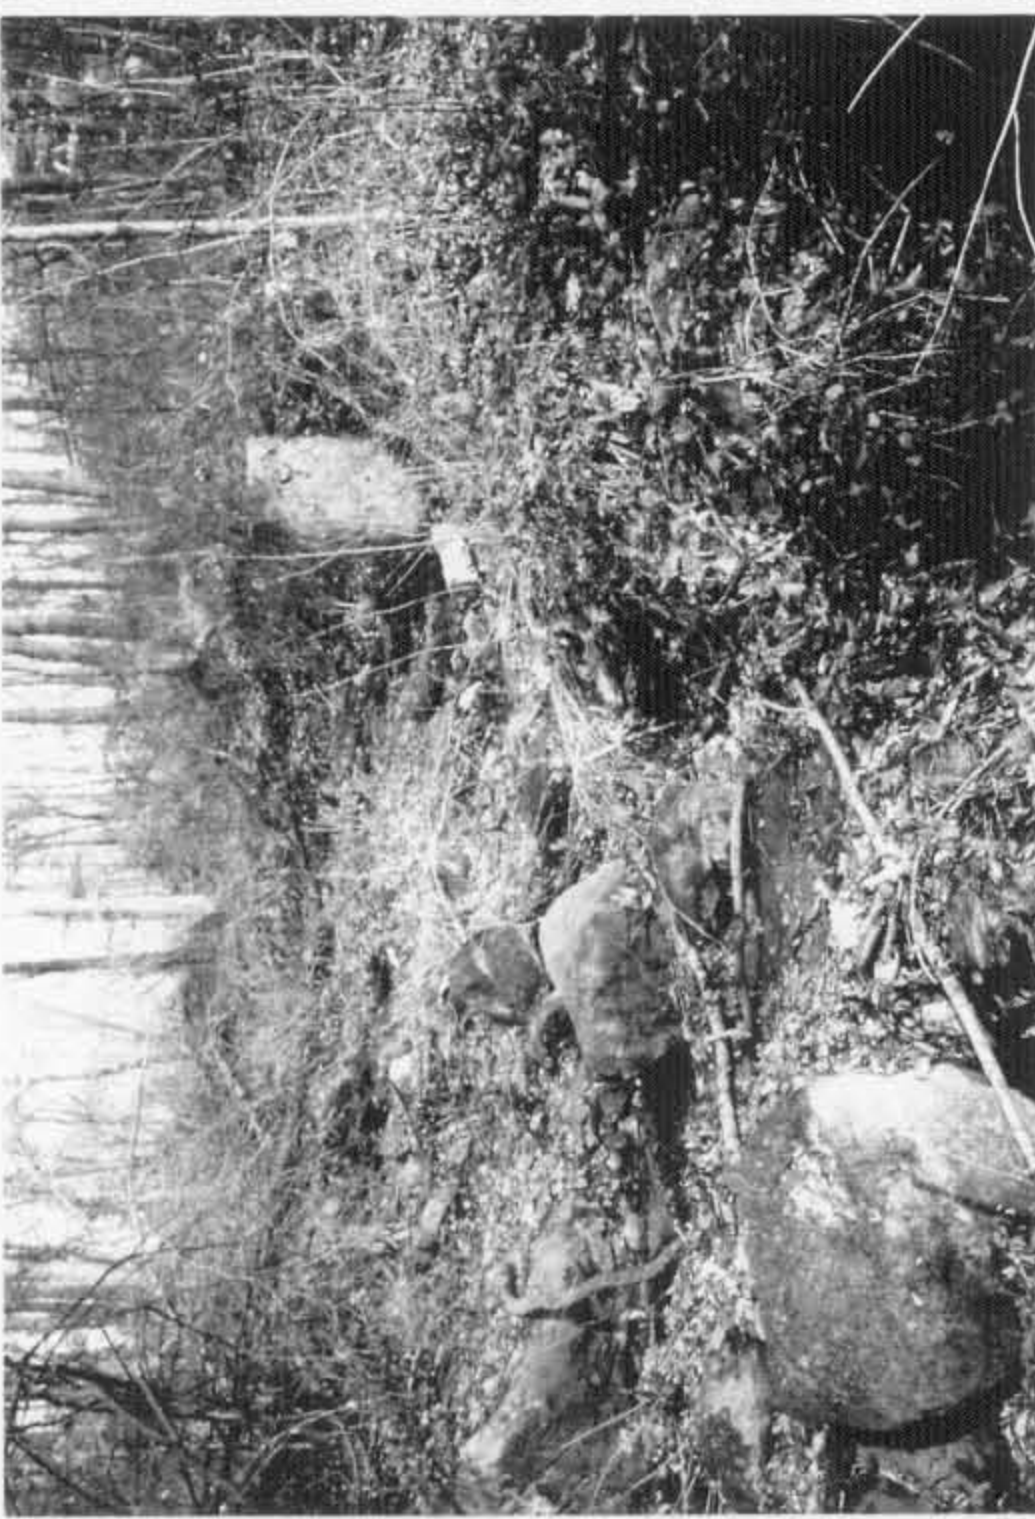
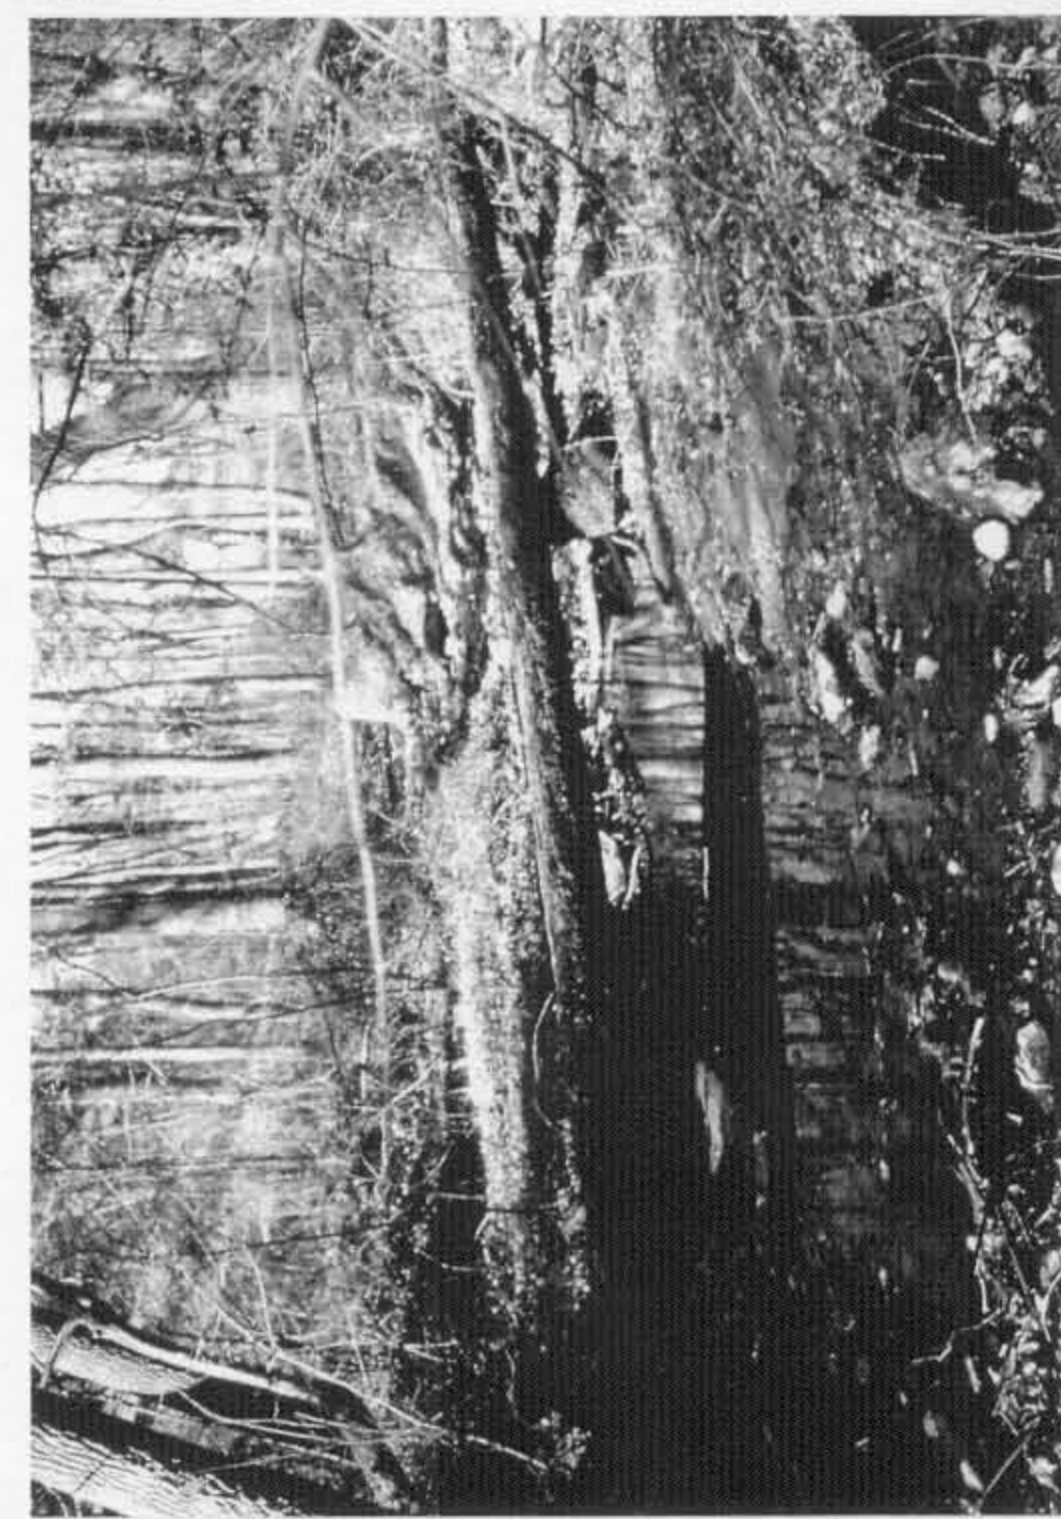
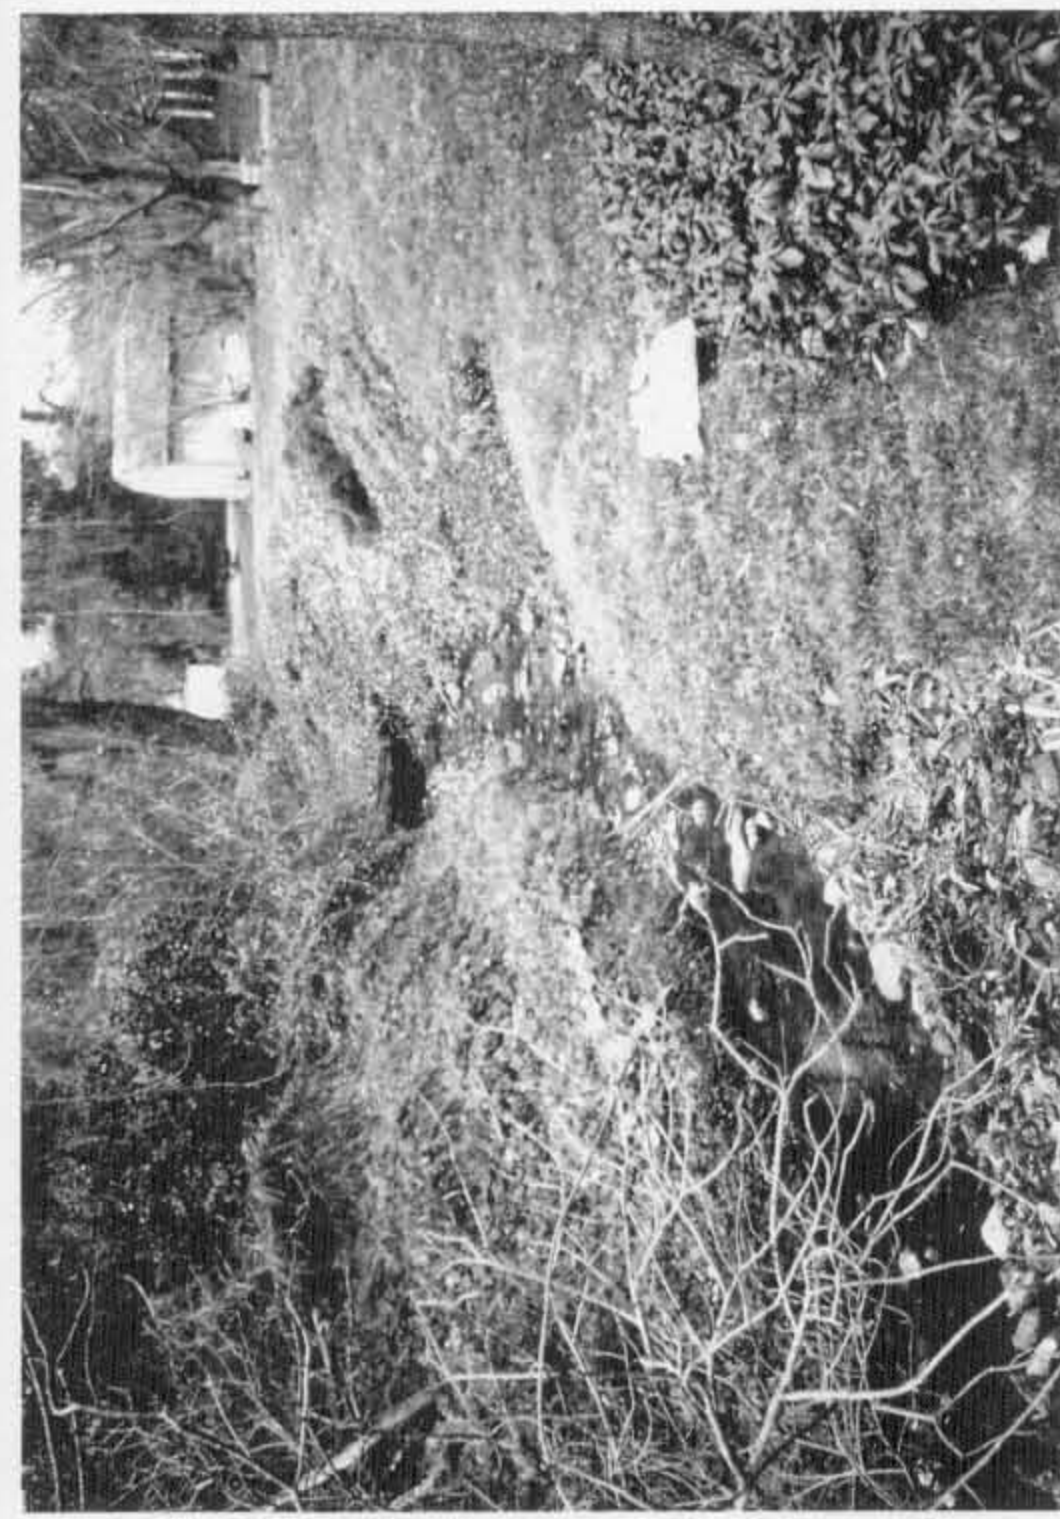
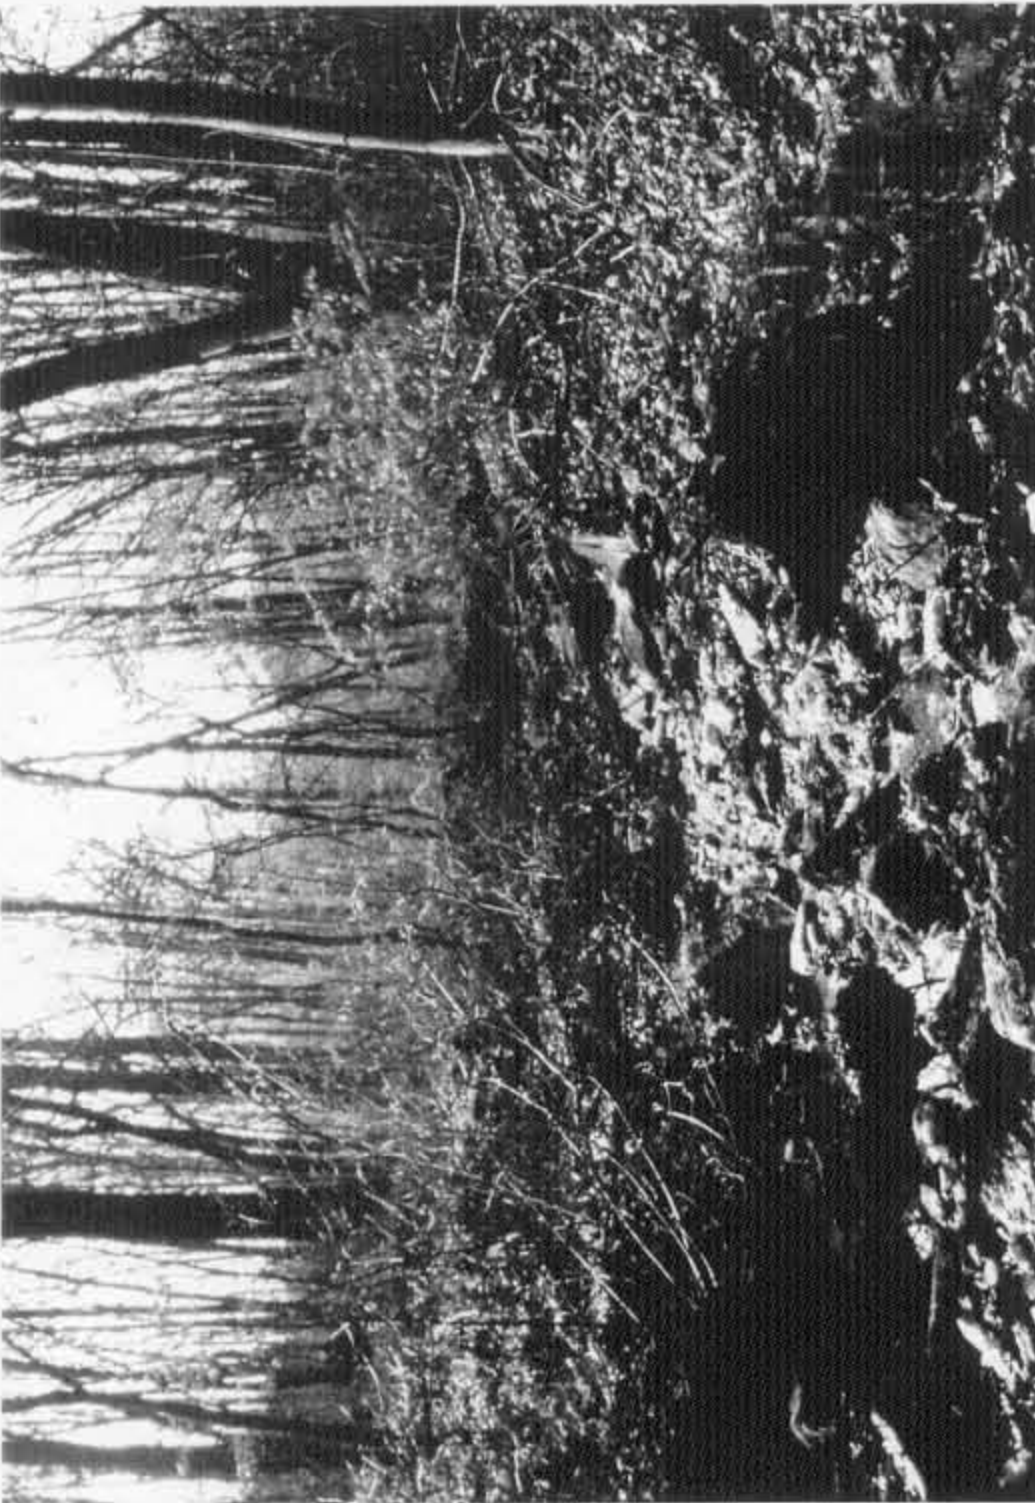
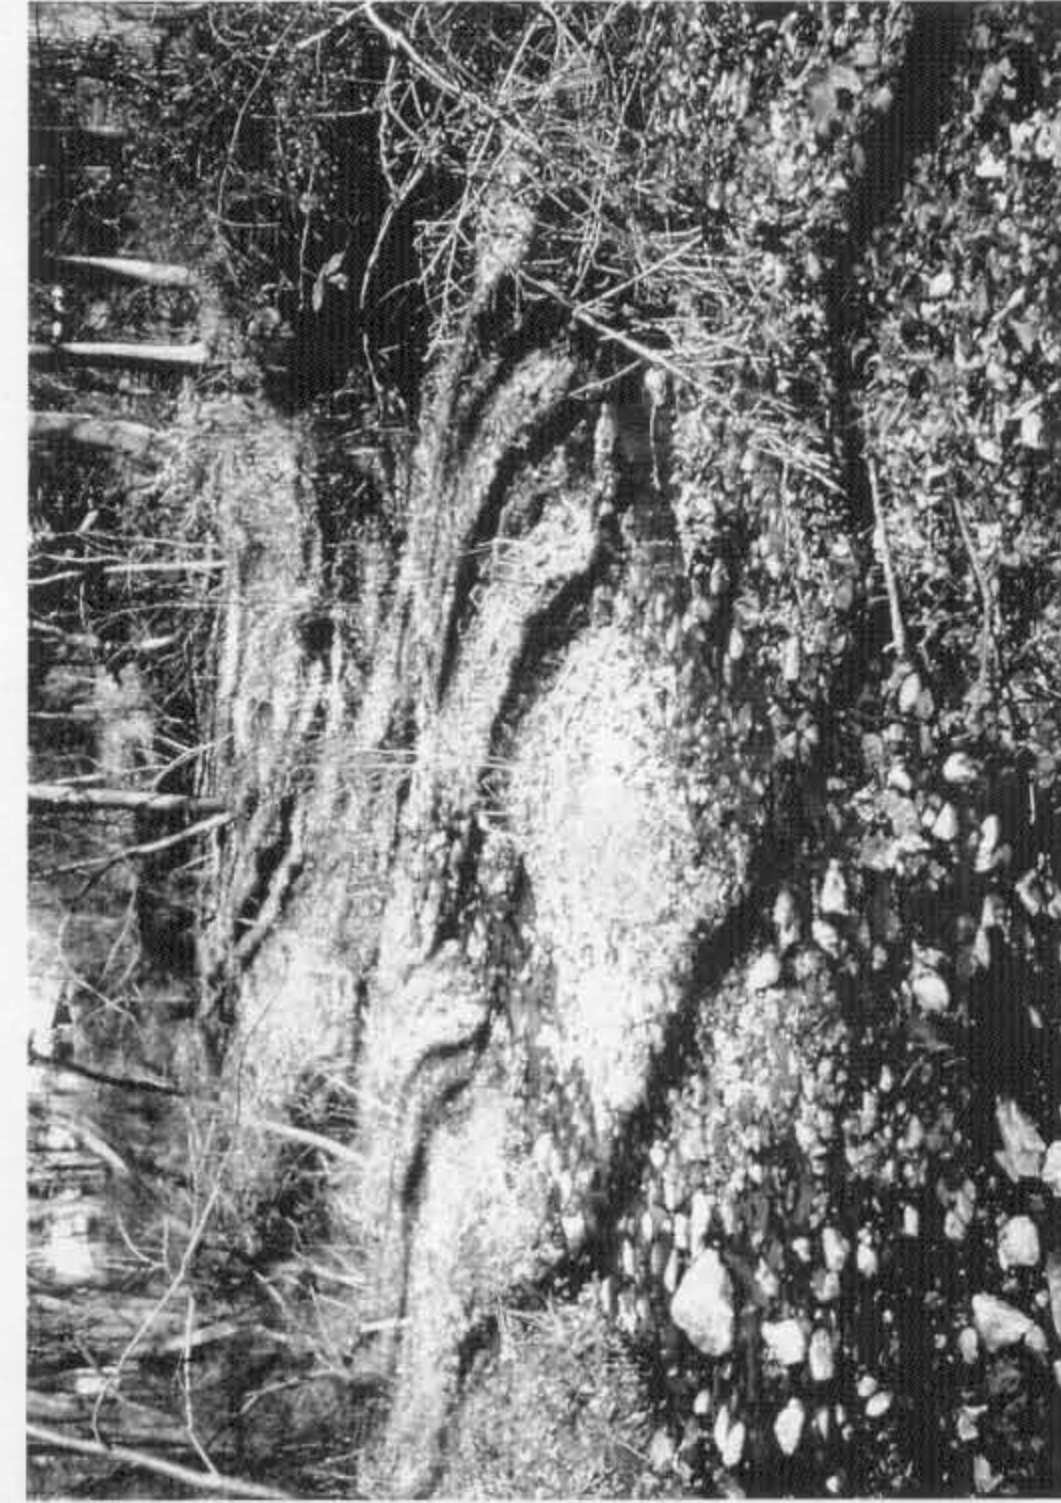
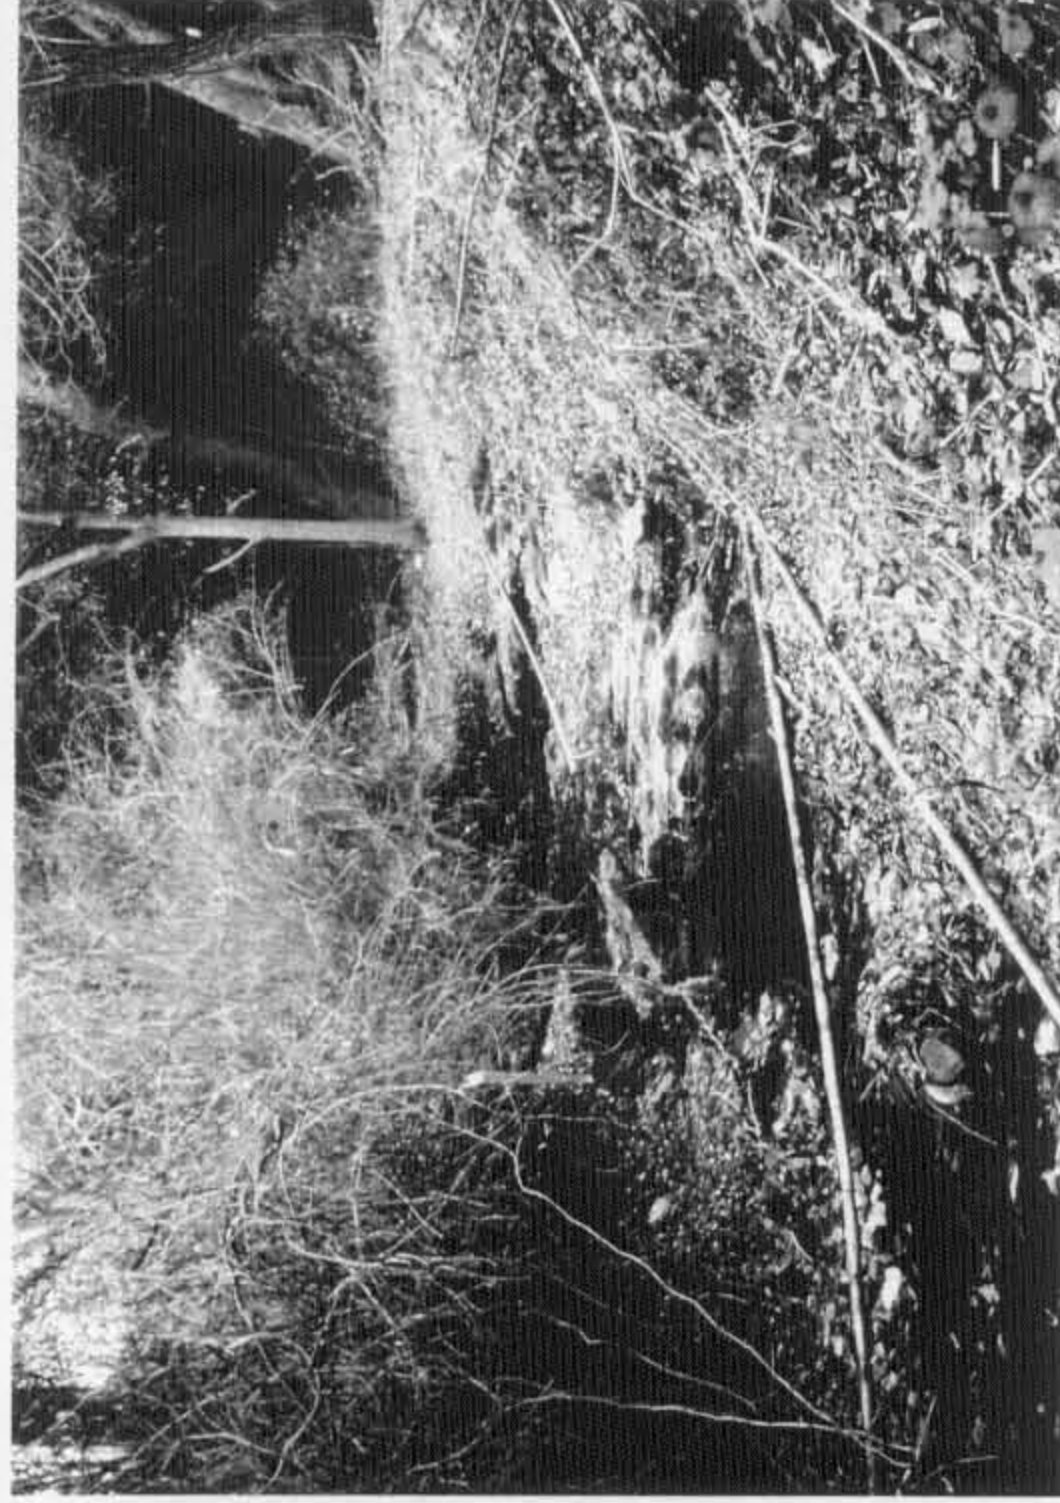
CHANNEL TYPES

1. KILLORAN ROAD -
TIMONIUM ROAD SECTOR
AT TRAVERSE POINT 10 (G).
2. KILLORAN ROAD -
TIMONIUM ROAD SECTOR
BELOW KILLORAN ROAD
OUTFALL (F).
3. KILLORAN ROAD - TIMONIUM
ROAD SECTOR UPSTREAM
FROM TRAVERSE
POINT 4 (F).
4. KILLORAN ROAD -
TIMONIUM ROAD SECTOR
BETWEEN TRAVERSE POINTS
3 & 4. NOTE MID-CHANNEL
BAR (C).
5. TIMONIUM ROAD -
CONFLUENCE SECTOR AT
TRAVERSE POINT 29 (C).
6. TIMONIUM ROAD -
CONFLUENCE SECTOR ABOVE
TRAVERSE POINT 27 (B1).

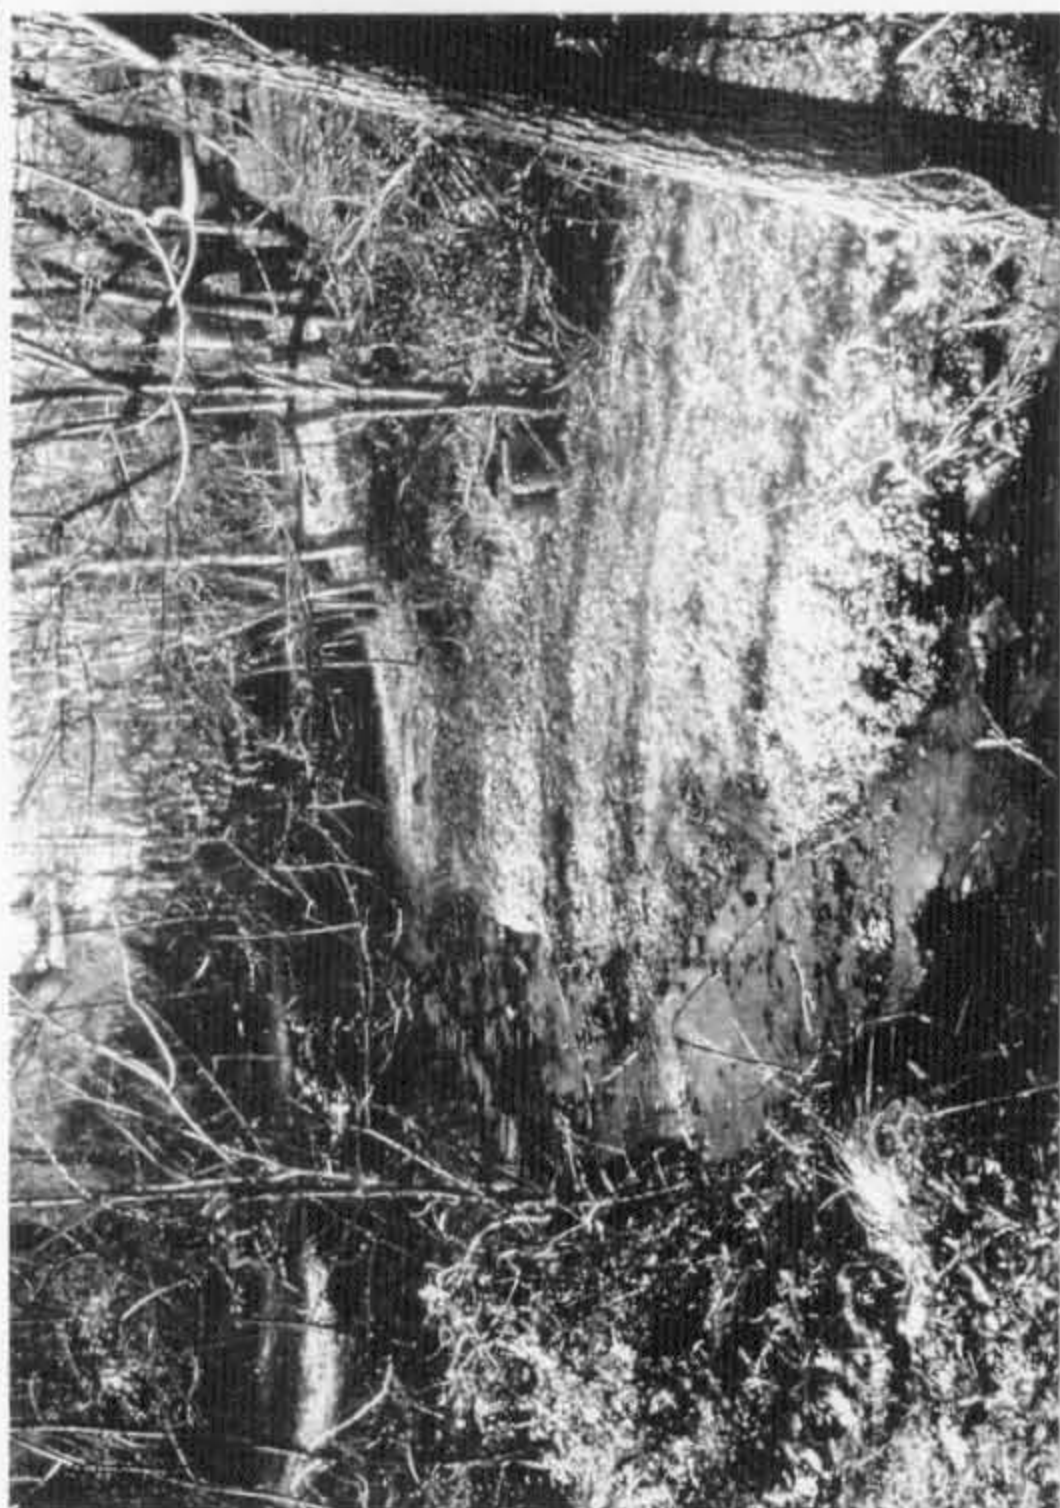
②

1. CONFLUENCE - REUTER ROAD SECTOR BELOW HATHAWAY ROAD OUTFALL (G).

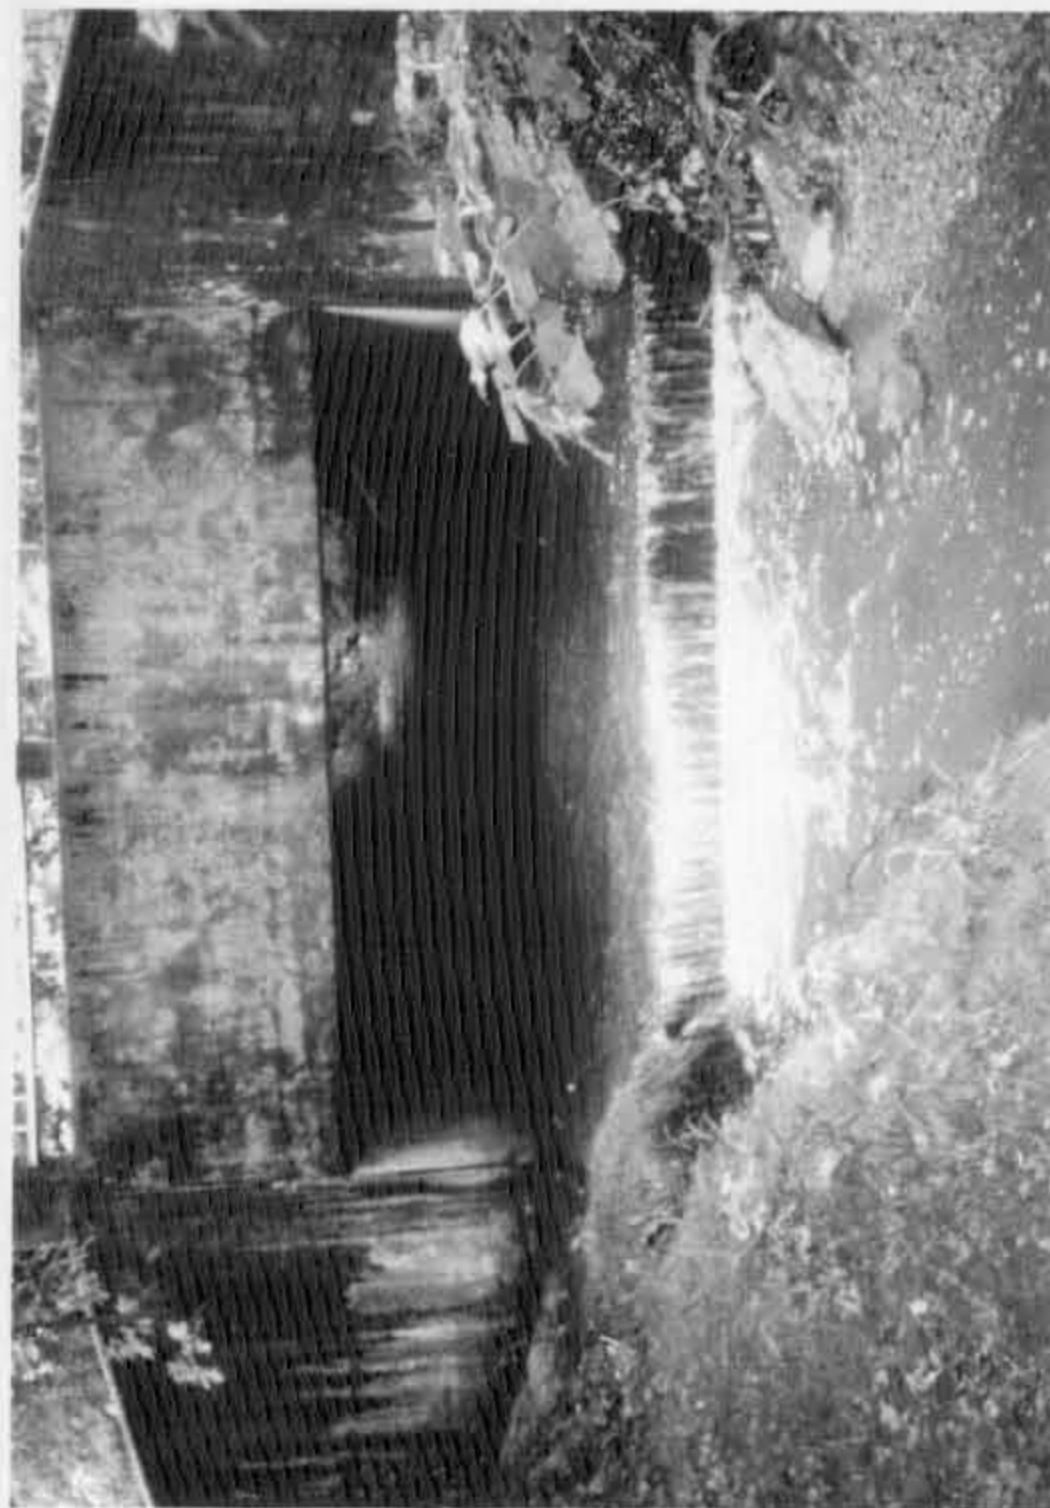
⑥

6. REUTER ROAD CULVERT.(F)
