Spring Branch Subwatershed - Small Watershed Action Plan

Volume 2: Appendices D Through G

Spring Branch Stream Restoration – Conceptual Plan Report (Biohabitats, 1995)

Spring Branch Stream Restoration Project

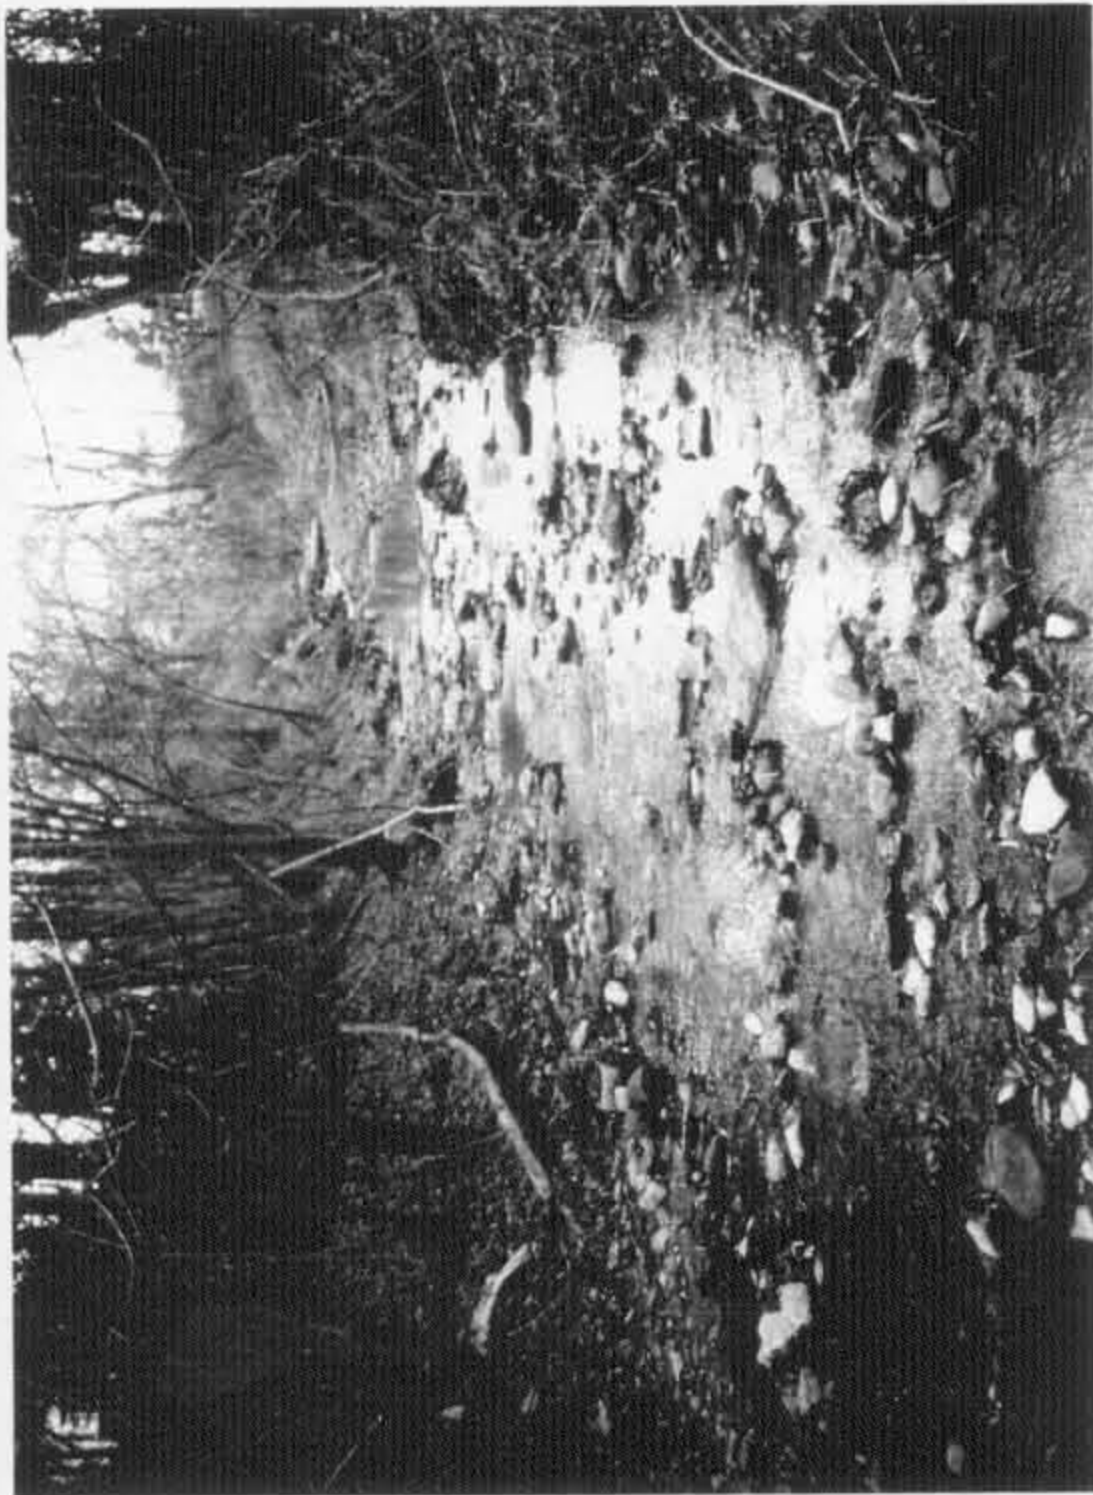
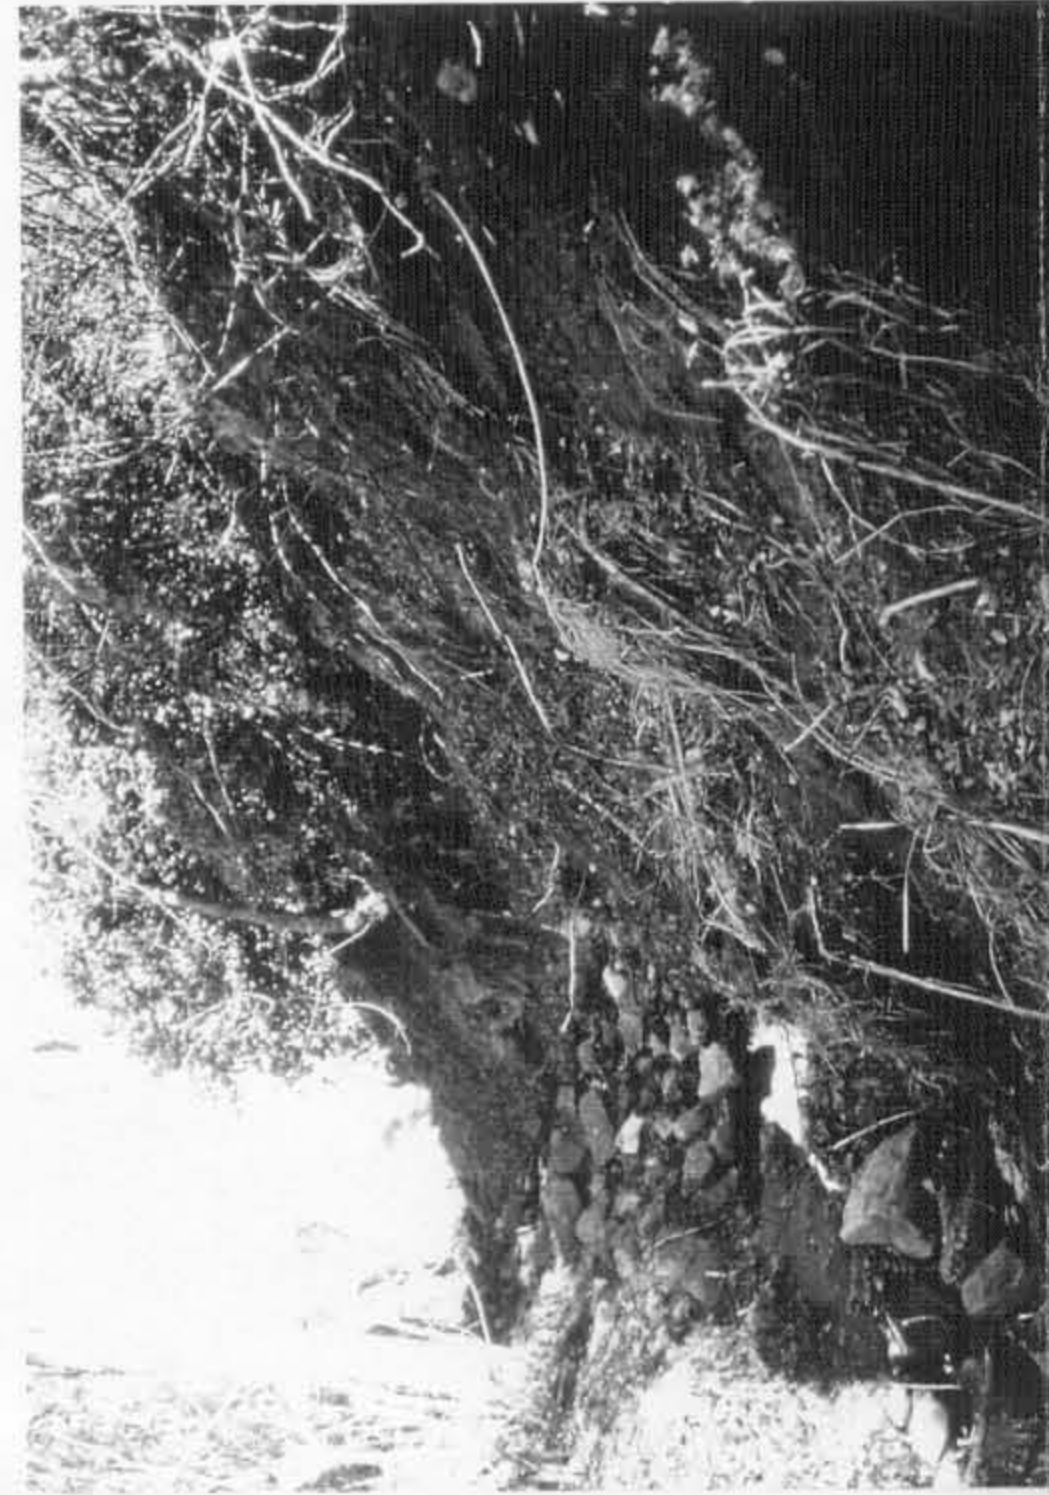
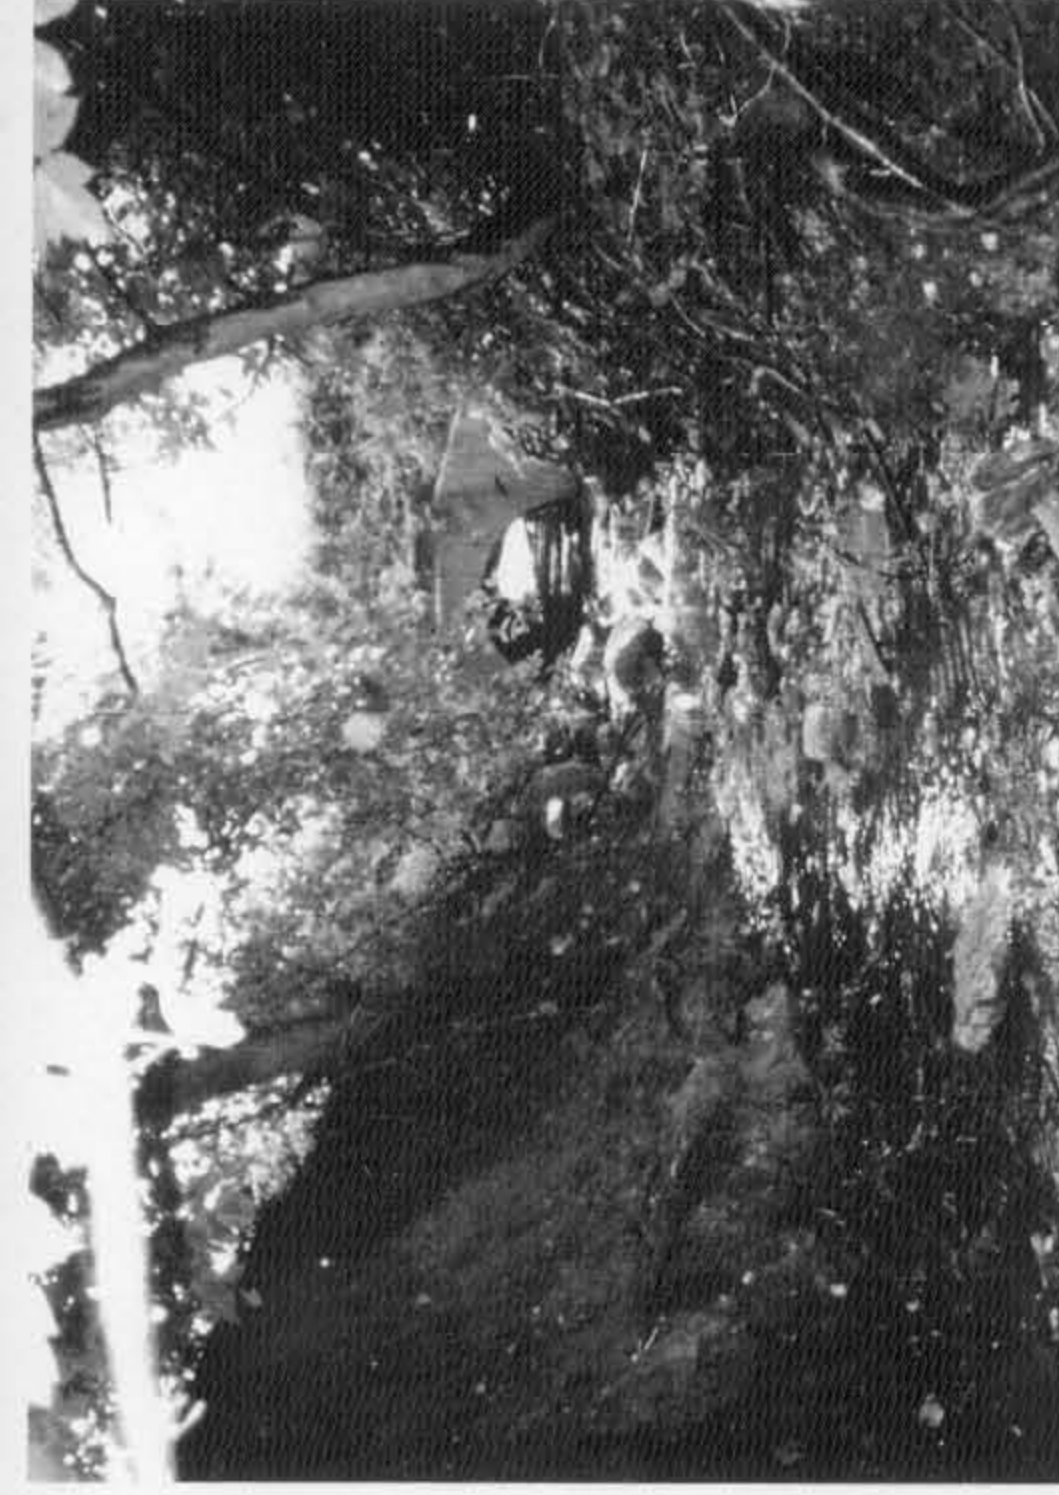
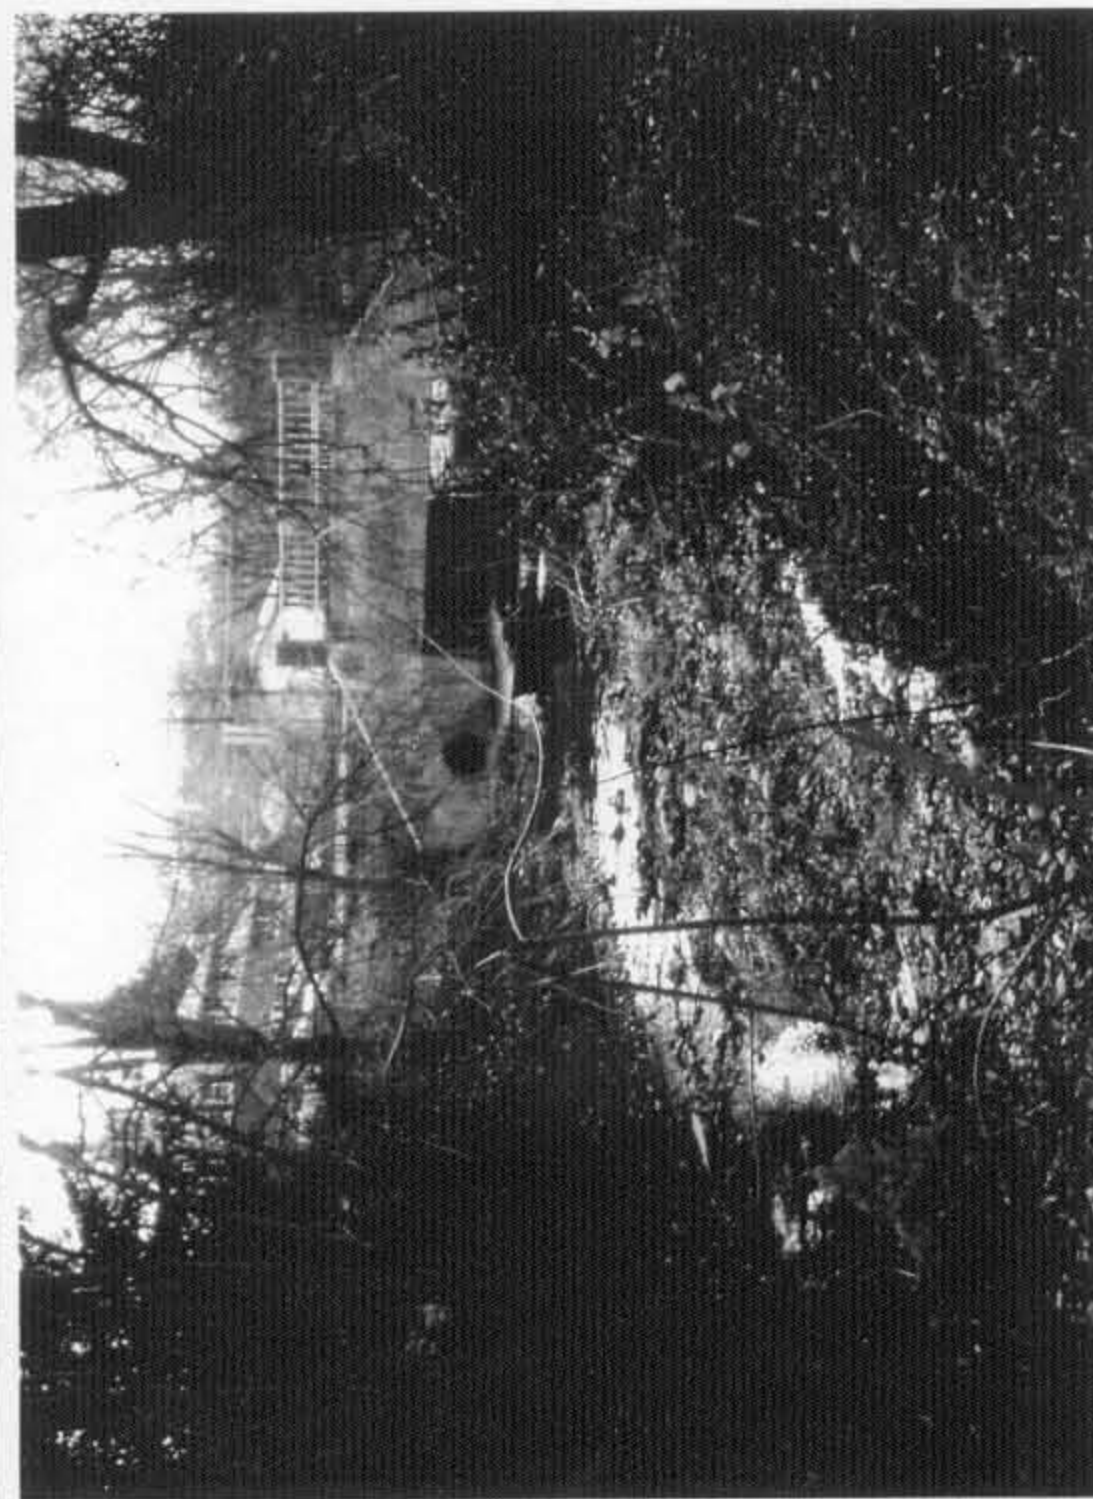
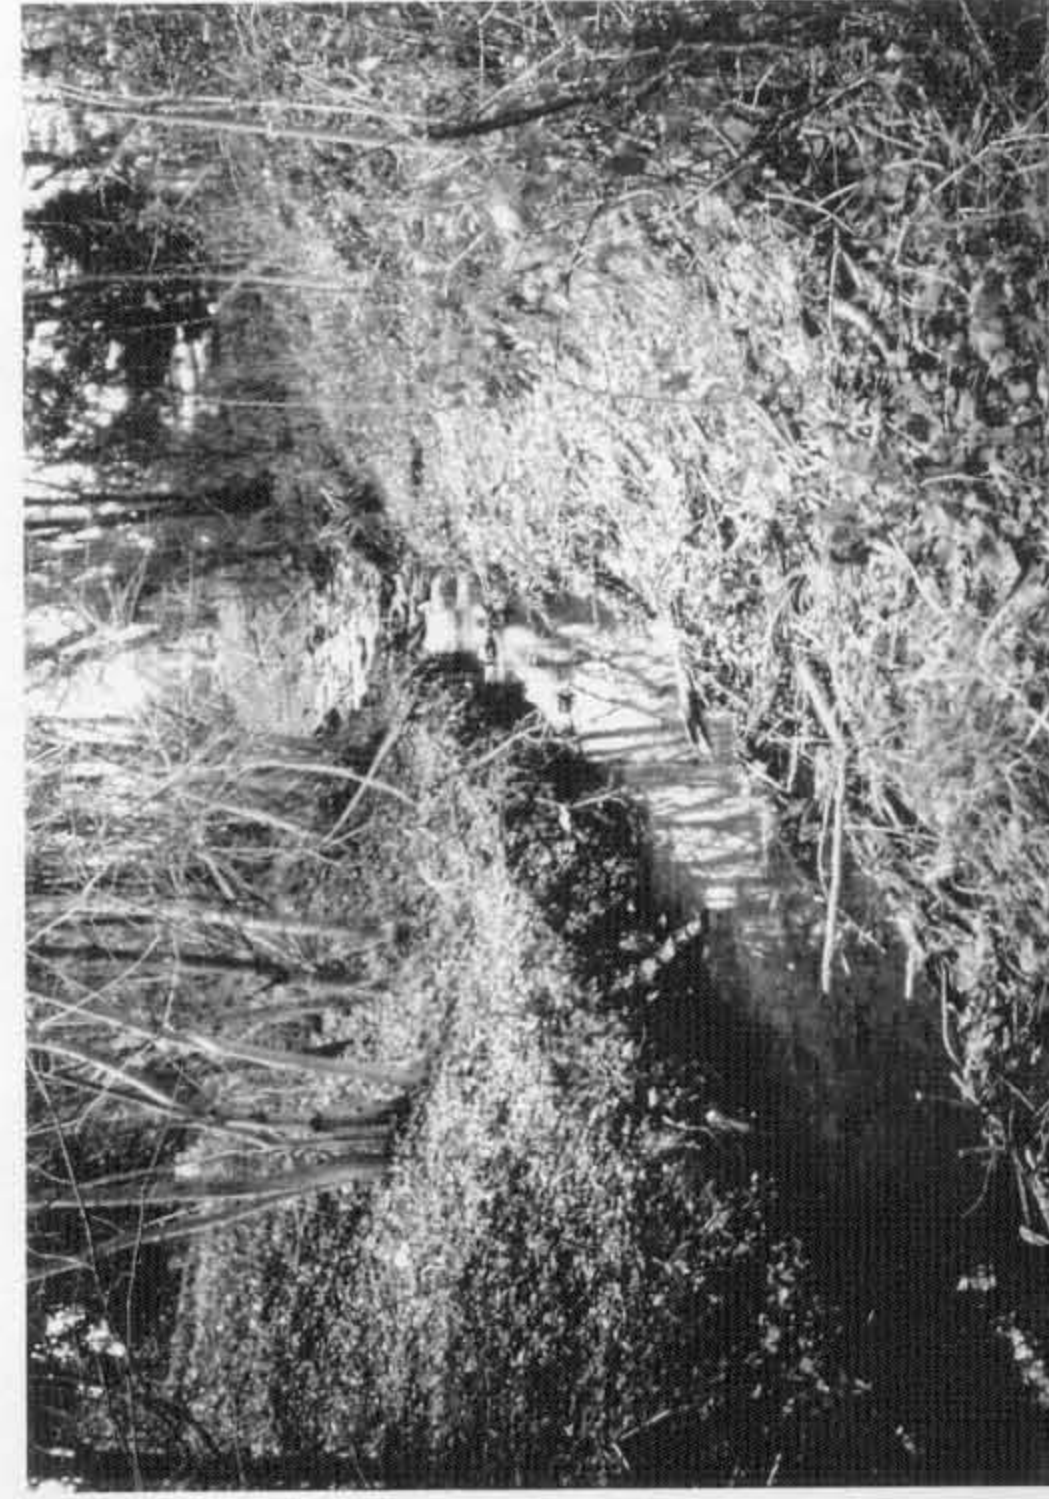
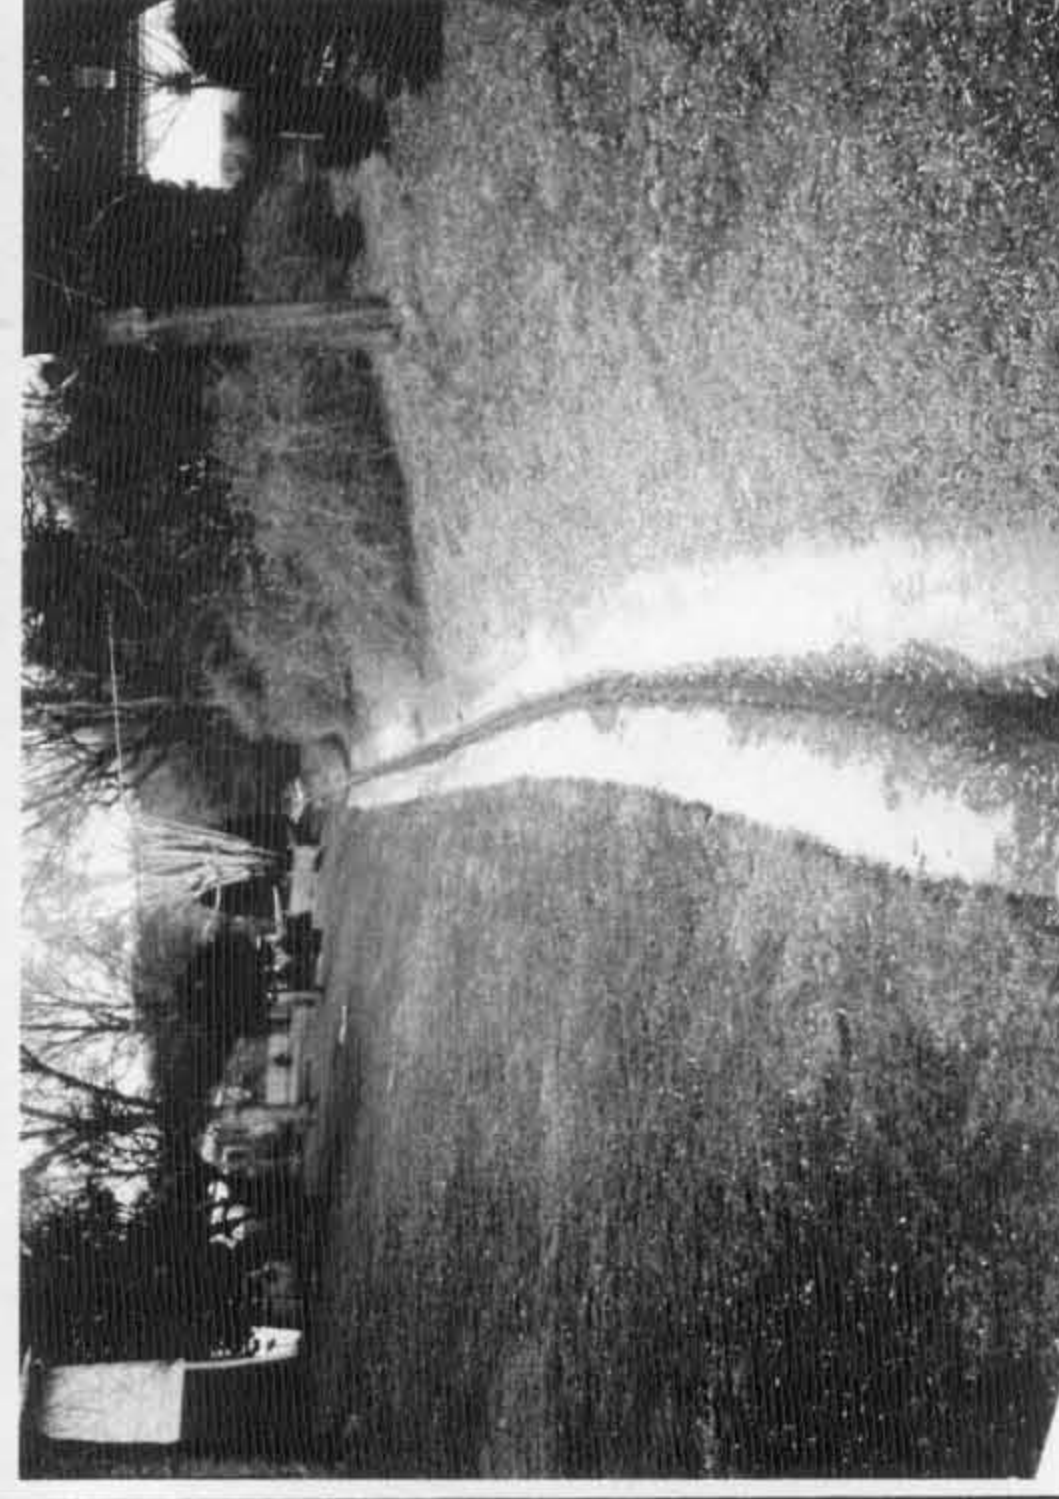
CHANNEL TYPES

1. REUTER ROAD - CINDER ROAD SECTOR AT TRAVERSE POINT 46 (F).
2. REUTER ROAD - CINDER ROAD SECTOR BELOW EASTRIDGE ROAD CULVERT (F).
3. HOLLOWBROOK TRIBUTARY AT CONFLUENCE WITH MAIN STEM.
4. REUTER ROAD - CINDER ROAD SECTOR AT TRAVERSE POINTS 48 & 47 (ATYPICAL/GABIONS).
5. HOLLOWBROOK TRIBUTARY AT HOLLOWBROOK ROAD CULVERT. (G)
6. HOLLOWBROOK TRIBUTARY CONCRETE FLUME. (ATYPICAL)

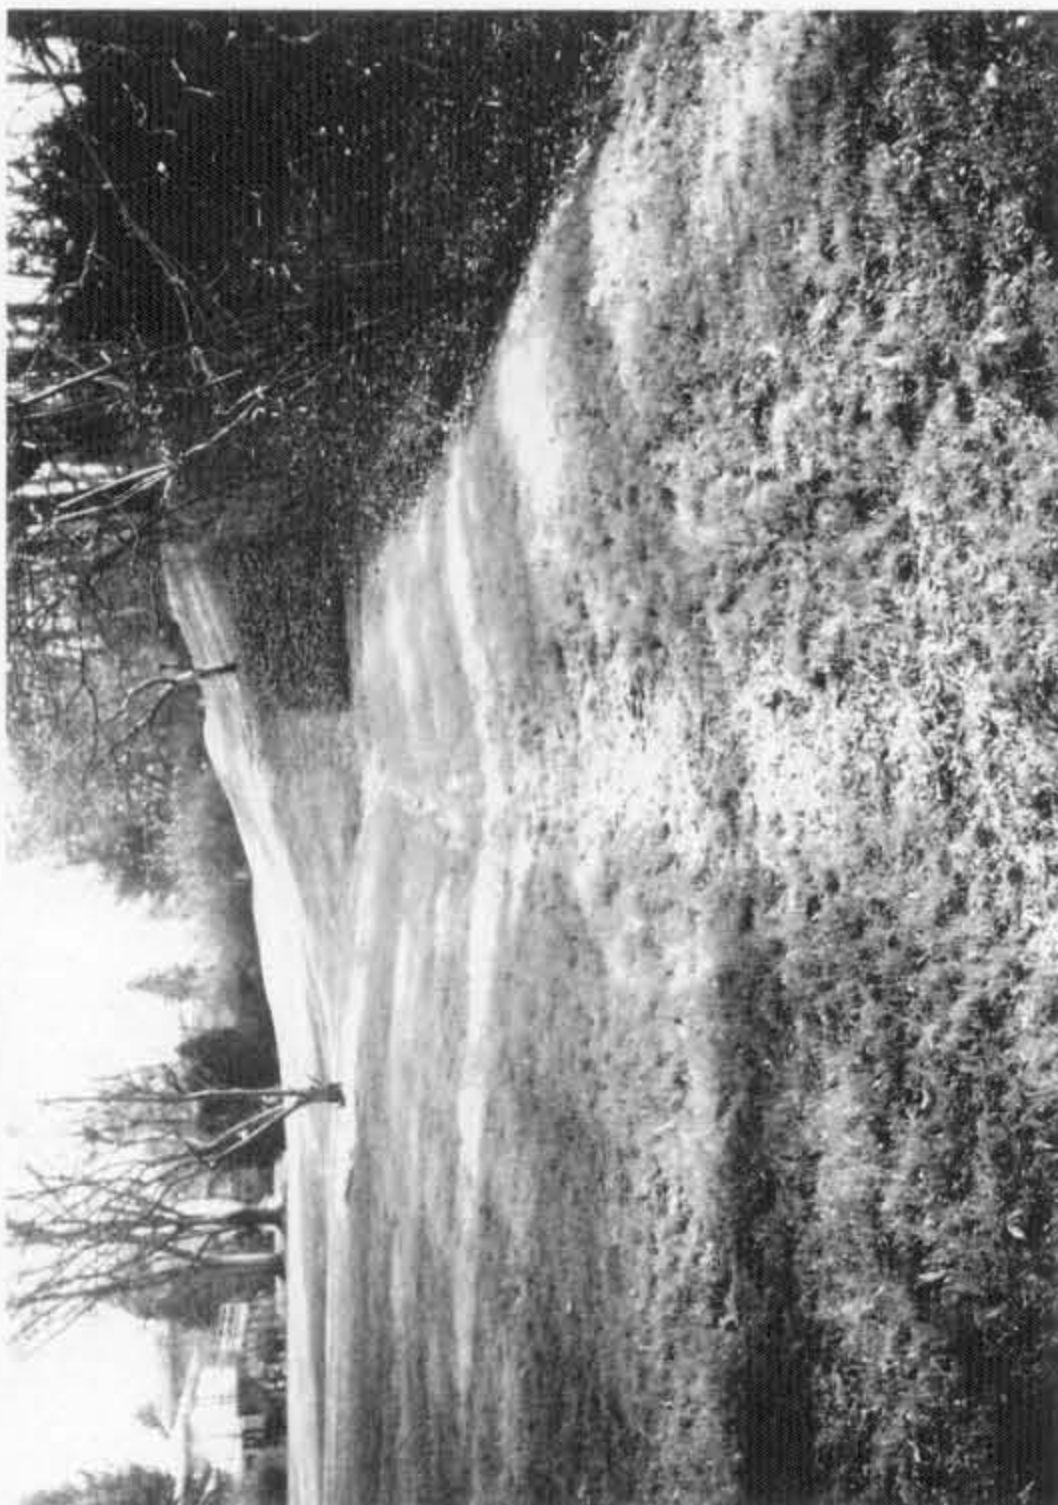
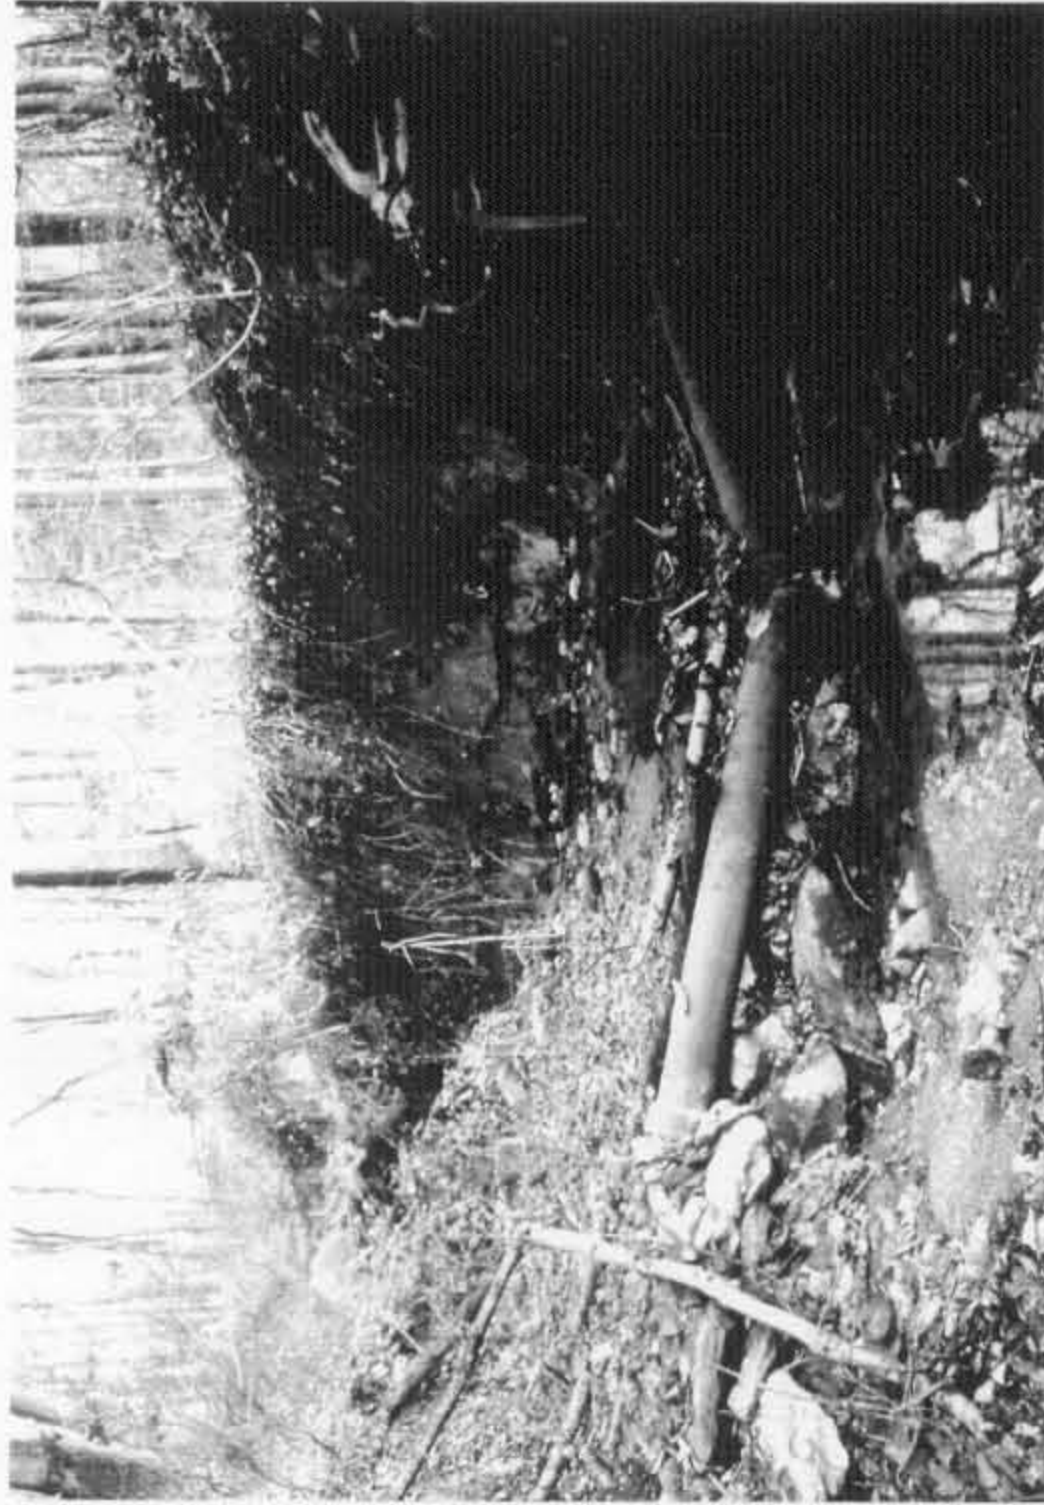
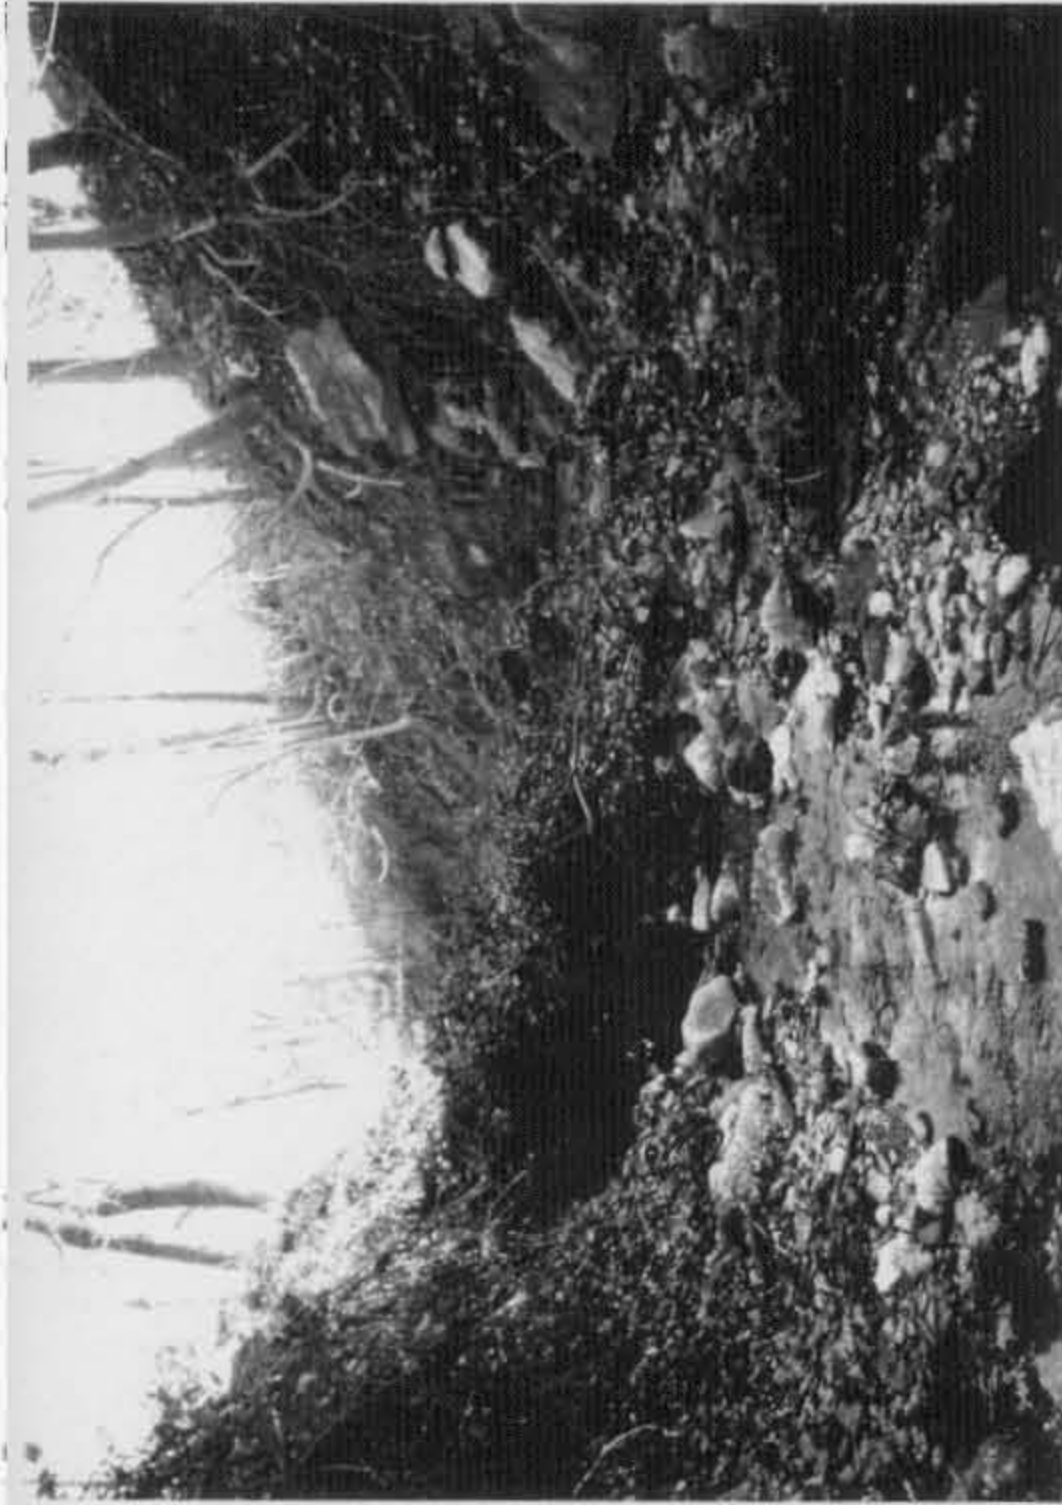
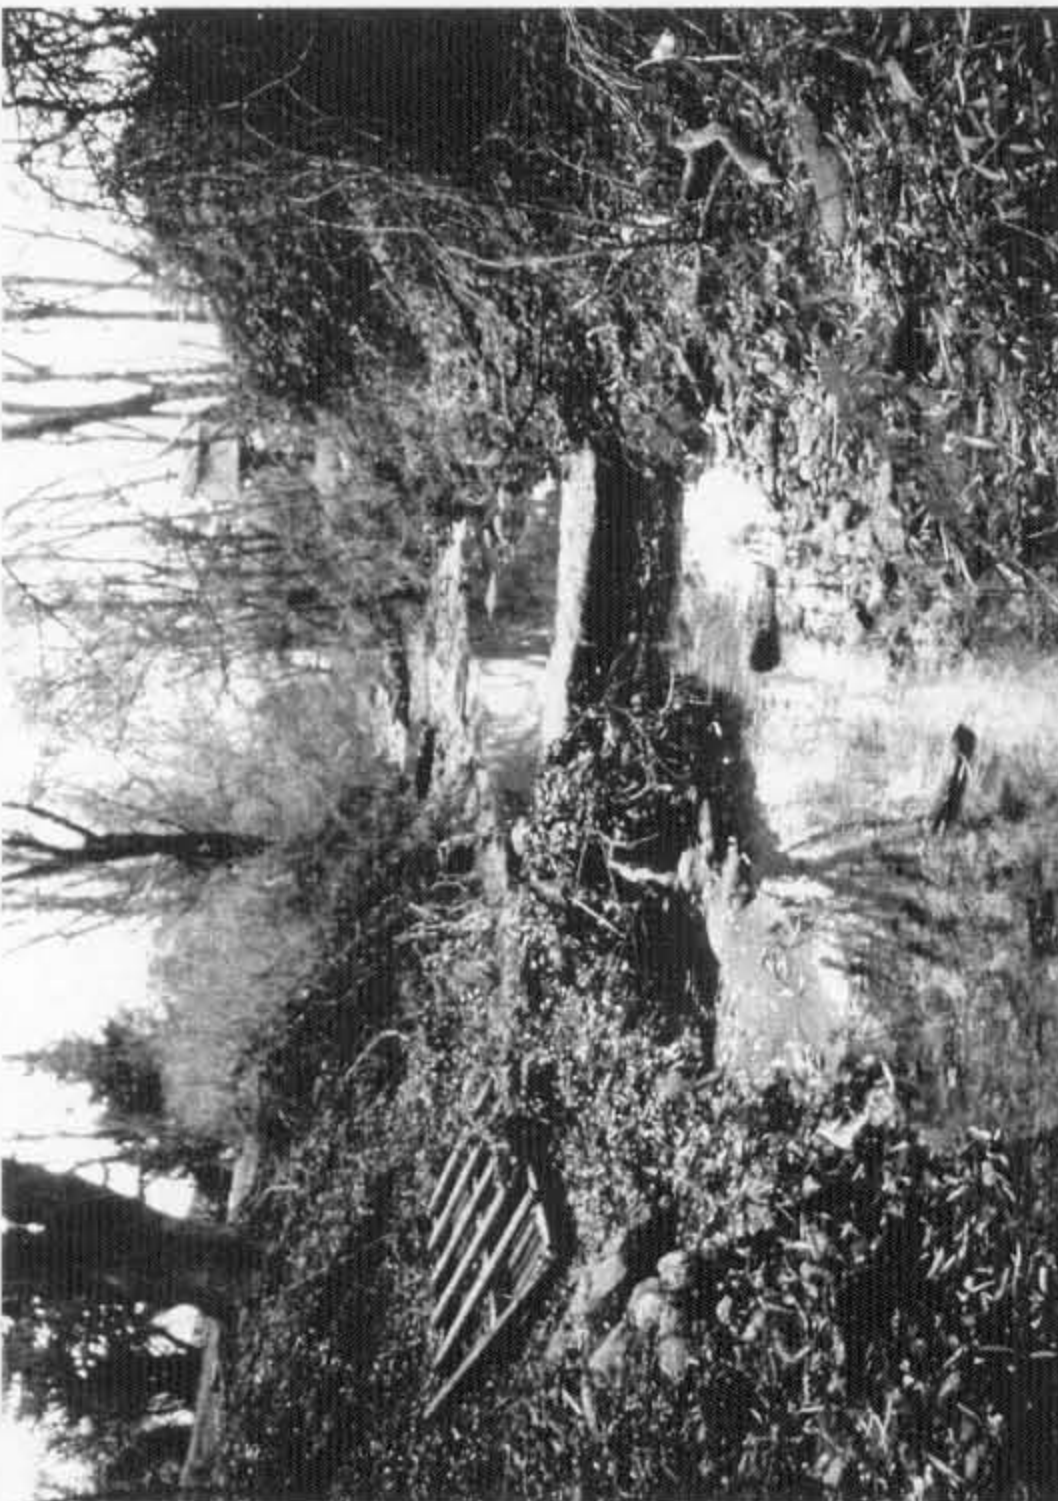
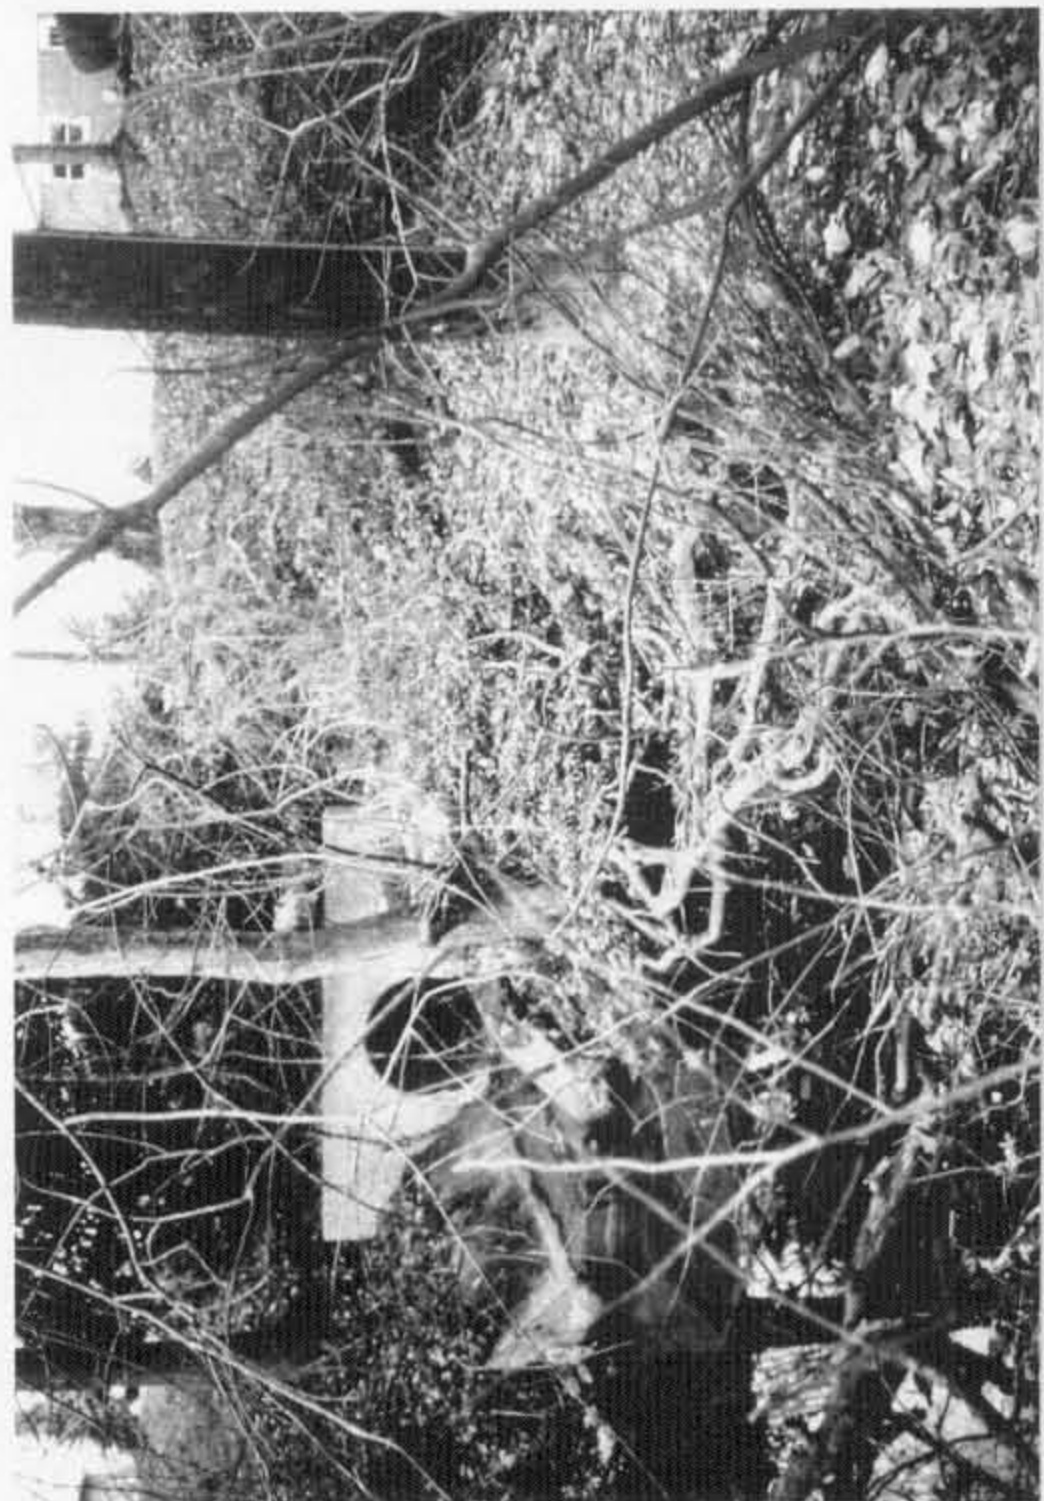
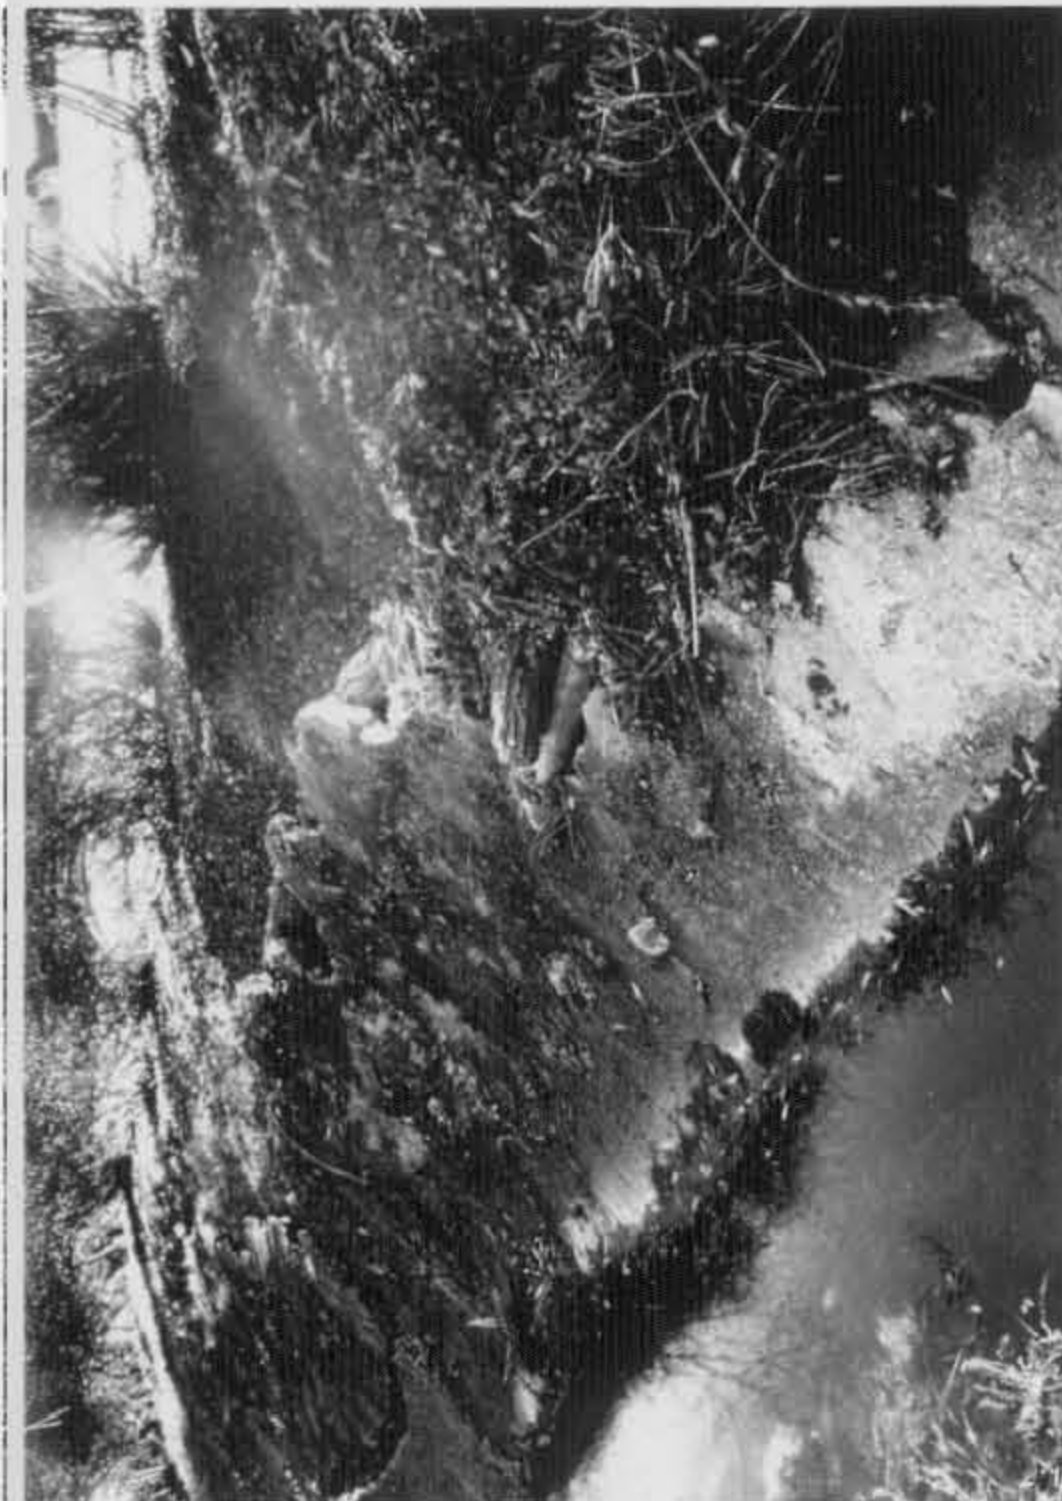
PROBLEM AREAS
OF INTEREST

1. CONCENTRATED OVERLAND FLOW ABOVE KILLORAN ROAD OUTFALL.
2. EXPOSED SEWER TRUNK LINE CROSSING IN REUTER ROAD - CINDER ROAD SECTOR ABOVE TRAVERSE POINT 46.
3. BROKEN SEWER LATERAL IN KILLORAN ROAD - TIMONIUM ROAD SECTOR.
4. EROSION AT KILLORAN ROAD OUTFALL.
5. DEBRIS DAM IN CONFLUENCE - REUTER ROAD SECTOR ABOVE TRAVERSE POINT 35.

6. FAILED CONCRETE BANK REPAIR ABOVE EASTRIDGE ROAD CULVERT.
