Spring Branch Subwatershed - Small Watershed Action Plan

Volume 2: Appendices D Through G

Spring Branch Stream Restoration – Conceptual Plan Report (Biohabitats, 1995)

Spring Branch Stream Restoration Project

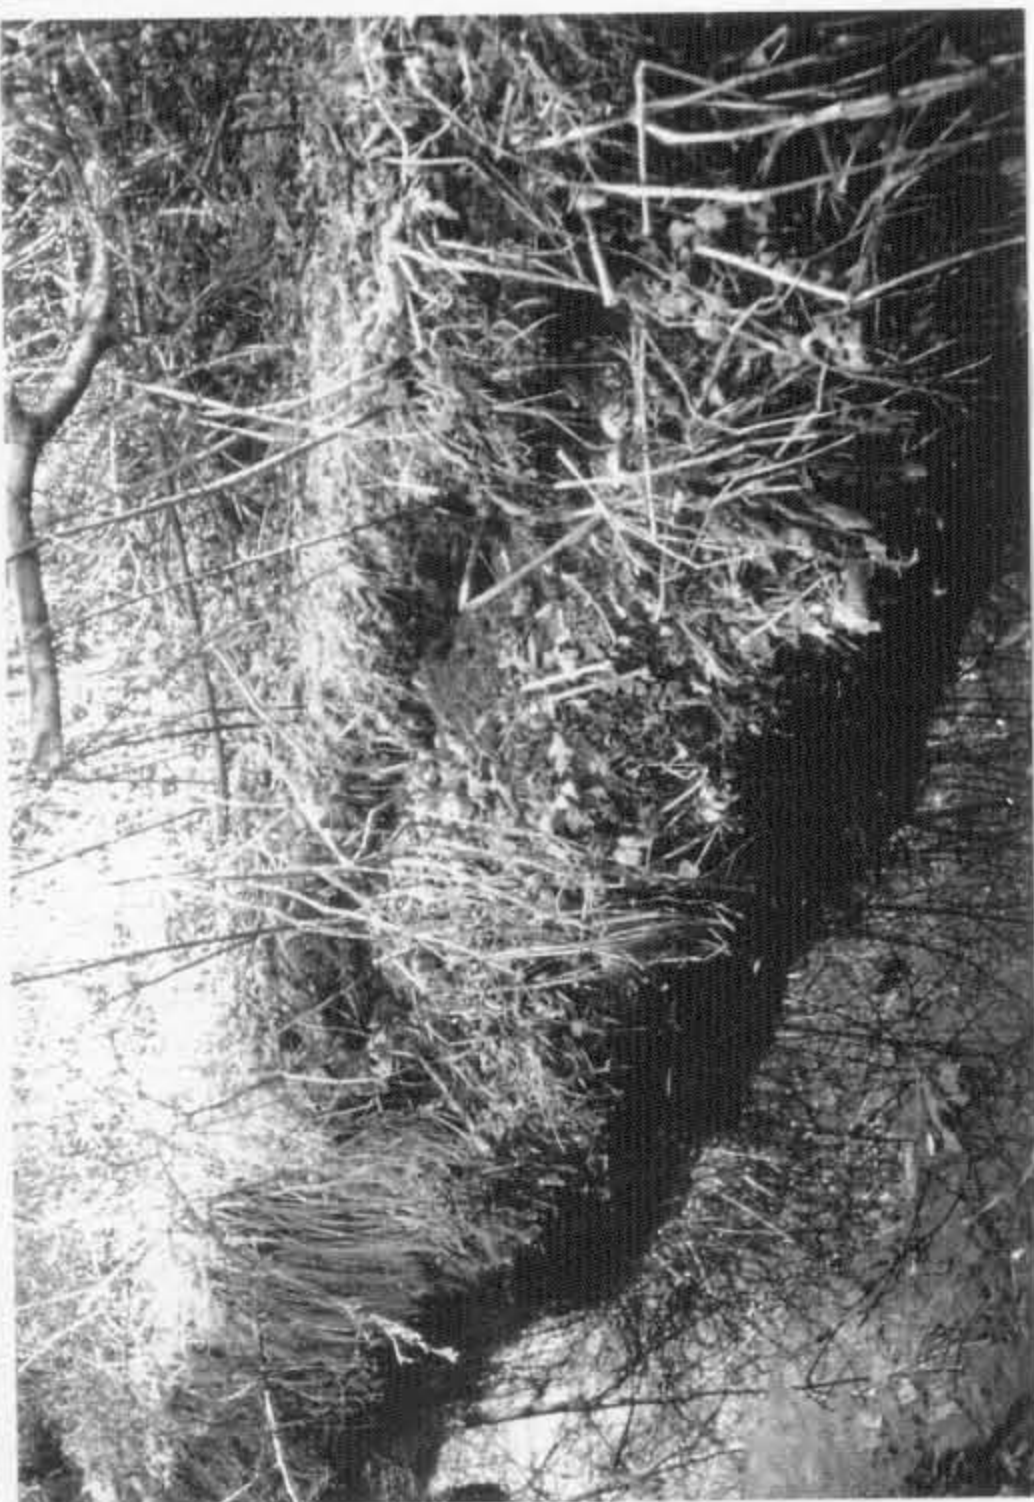
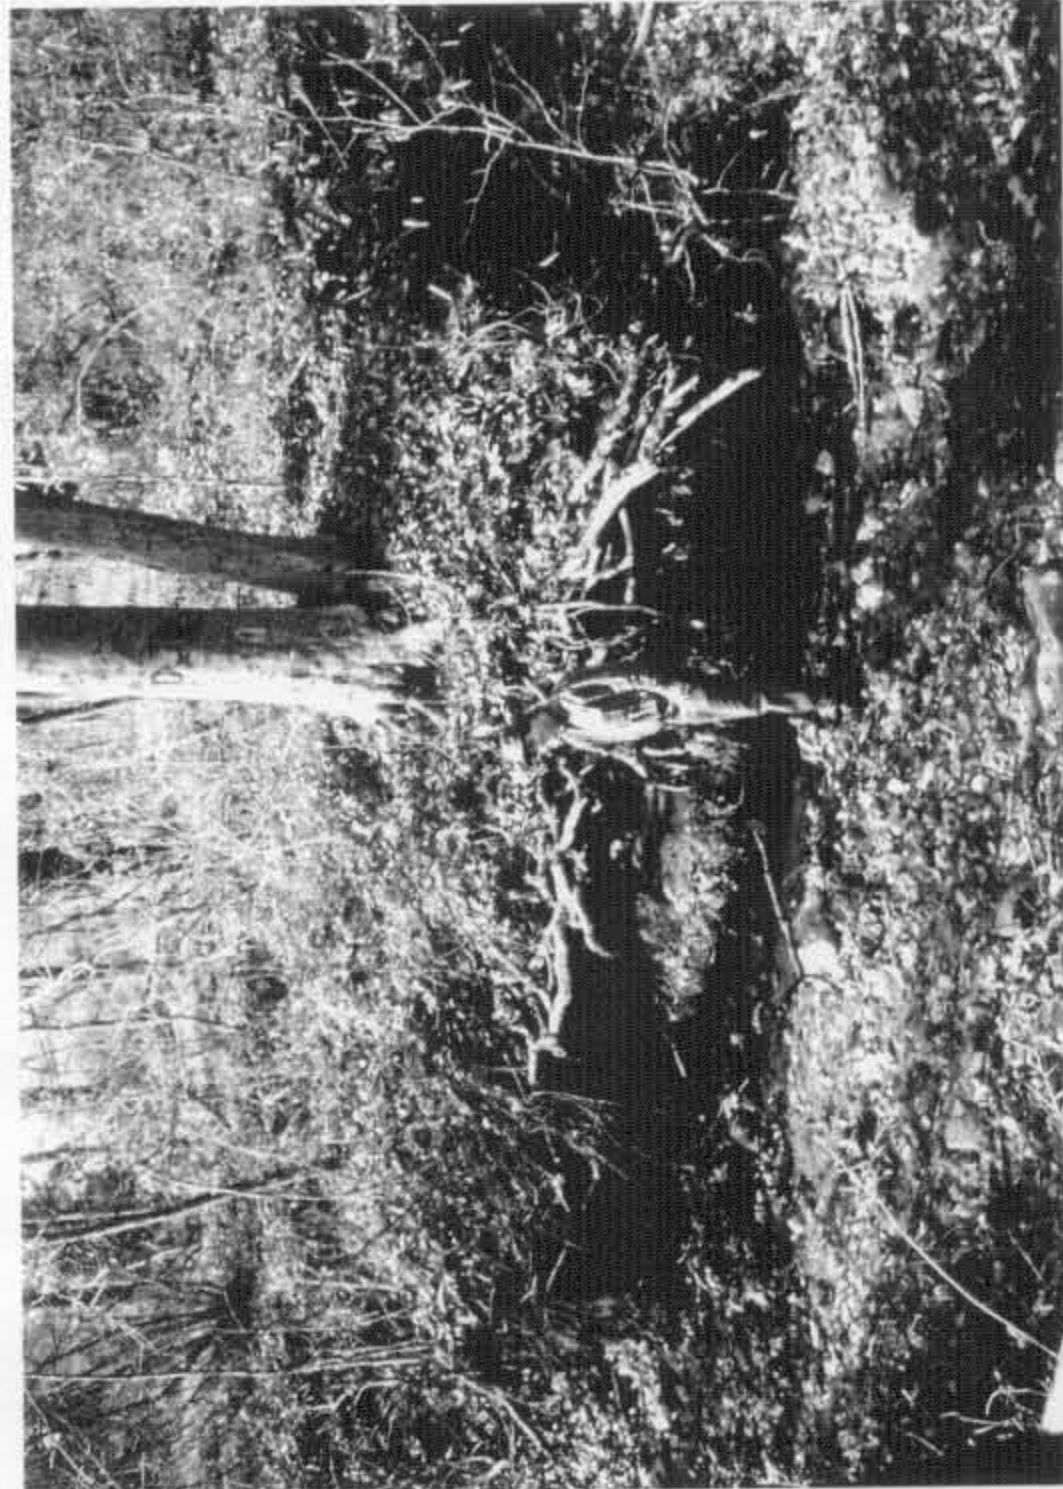
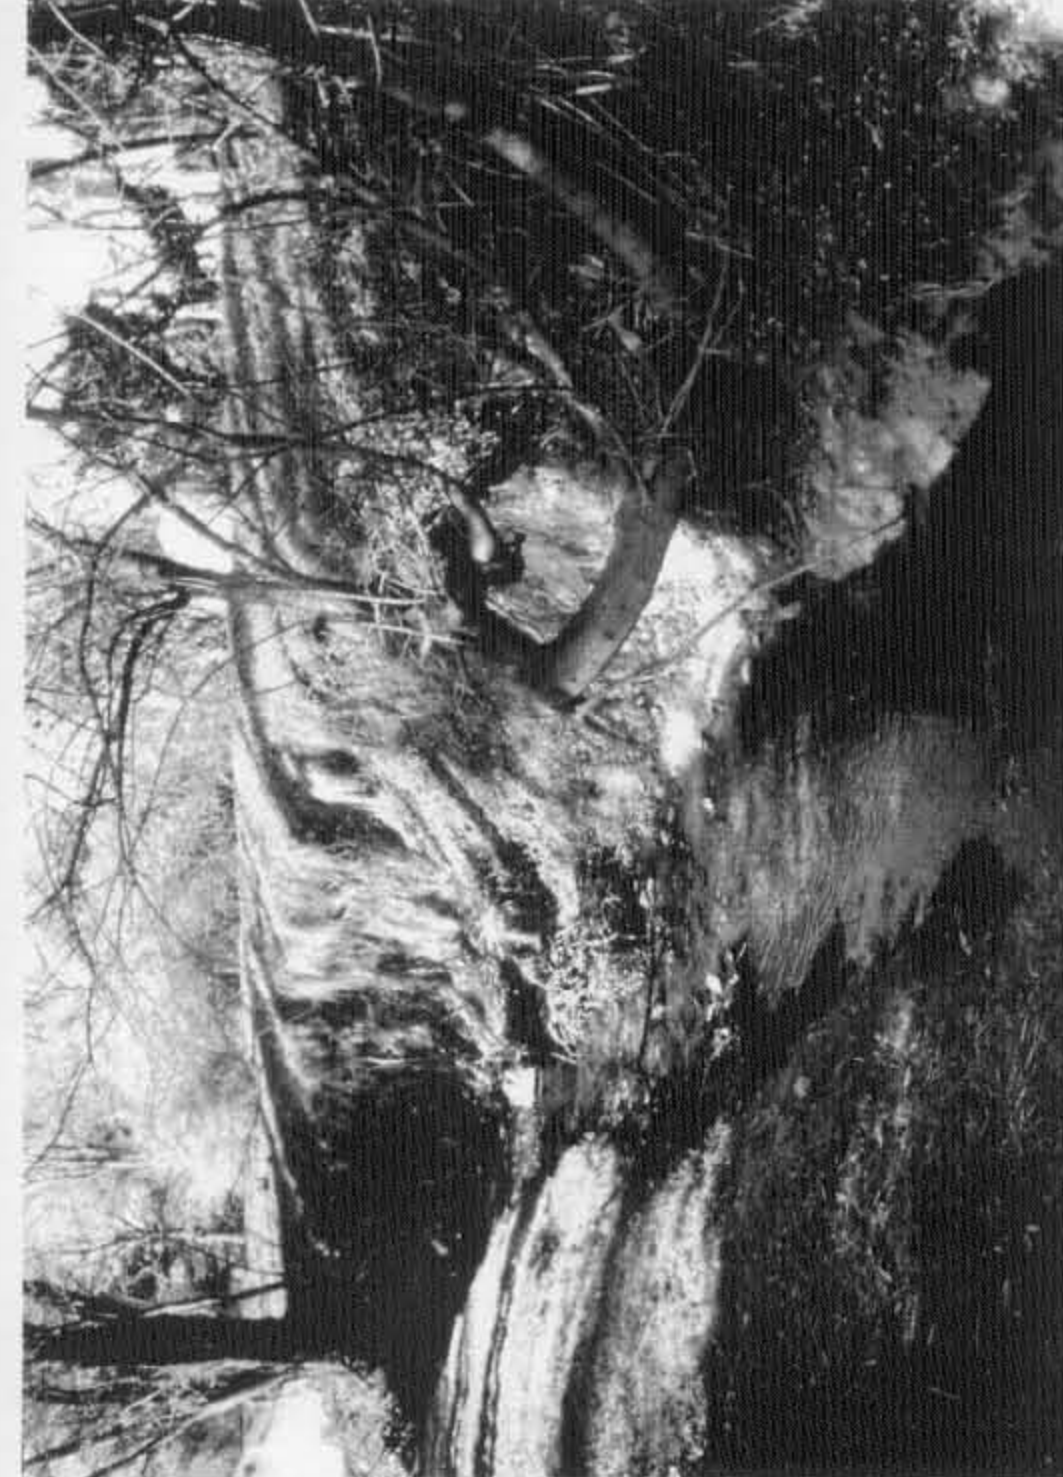
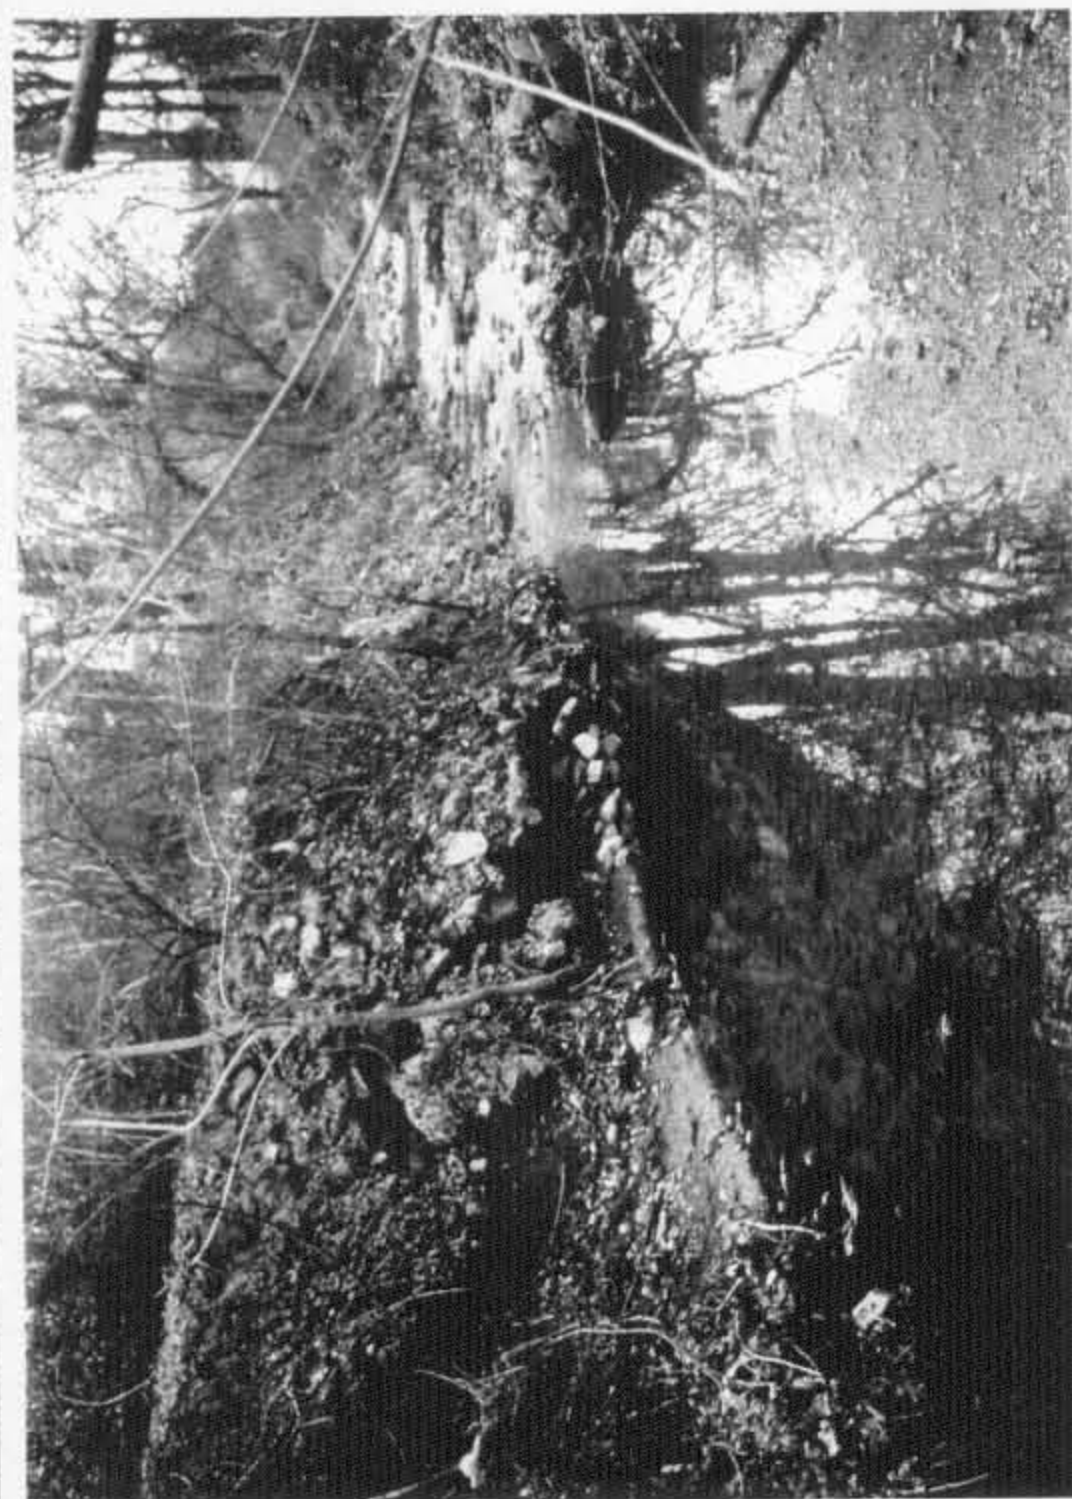
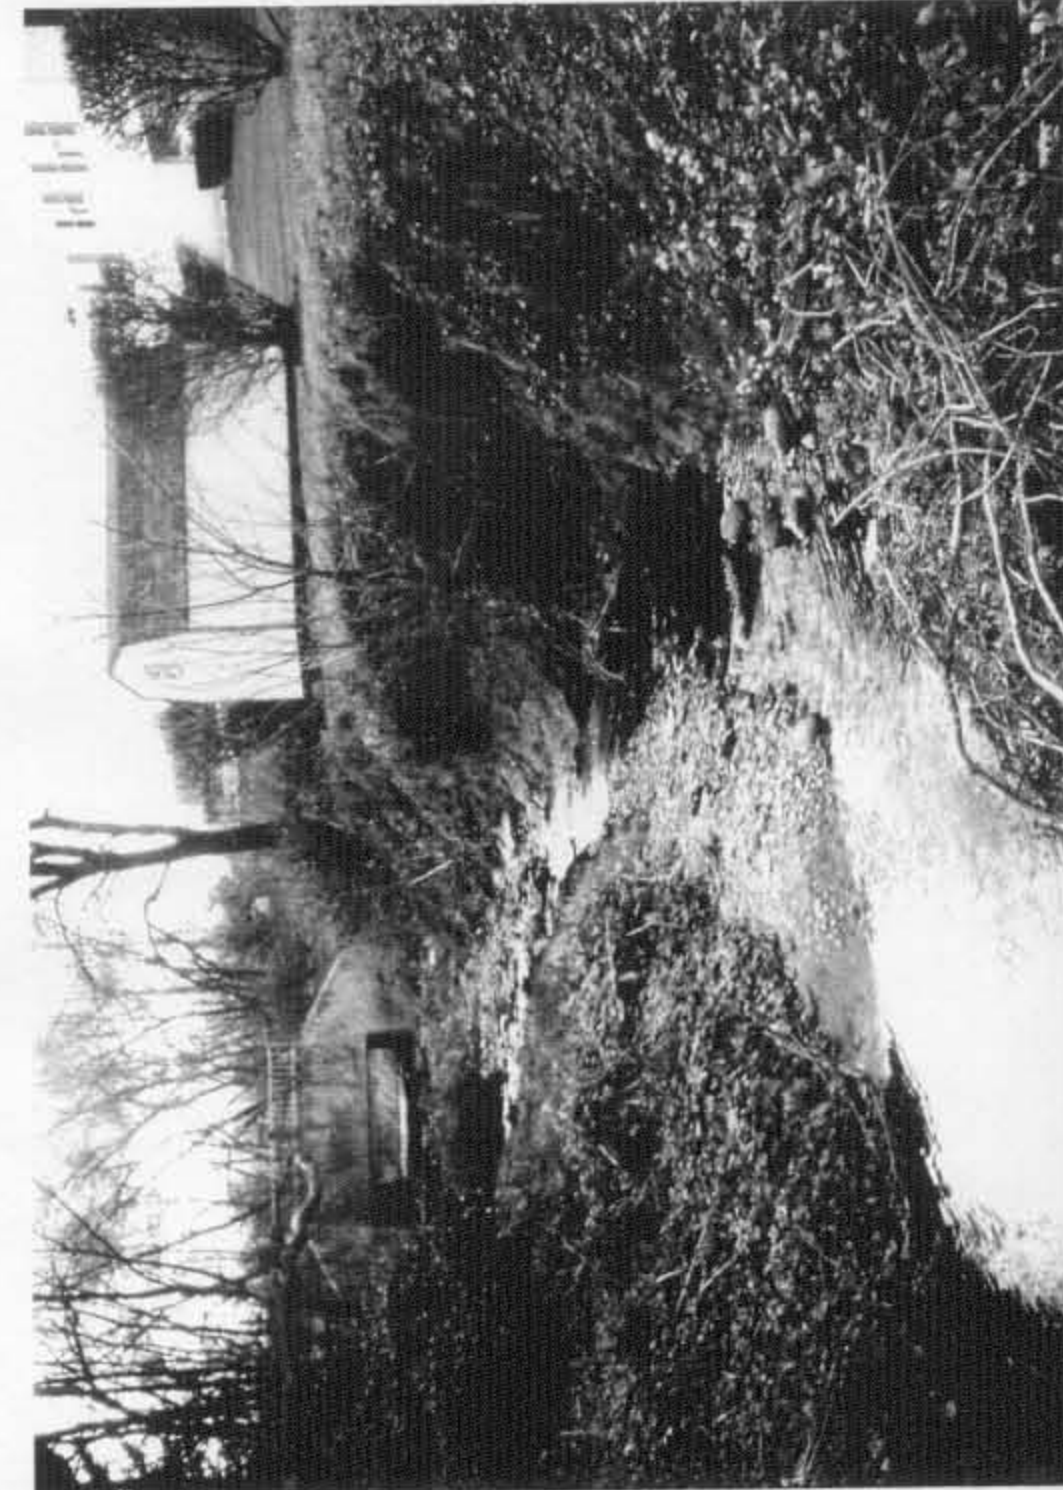
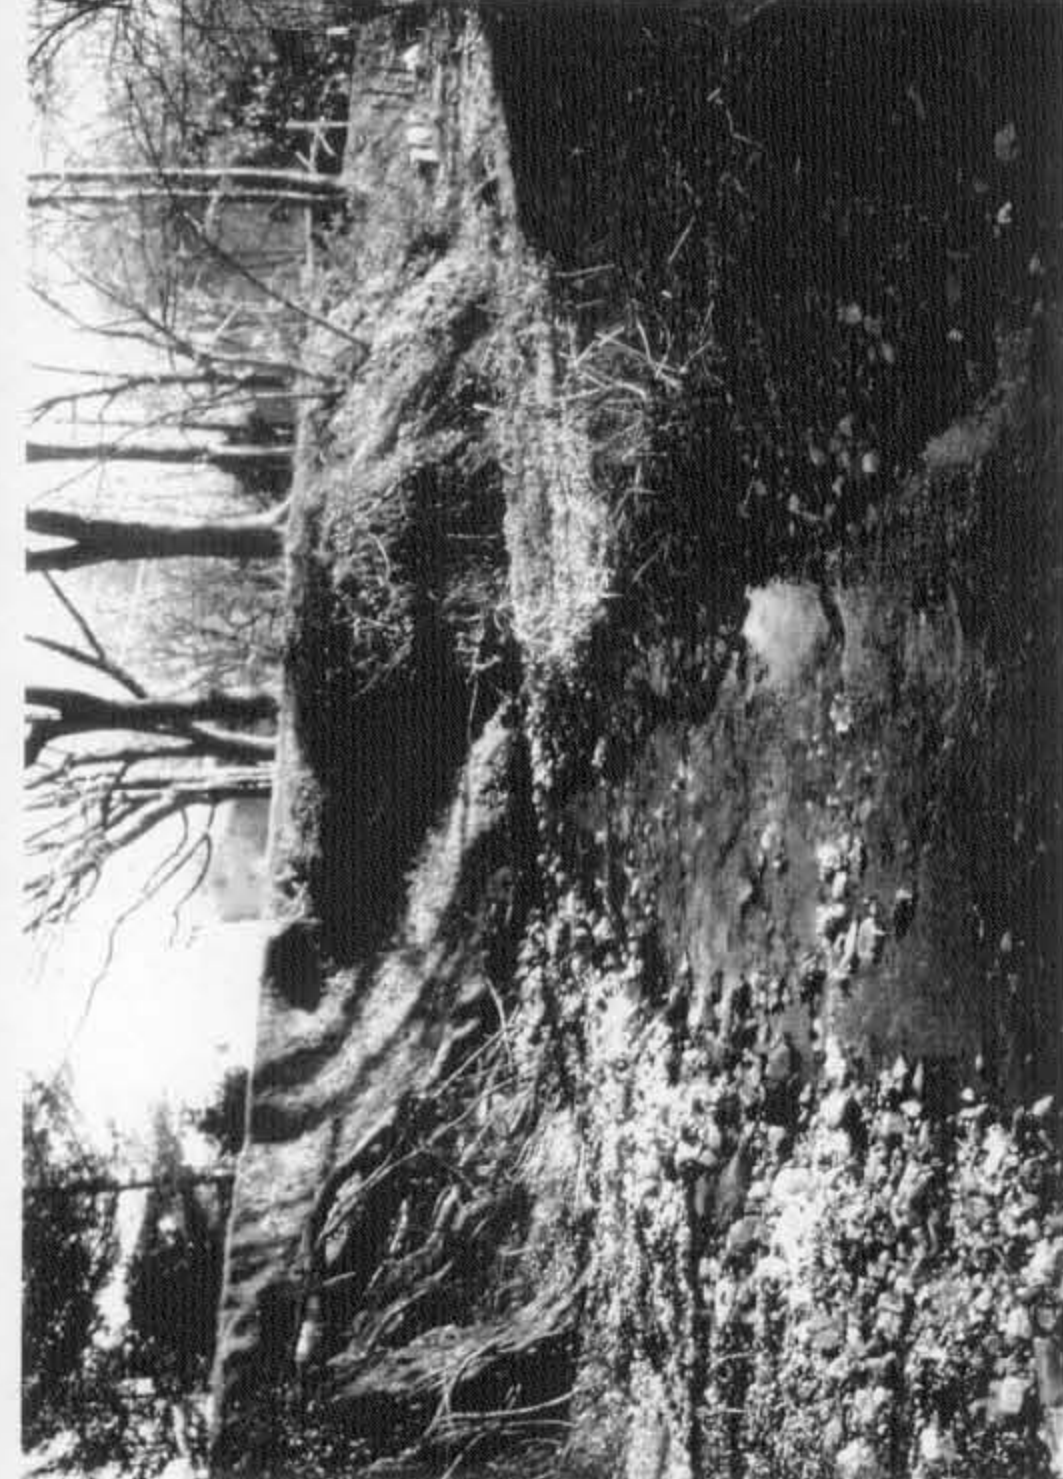
BANK EROSION
EXAMPLES

1. RIGHT BANK OF HOLLOWBROOK TRIBUTARY.
2. RIGHT BANK OF THE REUTER ROAD - CINDER ROAD SECTOR.
3. KILLORAN ROAD - TIMONIUM ROAD SECTOR, OPPOSITE TRAVERSE POINT 9.
4. LEFT BANK BELOW EASTRIDGE ROAD.
5. LEFT BANK BELOW REUTER ROAD CULVERT.
6. RIGHT BANK AT AND BELOW SPRINGSIDE DRIVE PIPE OUTFALL.

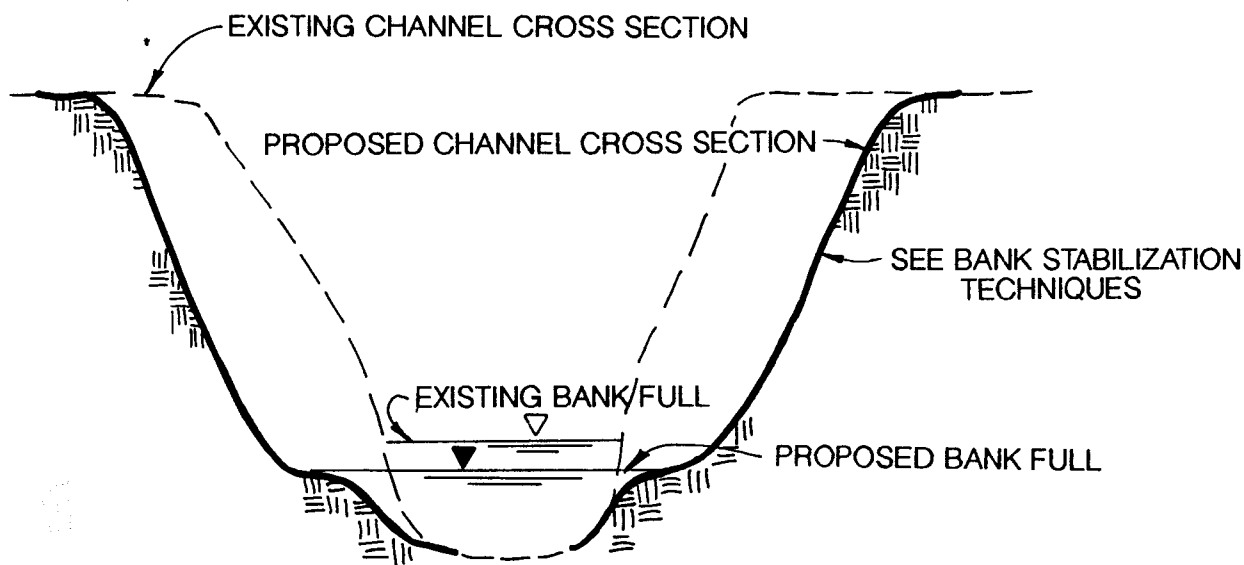
CHANNEL GEOMETRY MODIFICATION

"B" WITHIN A "G"

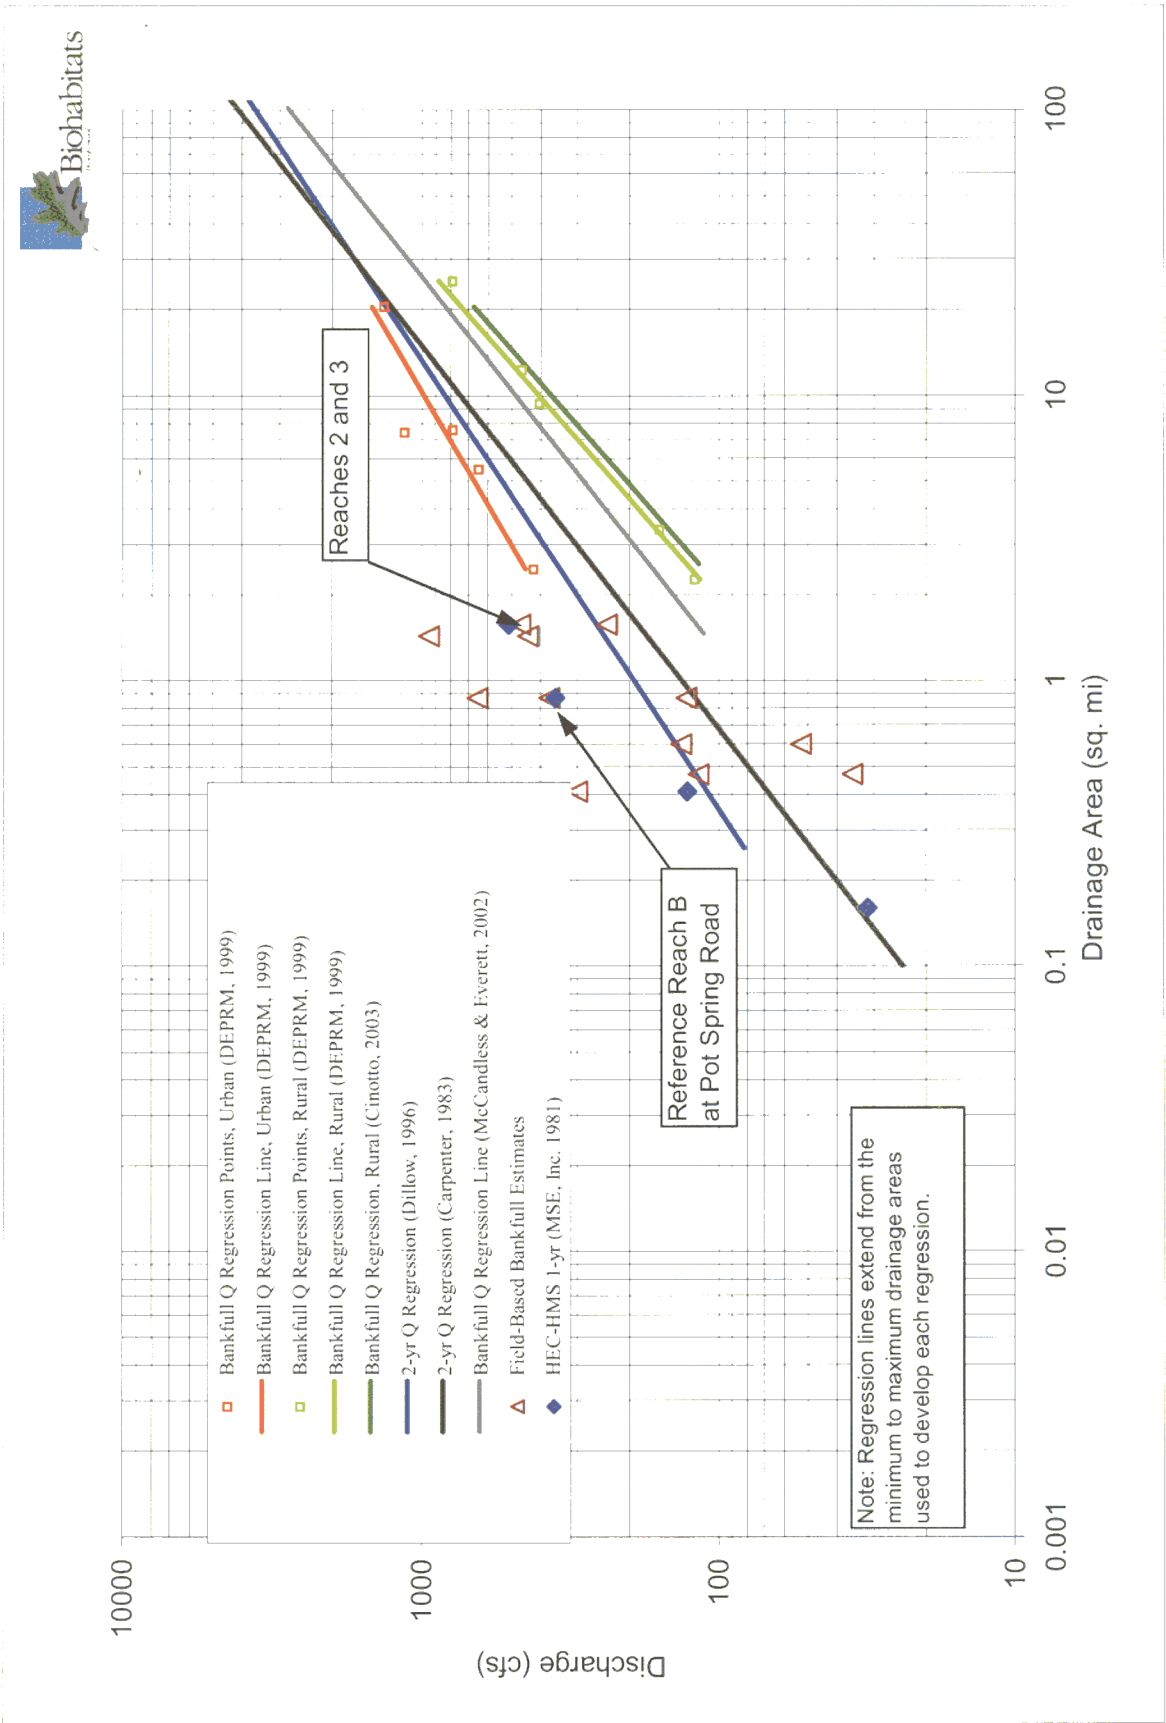
Figure 3.1. Comparison of Field Bankfull Estimates, HEC-HMS Results, and Regional Regressions.

As previously noted, the best bankfull indicators were located on the reference reaches and within Reaches 2 and 3. The field based discharge values calculated for these reaches fall in line with the DEPRM Urban (1999) regression; however, the drainage areas used for the regression are out of the range of the drainage area of our study (Figure 3.1). More support for these values can be found in the results of the 1-year discharge from the HEC-HMS model. The high bankfull discharge calculated for reference Reach B (375.1 CFS) near Pot Spring Road corresponds very well with the value returned for the HEC-HMS model (359 CFS) at the same location (Tables 3.3 and 3.5). In addition, the value (516 CFS) modeled for the downstream end of the site at Dulaney Valley Road corresponds well with the bankfull measurements for Reaches 2 and 3 (443.8 and 471.9 respectively).

From these relationships we propose a high bankfull design discharge of 360 CFS from Pot Spring Road to Tributary A and a design high bankfull discharge of 520CFS from Tributary A to Dulaney Valley Road (Table 3.7). The comparison of the field based, and HEC-HMS discharge estimates indicate that the model is a good indicator of the bankfull discharge. Therefore the 1-year HEC-HMS discharge estimates will be used for Tributaries A and B.

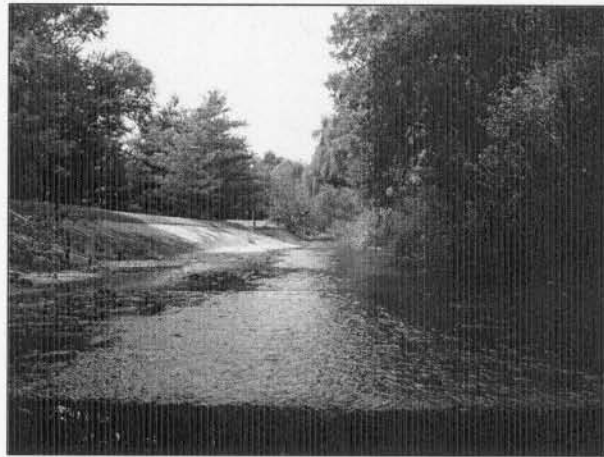
Photo 1. Reach 1 looking upstream from the end of the reach.

At the upstream end of this reach sandy debris and vegetation has blocked baseflow through the north side of the double box-culvert forcing baseflow through the south side of the culvert. Currently, only flows at bankfull or greater pass through the north side of the culvert. At approximately 70 feet downstream of the culvert, the concrete channel constricts down to 24.0 feet at the top of the channel. At approximately 140 feet downstream of the Pot Spring Road culvert, a perennial stream (Tributary A) enters the channel from the north (Appendix C). The last 20 feet of the channel enters Spring Branch through a small concrete channel. A dry concrete stormwater channel enters Spring Branch from the south approximately 340 feet downstream from the Pot Spring Road culvert. This reach will be further described below as Tributary B. After Tributary B enters the Spring Branch mainstem, the mainstem concrete channel widens to 34.0 feet at the top of the bank. This width continues until the end of the

This reach is a trapezoidal concrete channel that begins at the downstream side of the Pot Spring Road double box culvert and extends approximately 450 feet to the end of the concrete section (Appendix C). This reach was channelized in the early 1970's to accommodate underground sewers and overhead utility lines on the south bank, and residential properties along both banks.

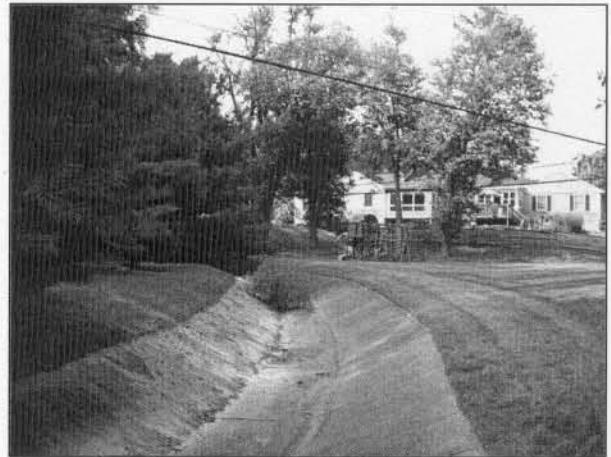
Photo 2. Tributary B looking upstream.

This reach enters Spring Branch from the south approximately 340 feet downstream of Pot Spring Road. It is a 14 foot wide (at the top of bank) trapezoidal concrete channel that carries no baseflow much of the year. It was constructed at the same time as the concrete armoring of Spring Branch. The reach begins from a single culvert downstream of Pot Spring Road and flows approximately 490 feet to Spring Branch. The slope within the downstream 100 feet of this reach is approximately 2%.

Along the downstream 80 feet of this reach the riparian areas flatten into mowed residential yards that line both sides of the channel. Here the riparian areas are comprised of primarily maintained lawns, with a few mid size White Pine (*Pinus strobus*) trees.

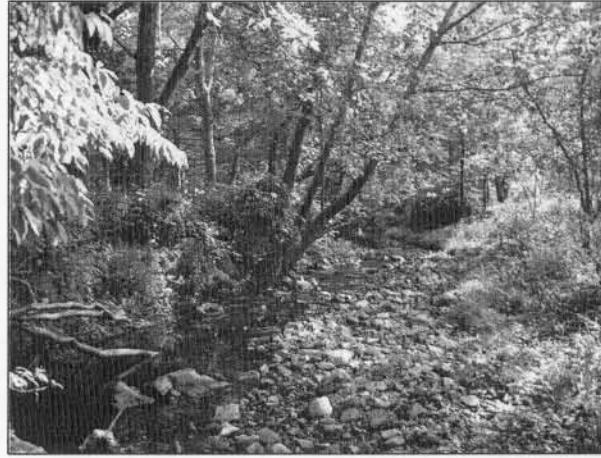
Photo 3. Reach 2 Looking downstream from the upstream end of the reach.

and riparian areas widen slightly. This reach has flat, extended riffles with a few shallow pools. The stream channel within this reach consists of a mix of small cobbles and boulders that appear to be moderately embedded and generally stable. They provide substantial habitat for macroinvertebrate fauna.

Much of the north bank of this reach is a four to six foot eroding vertical wall that flattens sharply at the top where maintained lawns meet the channel. On the north bank approximately 560 feet downstream of Pot Spring Road, about ten feet of 18 inch concrete pipe have fallen into the channel. This pipe drains a small pond north of Chapelwood Lane (Appendix C). The south bank is more gently sloping, and well vegetated until it reaches the top of bank, where the established stream buffer has been mown. At approximately 700 feet downstream of Pot Spring Road a perennial channel enters the stream from a small, spring-fed pond slightly outside of the Spring Branch floodplain. This small tributary is stable at its confluence with Spring Branch. The remainder of the channel to the end of the reach becomes slightly more incised and lined with boulders before entering Reach 3.

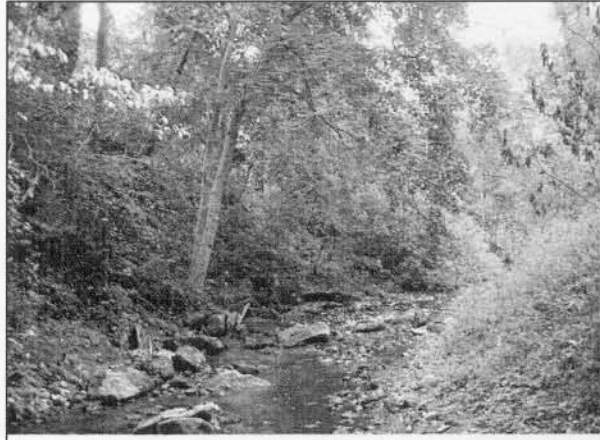
Photo 4. Reach 3 looking upstream toward Reach 2.

At the top of the north bank, the riparian area flattens sharply and is composed of a few trees scattered within maintained residential lots.

The riparian area along the south bank beyond the forested slope flattens more gradually into maintained residential lots.

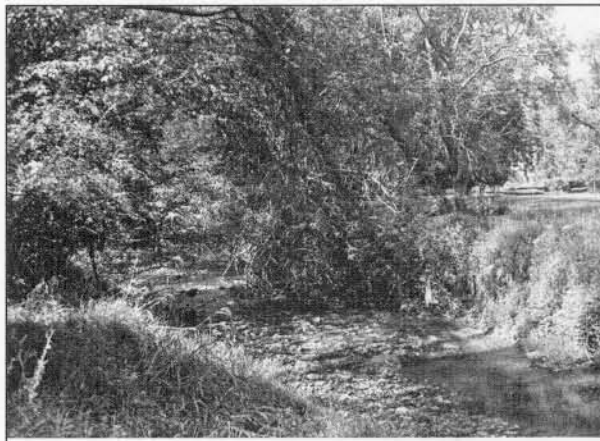
Photo 5. Reach 4 looking upstream.

Reach 4 begins where the floodplain and channel widen, the stream begins to meander, and the substrate changes to fine sand, gravel, and small cobble. The reach extends to the end of the study area at Dulaney Valley Road. Both the north and south banks within this reach are vertical and eroding along many of the outside meander bends. Two small intermittent drainage ditches enter the channel from the north at approximately stations 1,740 and 2,100 feet downstream of Pot Spring Road (Appendix C). Both appear to be stable and may only carry water during storm events, or serve to drain the floodplain after high flows. Approximately 300 feet upstream of Dulaney valley Road the stream has downcut and exposed 15 feet of 18 inch concrete sewer line. The line appears to be intact; however, further downcutting may

compromise this line. Shortly before reaching Dulaney Valley Road, the stream makes a sharp bend to the southeast. Here the channel has been lined with riprap to protect the road culvert.

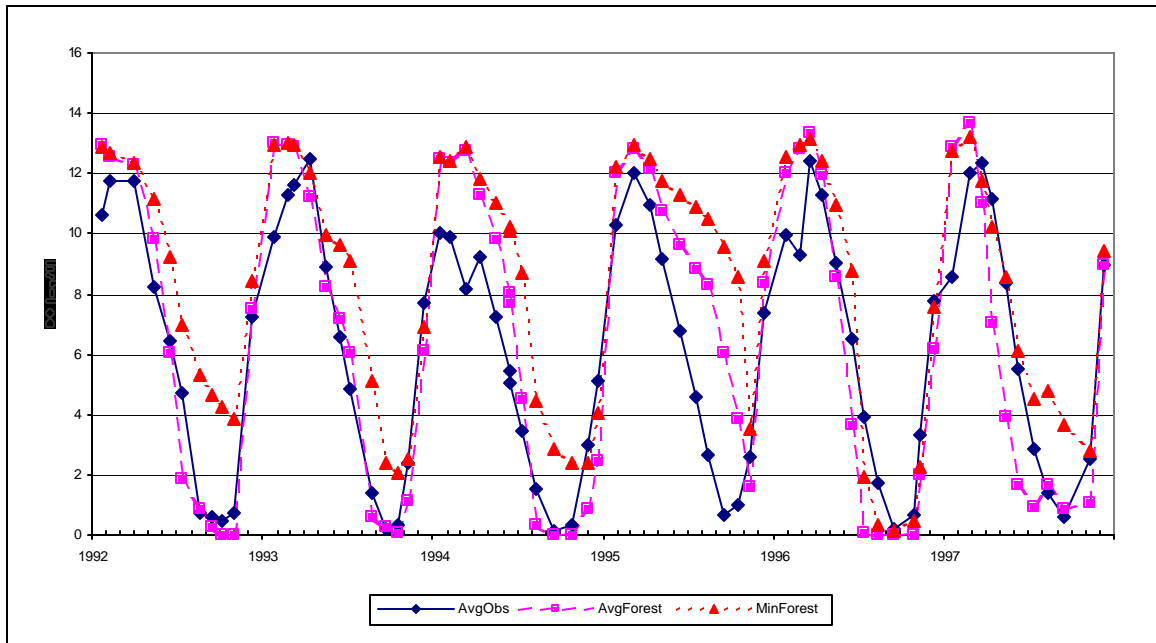
Figure 13: Observed and Simulated Average Bottom DO Concentrations, Lower Stations, All-Forest Scenario, Prettyboy Reservoir

Average DO in the bottom layers of both reservoirs improves considerably under the All-Forest Scenario. The minimum DO concentration, however, frequently drops below 5.0 mg/l. Even under the All-Forest Scenario, the hypolimnion remains hypoxic in many (but not all) years of the simulation. The hypoxia tends to be worse in the lower stations of the reservoirs where the depths are greatest.

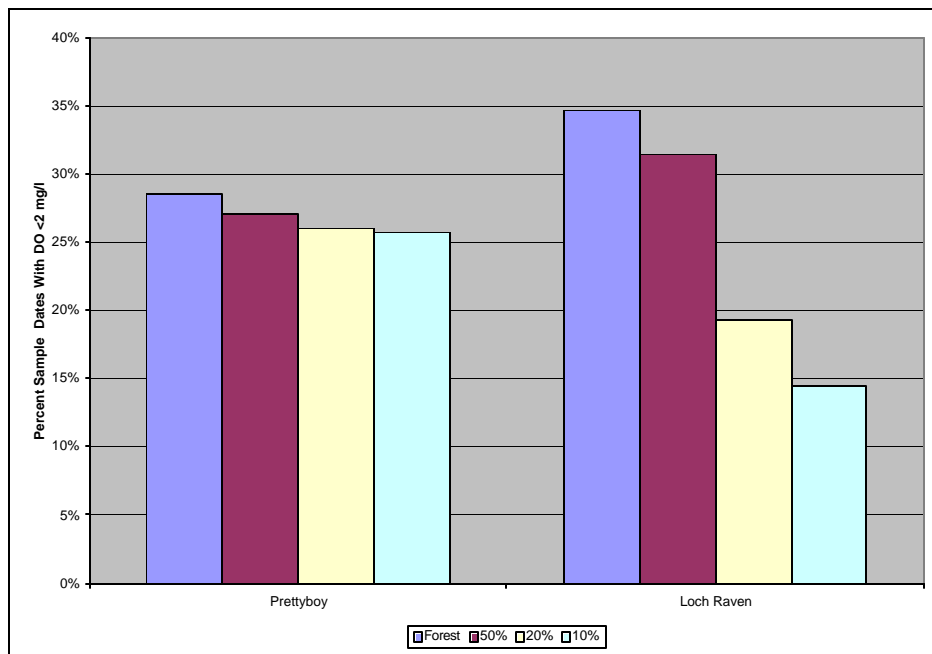
Figure 15: Percent of Sampling Dates on which $DO < 2.0$ mg/l as a function of proportion of All-Forest Scenario

A sensitivity analysis was performed to better determine how phosphorus and organic matter loading rates impact hypoxia in the hypolimnion. POM and TP loading rates were reduced to 50%, 20% and 10% of the loads of the All-Forest Scenario, and the percent of sampling dates where $DO < 2.0$ mg/l at the sampling locations was calculated. Figure 15 shows the results. Significant hypoxia persists even when loads are reduced to only 10% of the All-Forest Scenario, particularly in Prettyboy Reservoir, which is deeper than Loch Raven even though it has less volume. The sensitivity analysis shows that low DO in the bottom layers of the reservoirs is relatively insensitive to the particular assumptions used to determine organic matter loads in the models, and demonstrates that hypolimnetic hypoxia is primarily driven by stratification and reservoir morphology, rather than by external loads. The All-Forest Scenario demonstrates that current loads, and loads simulated under the TMDL Scenario, do not result in hypoxia that significantly exceeds that associated with natural conditions in the watershed. Low DO concentrations in the bottom layers of the reservoirs are therefore a naturally occurring condition, as described by the interim interpretation of Maryland's water quality standards. The TMDL Scenario thus meets water quality standards for DO under the interim interpretation.
