**9.0 Permit Requirements**

**F. Discharge Characterization**

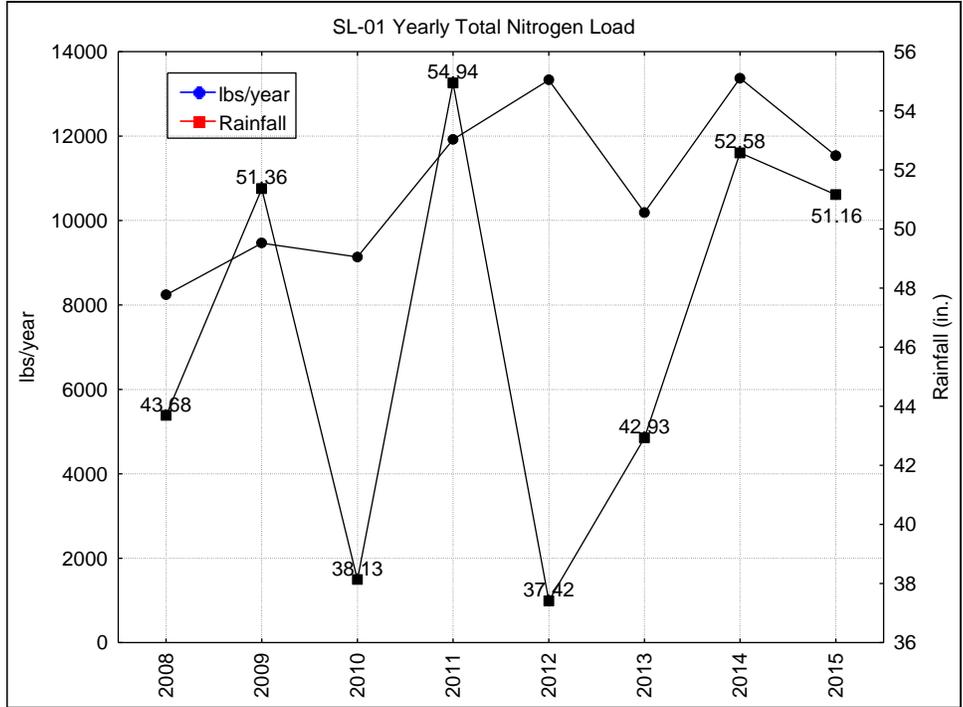
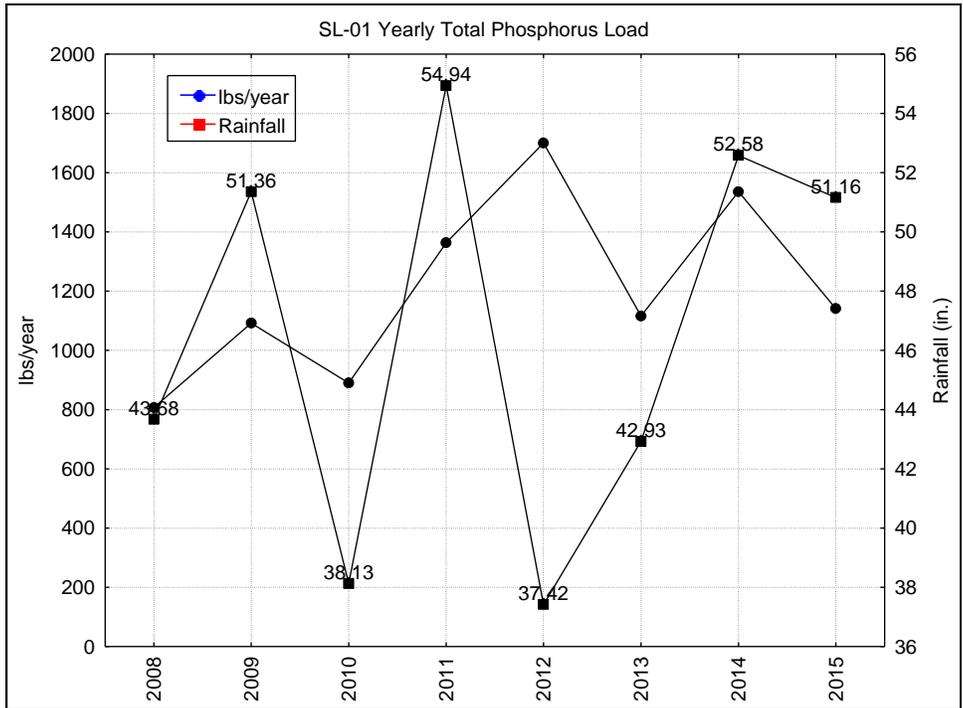
Figure 9-4 shows pollutant loads for TN, TP and TSS at the SL-01 gage throughout the year. This data is adjusted for average annual rainfall. In 2015, the total annual rainfall was 51.16 inches, compared to the average annual rainfall of 41.94 inches. As can be seen from the graphs, rainfall loosely follows pollutant load. A regression analysis shows that the total pollutant load for all three pollutants had a moderately to strongly positive correlation to rainfall. Pollutant loads adjusted for average annual rainfall had weak to very weak correlation to rainfall amounts.

However, factors such as intensity of rainfall and length of storm event may account for the variability.

There are distinct seasonal differences in the delivery of nutrient and total suspended solids pollutant loads at SL-01. For Suspended Solids at SL-01, winter was observed to be the season of reduced loading. Nutrients had reduced loading during the summer. SL-09 showed higher loading during the winter than the other seasons for all parameters.

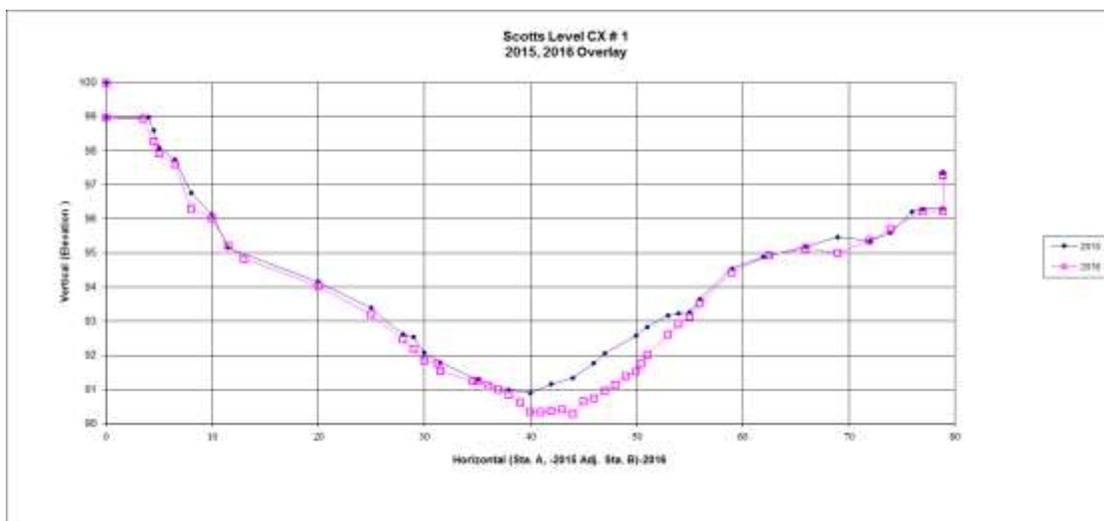
Figure 9-5: Scotts Level Branch Geomorphic Cross Section 1 Overlay showing differences in channel morphology between the 2015 and 2016 surveys.

The morphology of 17 cross sections was examined to show changes that occurred in fall and winter of 2015/2016 and the changes over the period of 2006 through 2016. Figure 9-5 shows an overlay of CX #1 for 2015 and 2016. Table 9-6 presents the amount of aggradation (filling) or degradation (cutting) within the active channel, and Table 9-7 (listed from upstream to downstream) summarizes Table 9-6. Data in Table 9-6 were annualized by multiplying the cut/fill value by 365 over the number of days between measurements to standardize the aggradation and degradation estimates. The data files and plots are included on the CD accompanying this report. SL-18, SL-12, and SL-4 cross sections were not sampled. Both left

and right bank pins for SL-18 could not be located. The pins for SL-12 were removed during stream restoration construction. The contractor, EA Engineering Science, will take future cross sectional data within the restoration site. SL-4 is lacking property owner permission, so this cross section was not sampled. A majority of cross sectional reaches showed minor adjustments in channel morphology between 2015 and 2016. SL-19, SL-11, SL-9, SL-6, SL-2, and SL-1 were more active (cut/fill > ± 4.0 cubic feet) than the rest of the cross sections. SL-1 is on a straight, low-gradient reach following a series of high-gradient, alternating riffles and short pools. As the stream slows at the gradient break, it deposits sands and silts along the stream banks. However, in 2015 numerous storms removed the sand deposits on the right bank.

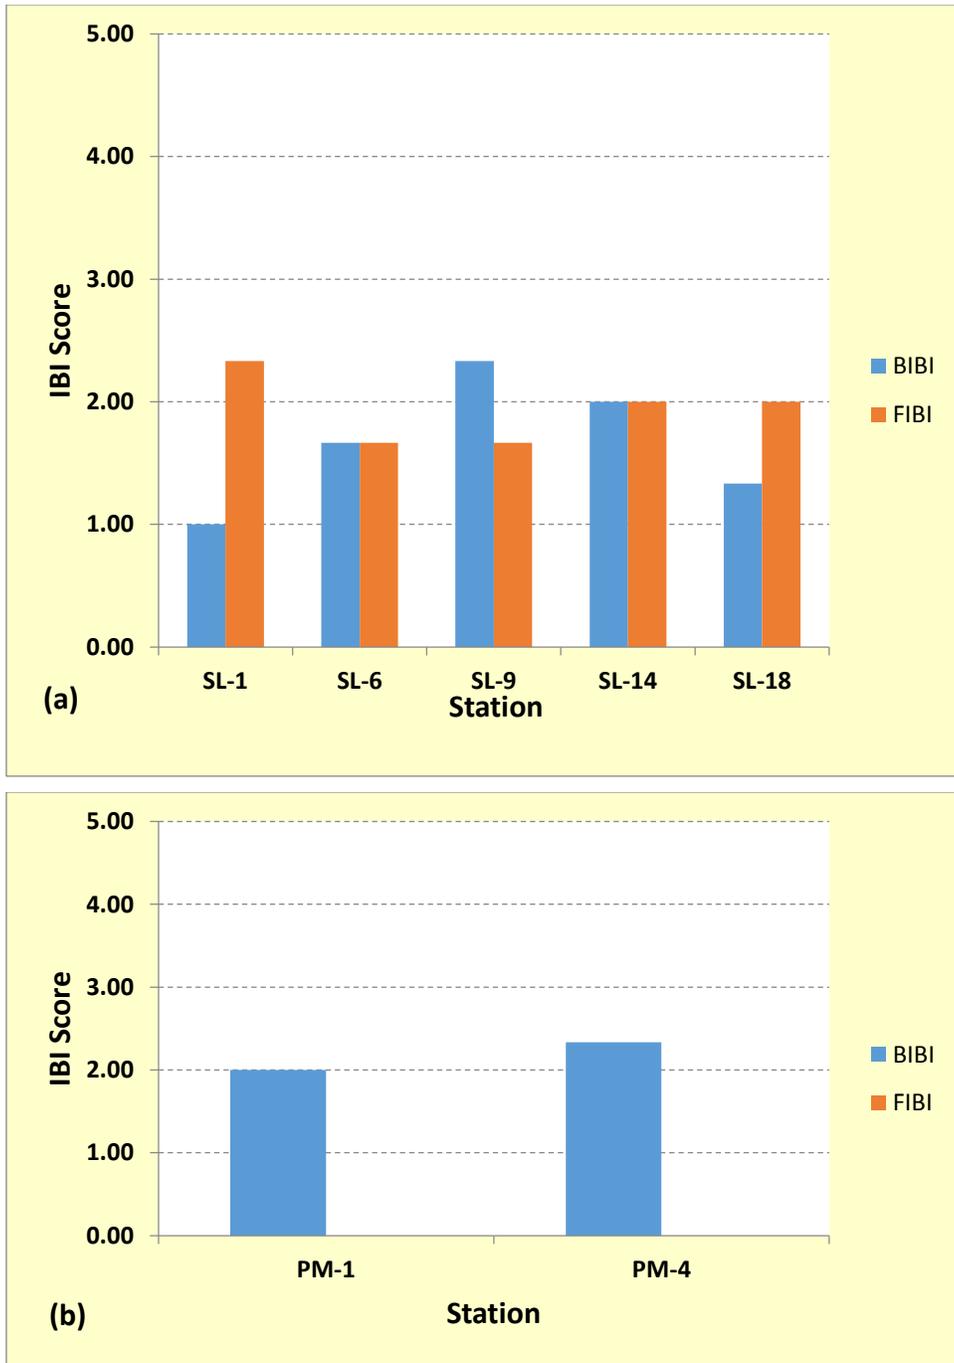
Figure 9-6: (a) Scotts Level Branch and (b) Powder Mill Run IBI Scores, 2015.

The IBI scores are shown in Figure 9-6. All Scotts Level and Powder Mill BIBIs were in the Very Poor or Poor condition category. The BIBI and FIBI scores for all sites in Scotts Level and Powdermill were Poor or Very Poor. The following sites sampled for fish will be discussed in the McDonogh Road restoration section: SL-11, SL-11a, SL-12, SL-12a, and SL-13. Fish in Scotts Level Branch are able to survive the acute and chronic water quality problems within both streams than benthic macroinvertebrates. The mobility of fish likely allows them to better exploit good habitat and avoid such episodic events as high storm flows. The PHI scores are

The benthic and fish communities of Scotts Level Branch and Powder Mill Run show the effects of environmental stress. Both are low in diversity and are primarily composed of pollution tolerant organisms. The stream habitat is degraded and provides poor living space for both benthos and fish. As reported in previous Baltimore County NPDES reports, these results have been consistent since monitoring began in 2005, i.e., BIBI and FIBI ratings of Poor or Very Poor annually. The biological community of Scotts Level Branch is so impaired that it does not respond to fluctuations in precipitation and water temperature the way healthy streams do.

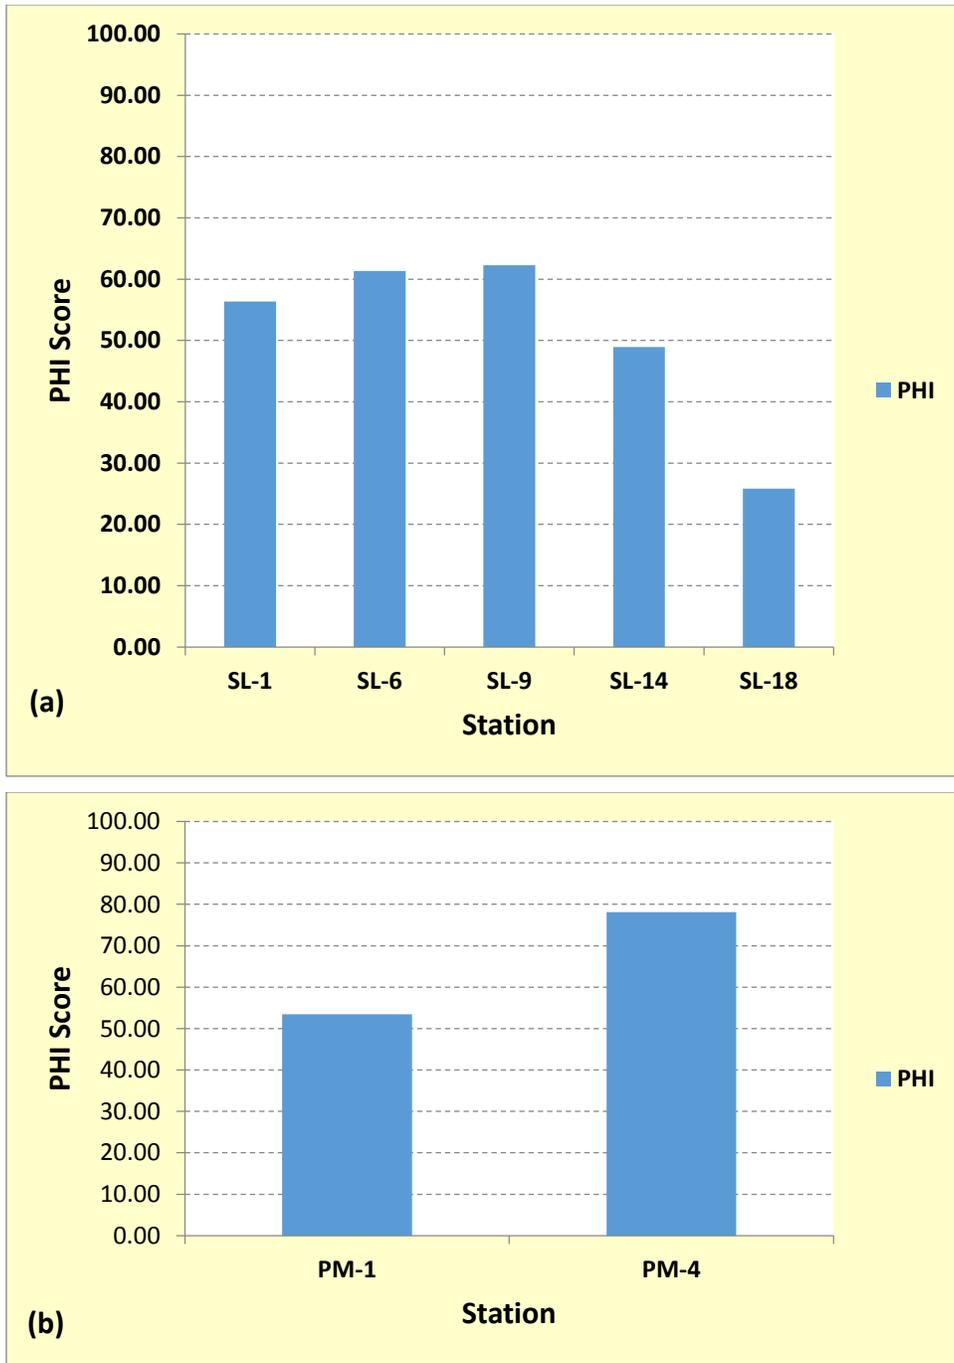
Figure 9-7: (a) Scotts Level Branch and (b) Powder Mill Run Physical Habitat Index 2015.

shown in Figure 9-7. Scotts Level Branch physical habitat condition was degraded at SL-6. SL-9. SL-14 and SL-18 were severely degraded. SL-1 was degraded.

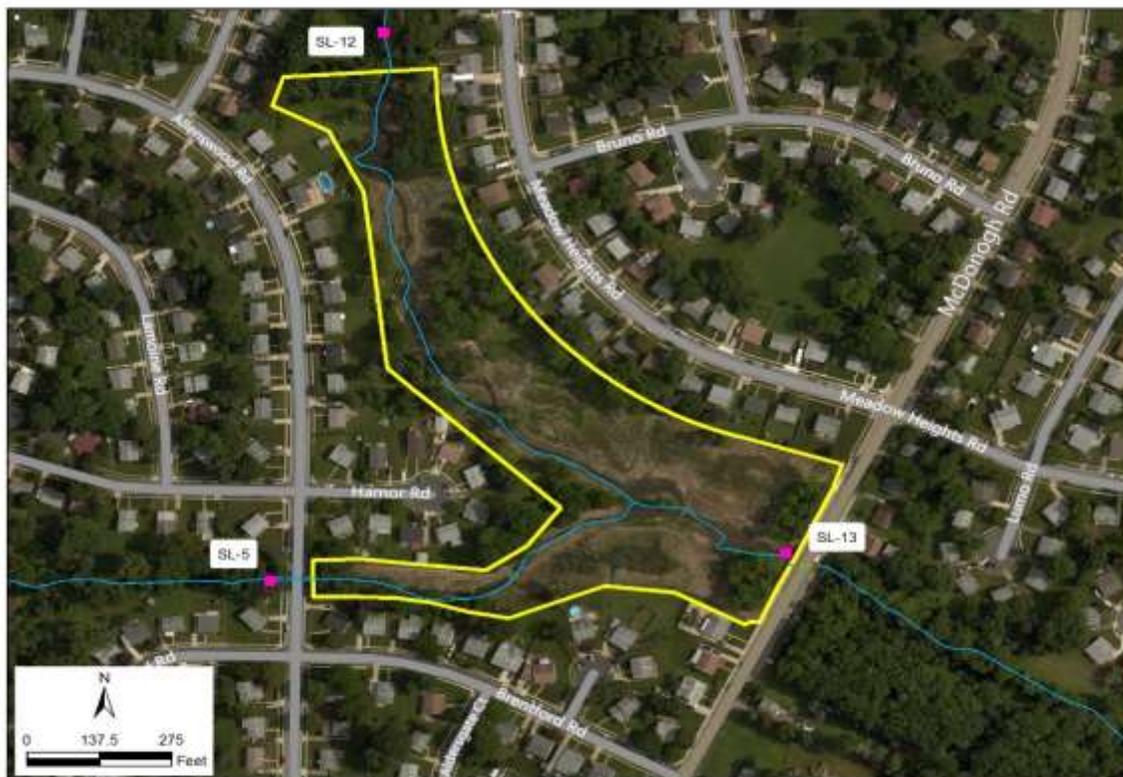
Figure 9-8: Scotts Level Branch McDonogh Road Restoration Water Chemistry Monitoring Locations

Restoration work in the Scotts Level Branch was started in 2014 with the completion of the McDonogh Road site. Pre restoration monitoring data has been collected since 2005 and post restoration monitoring data was started in the fall of 2014. Figure 9-8 shows the location of the three water chemistry monitoring sites for the McDonogh Road restoration project. All three sites are outside the restoration project, with SL-05 being the Allenswood tributary site along with SL-12 (Meadow Heights) and SL-13 (McDonogh) being the main stem sites above and below restoration. The monitoring will consist of flow monitoring, chemical monitoring, geomorphological monitoring, and biological monitoring as described below.

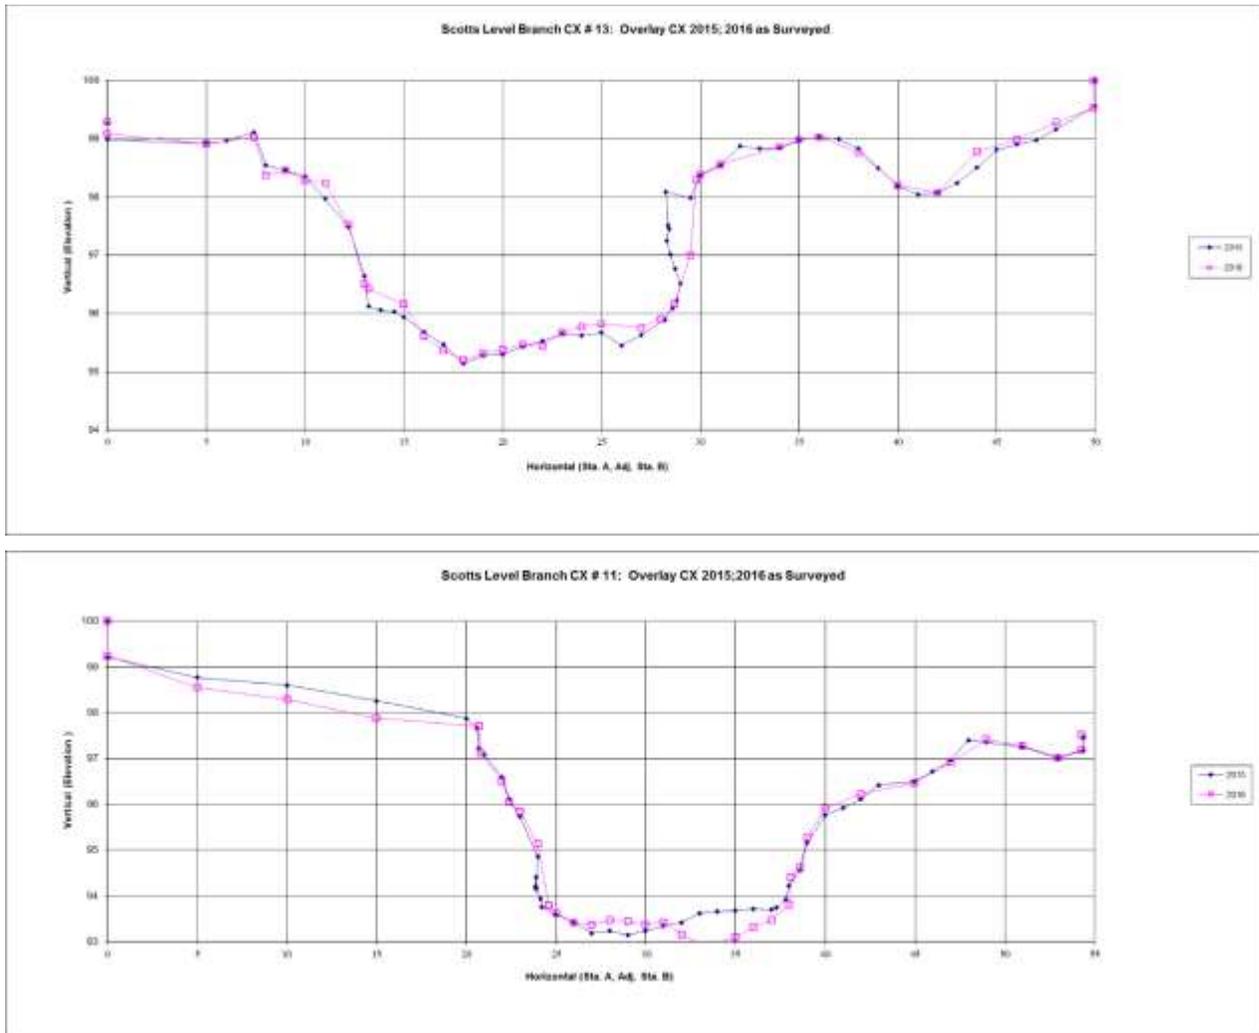
**Figure 9-9: McDonogh Road 2015 and 2016 cross-section overlays.**

Pre-Restoration monitoring consisted of three existing cross-sections (SL-11, SL-12, and SL-13) in Scotts Level Branch near McDonogh Road. A cross-section that was within the reach to be restored (CS 5) was added. Longitudinal profiles (20 bankfull widths long) and pebble counts were completed in each reach. SL-11 is downstream of the restoration, SL-13 is upstream of the restoration, CS 5 is within the restoration, and SL-12 is located on a tributary to Scotts Level Branch above the restoration site. A consultant will be monitoring geomorphic sites within the restoration. Baltimore County will monitor sites that are upstream and downstream of the restoration.

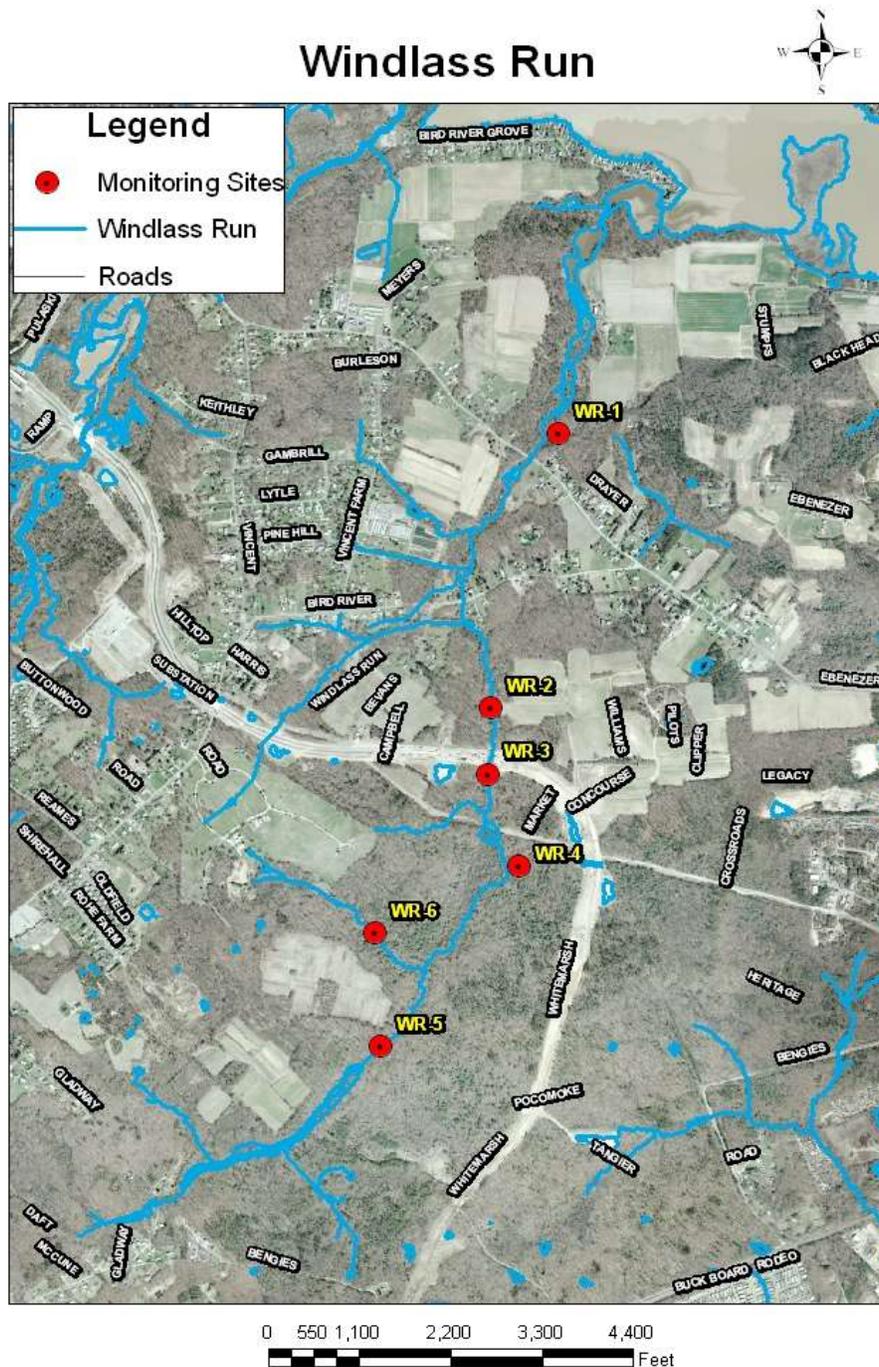
Figure 9-10: Windlass Run Aerial Photograph Showing Monitoring Station Locations.

Six (6) monitoring sites in the Windlass Run subwatershed are shown in Figure 9-10 below. The site selection process took into consideration the location of future development and the extension of MD Route 43. Three sites are located along the mainstem: two above (WR-3, WR-5) and one below (WR-2) the crossing of MD Route 43. WR-2 has experienced additional flow of water when a nearby SWM pond is drained into a forest buffer prior to entering the mainstem. This was observed in 2015. One site (WR-4) is on a tributary within the area of proposed industrial and high-density development, and downstream of Route 43. Another cross section (WR-6) is on a tributary within the area of under current residential development. The last cross section (WR1) is a reference site on a tributary near the bottom of the subwatershed. This tributary is within an area zoned for agricultural uses and should not be affected by the other development activities in the watershed.

The geomorphic monitoring consists of a monumented channel cross-section measurement, a channel slope/profile measurement, and a Wolman pebble count. Cross sections were selected on the reach between meander bends and where the conditions best represented confined flow. Profiles were also surveyed at all of the cross section reaches and include the cross sections. The procedures outlined by D. Rosgen (1996) were used for channel classification and stability assessment. The seven cross sections and six profiles have been surveyed annually since 2002. WR-6 is located on a tributary to Windlass Run. Its forest buffer has been cleared away for future development and impervious cover has increased. .

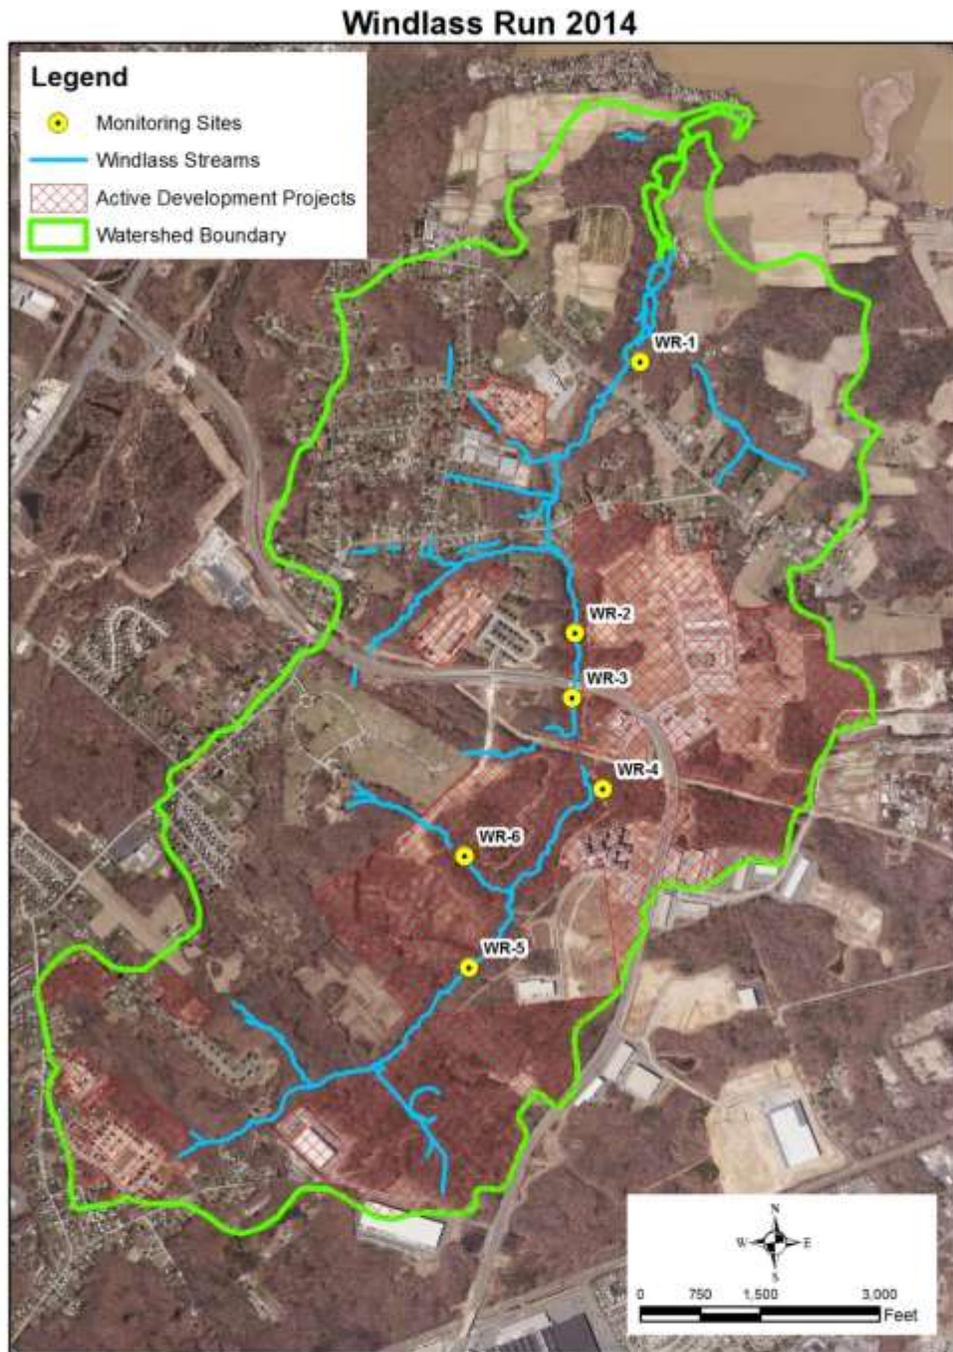
Figure 9-17: Windlass Run orthophotograph, 2014. New development/grading in red

Figure 9-11 shows the percentage of impervious land cover at each station in 2001, 2005, 2008, 2011, and 2014. Figure 9-12 through Figure 9-17 show the progression of development in Windlass Run, from 1995-2014, in years for which orthophotographs were available. Development occurring in the interval between years is summarized below. Any additional development that occur from 2014 – 2015 will be reflected in the 2016 Report, as the new

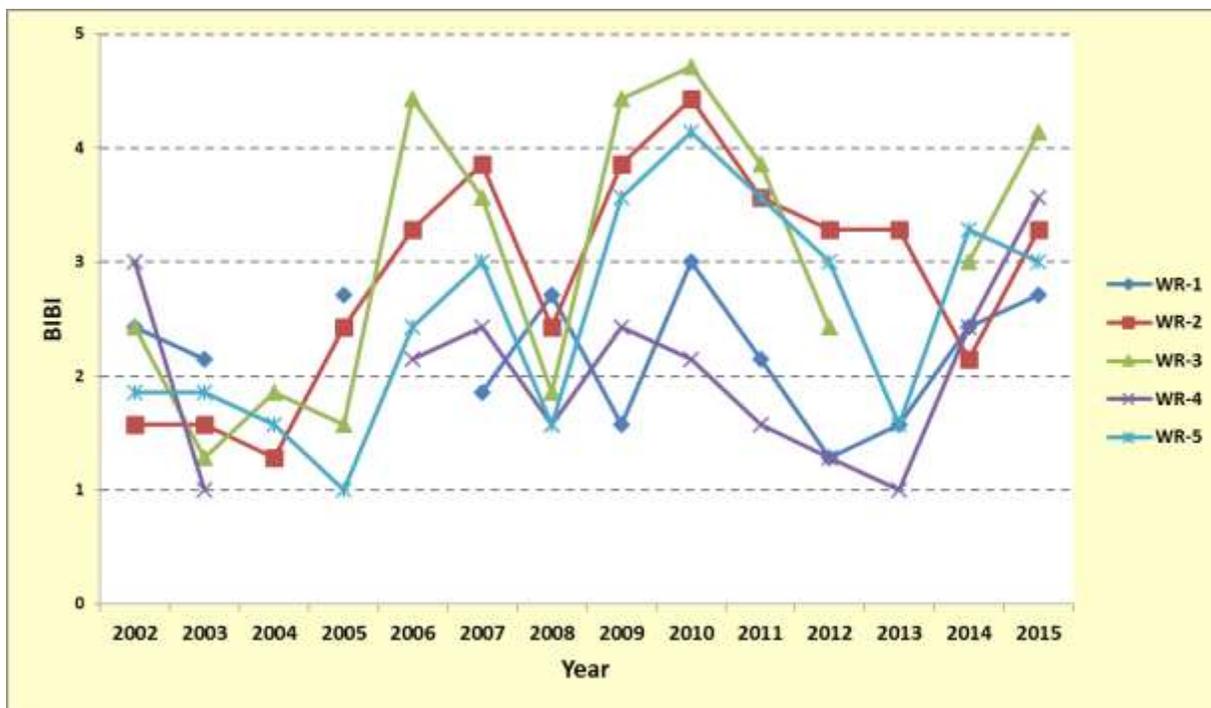
Figure 9-18: Windlass Run BIBI Scores

Benthic macroinvertebrate sampling was conducted as per MBSS protocols. Benthic macroinvertebrates were sampled annually, during the spring index period (March 1<sup>st</sup> - April 30<sup>th</sup>), at WR-1, WR-2, WR-3, WR-4, and WR-5. WR-1 was not sampled in 2004 and 2006 because a beaver dam downstream of the station, on the Windlass Run mainstem, was causing backwater effects within the station reach. Data for WR-1 from 2005 are missing because the sorted sample had dried before it could be identified. A Benthic Index of Biotic Integrity (BIBI) was calculated using metrics developed by MBSS for Coastal Plain streams (Figure 9-18). The BIBI scoring criteria are: 1.00-1.99 (Very Poor), 2.00-2.99 (Poor), 3.00-3.99 (Fair), and 4.00-5.00 (Good). Physical habitat assessments performed during benthic sampling were converted to a physical habitat index (PHI) developed by MBSS (Figure 9-19). The PHI scoring criteria are: 81-100 (minimally degraded), 66-80 (partially degraded), 51-65 (degraded), and 50 or less (severely degraded).

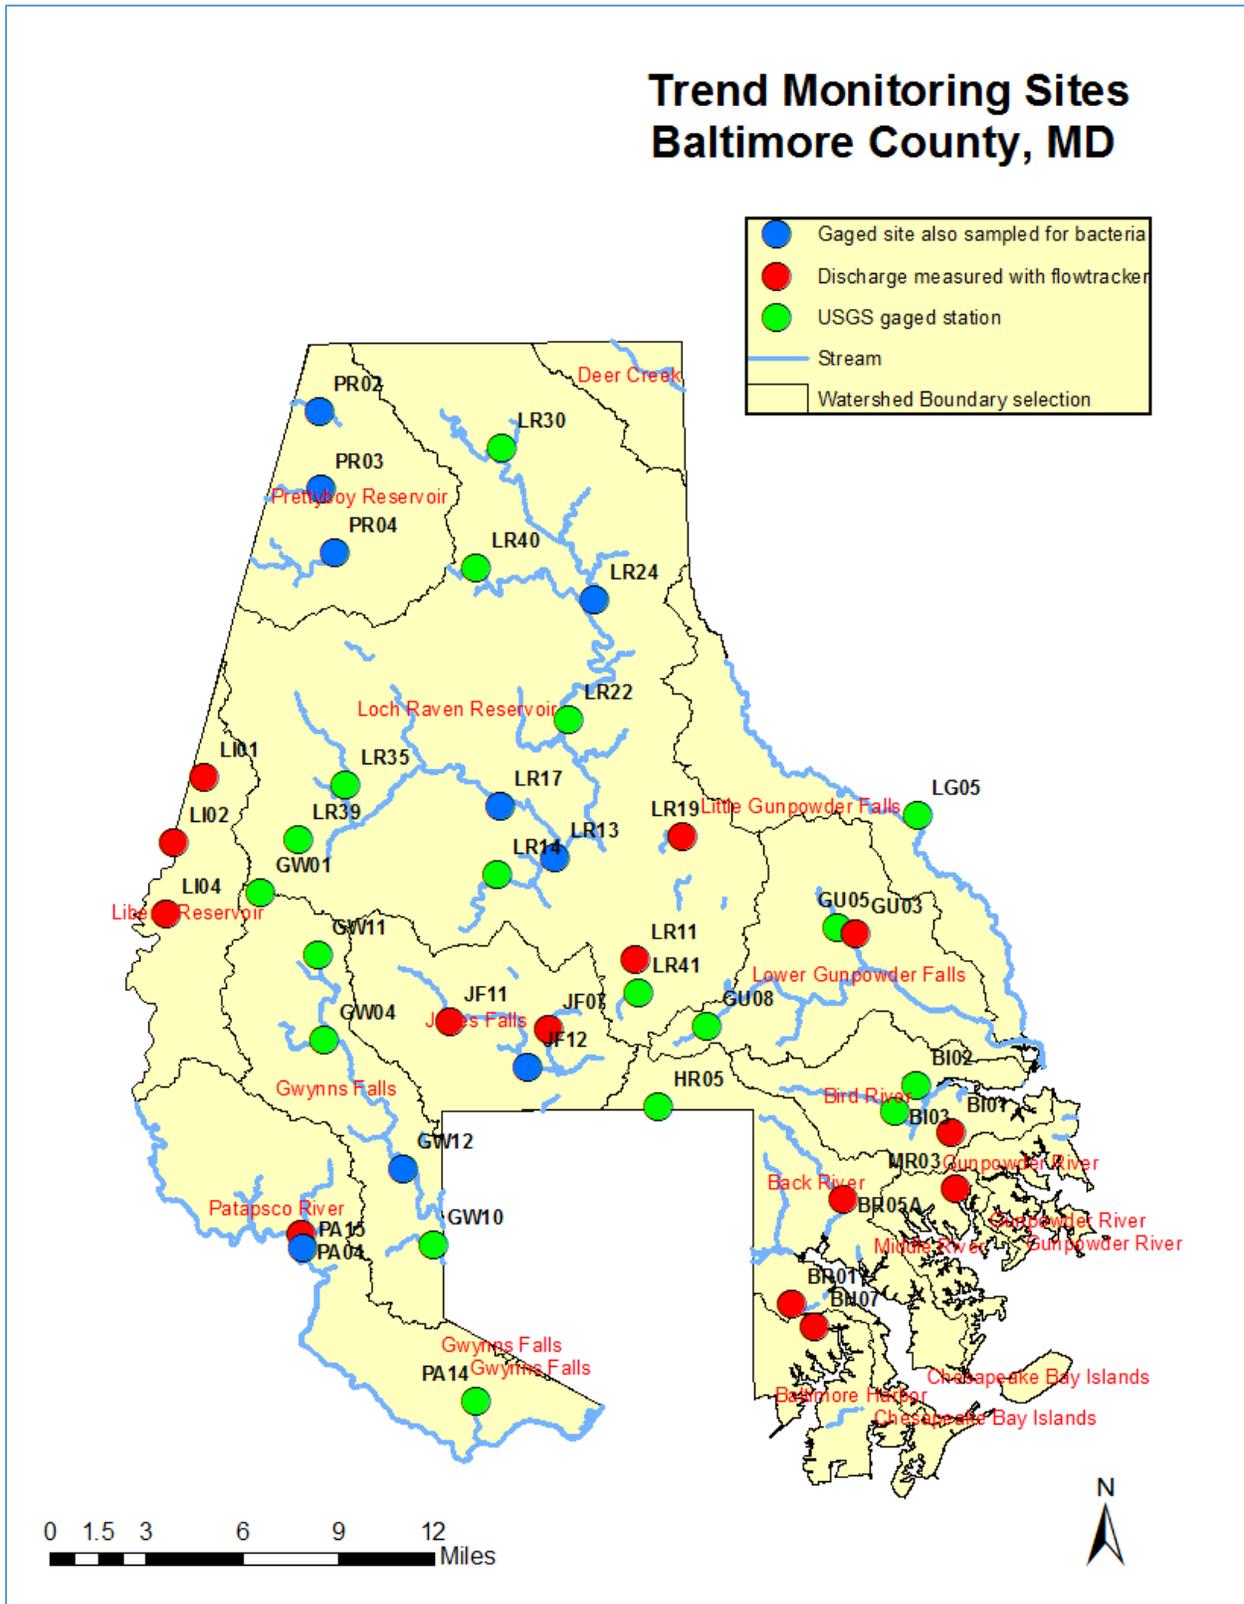
Figure 9-20: Trend Monitoring Sites

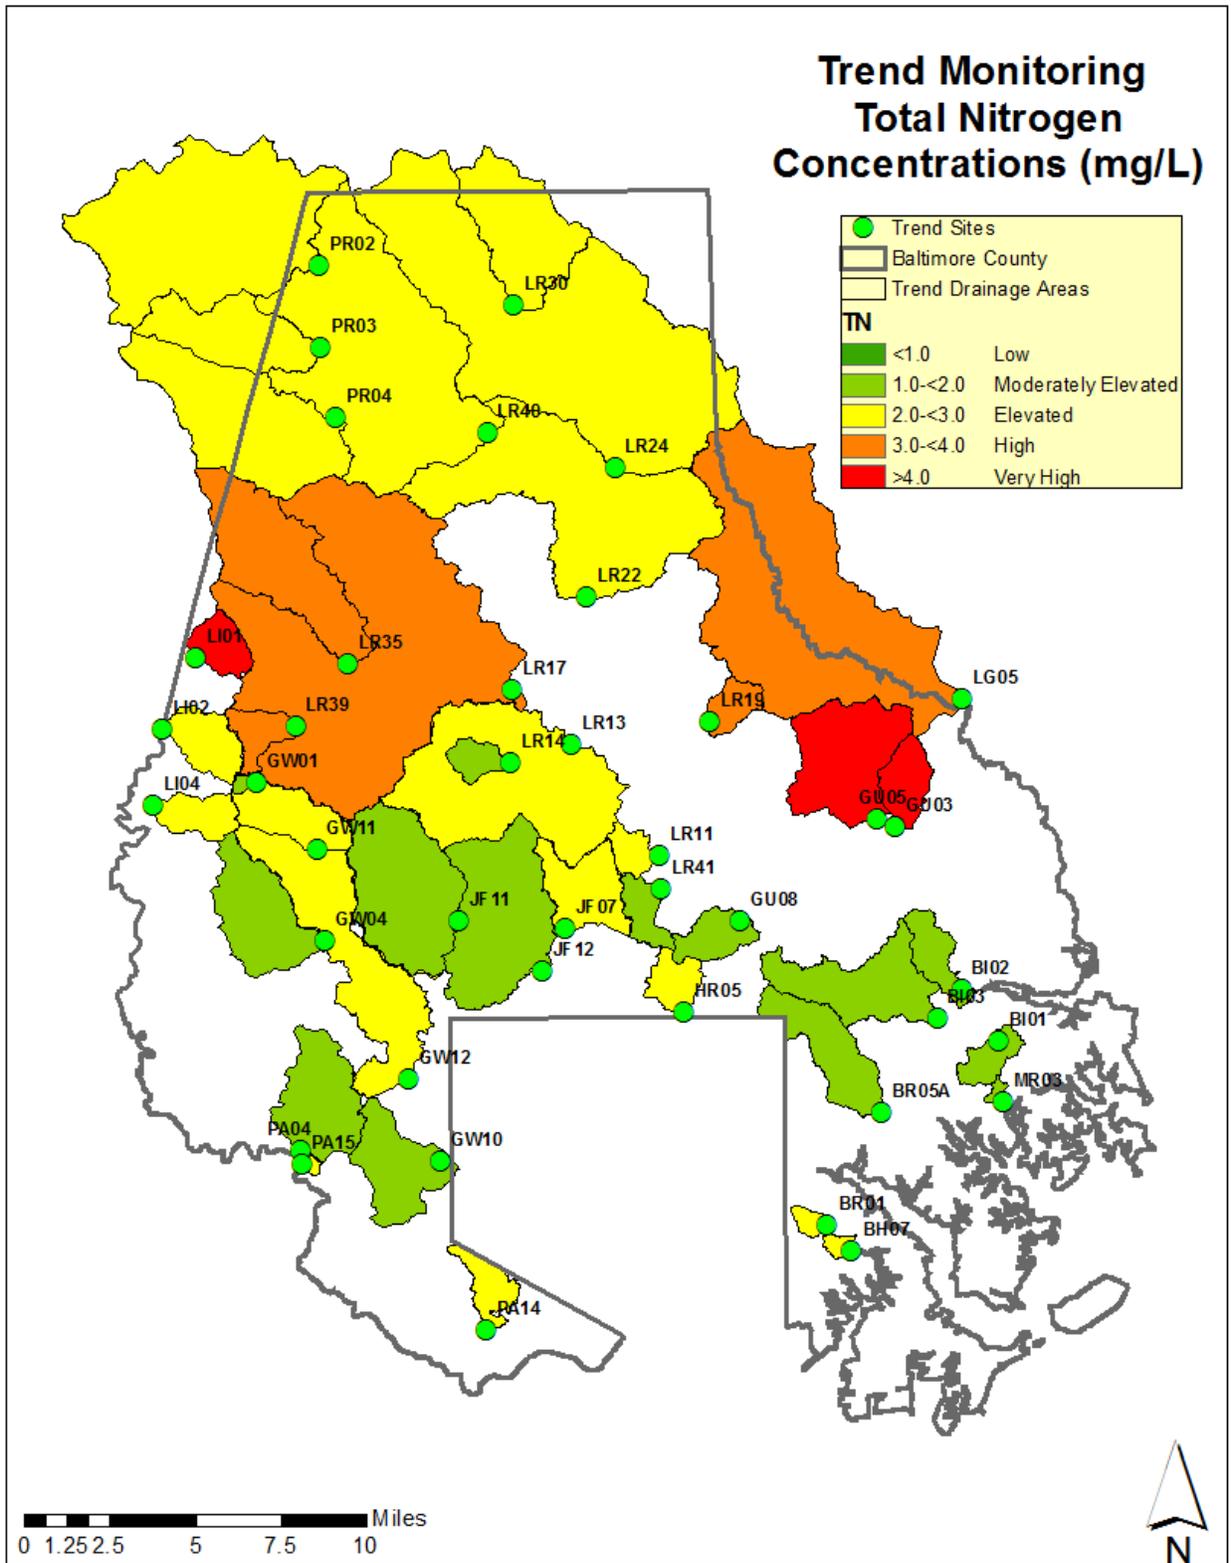
Figure 9-21: Trend Total Nitrogen Mean Concentrations for Monitoring Year 2015

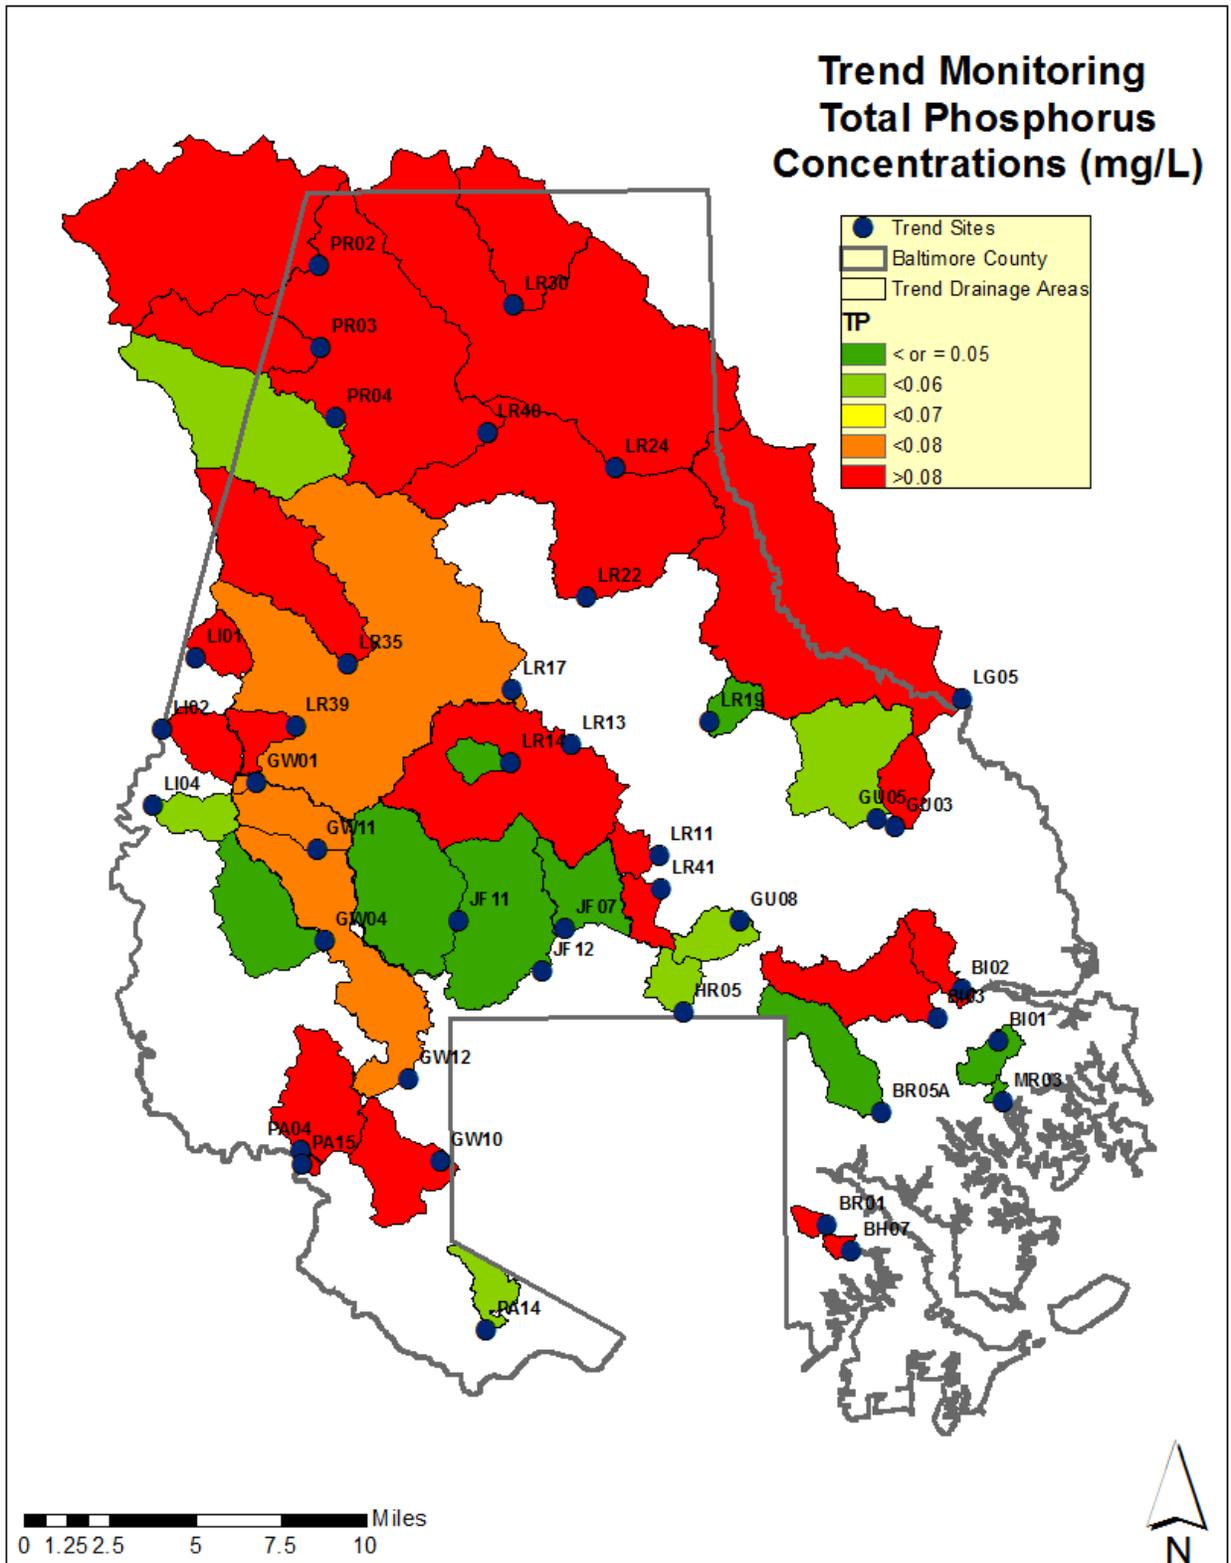
Figure 9-22: Trend Total Phosphorus Mean Concentrations for Monitoring Year 2015

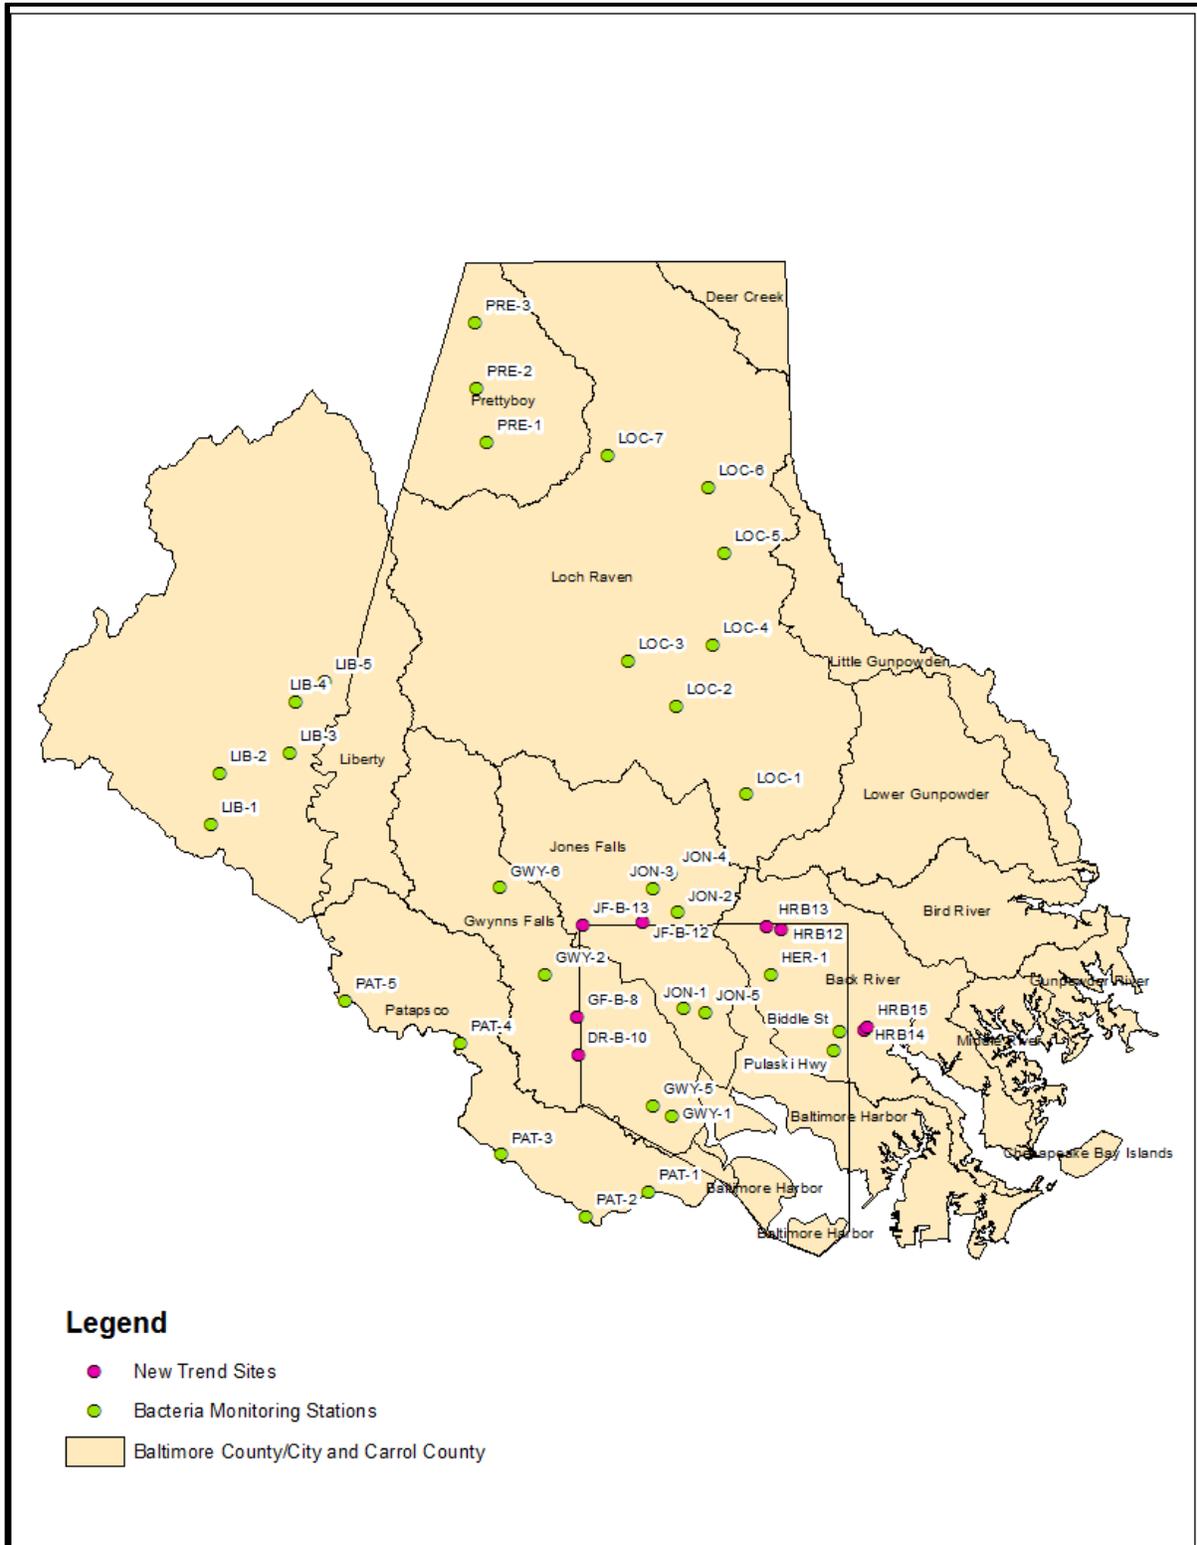
Figure 9-23: Map of Bacteria TMDL Monitoring Stations

In 2015, eight new trend sites were added to more directly assess how the portions of impacted watersheds in Baltimore County contributed to the total bacterial load observed at the bottom of the watershed located in Baltimore City. Two trend sites were added to the Gwynns Falls watershed, two to the Jones Falls, and four to the Herring Run portion of the Back River watershed. Table 9-19 lists the locations and descriptions of the new trend sites added in 2015. Additionally, seasonal monitoring of trend sites was enhanced in 2015 by sampling the 40 sites twice per month in order to develop a more accurate assessment of seasonal, low flow trends.

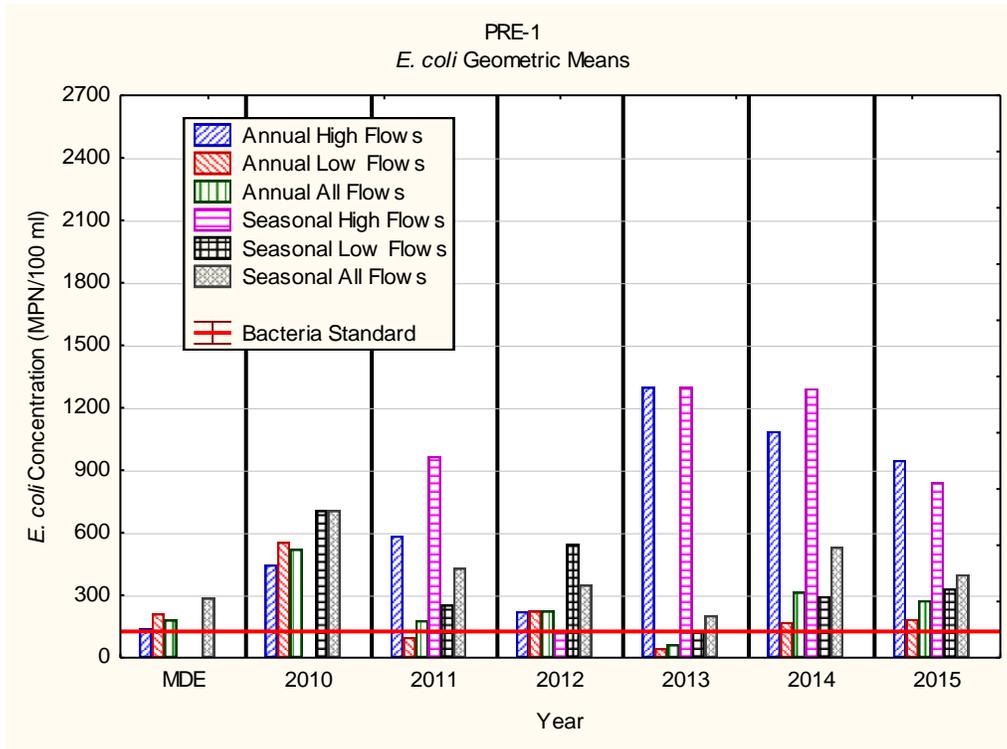
Figure 9-24: E. coli Geometric Mean Concentrations at Site PRE-1 for both Annual and Seasonal Flow Periods Stratified by Flow Condition, MDE Results Added for Comparison

Table 9-21 presents the number of samples and the geometric mean for high (wet) flow and low (dry) flow by year. It also presents the geometric mean of all samples by year regardless of condition. The table is stratified by annual data (includes all data collected for the year) and seasonal data (includes only those samples collected between May 1<sup>st</sup> and September 30<sup>th</sup> each year. Geometric means that meet the water quality standard (126 MPN) are highlighted in green. These data are displayed graphically in Figure 9-24 through Figure 9-26.

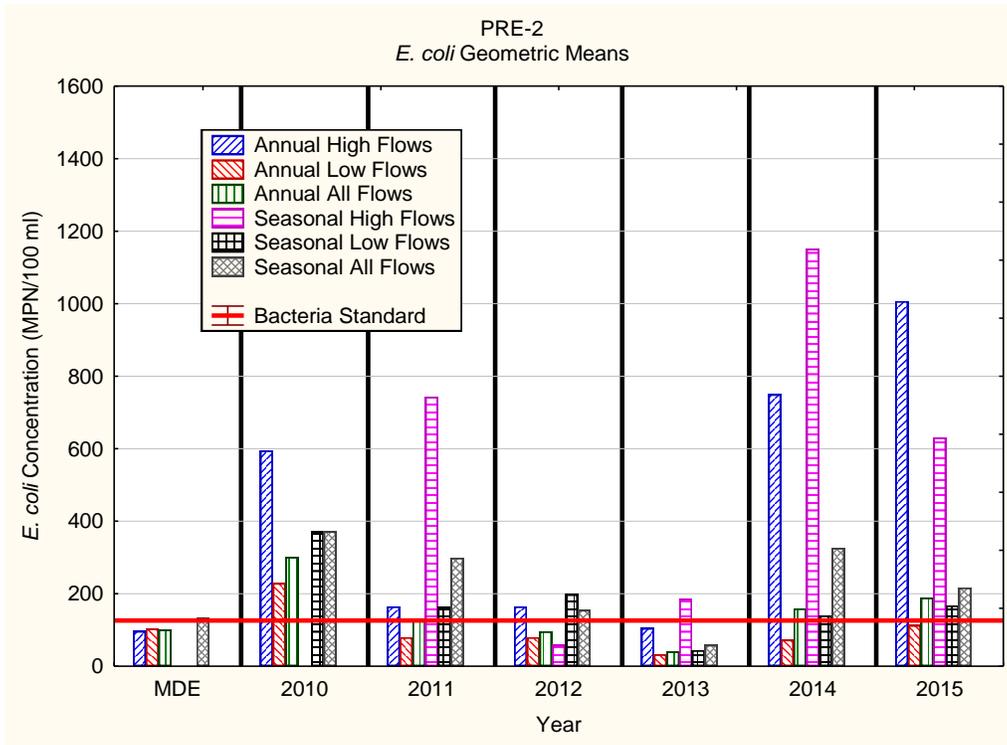
Figure 9-25: E. coli Geometric Mean Concentrations at Site PRE-2 for both Annual and Seasonal Flow Periods Stratified by Flow Condition, MDE Results Added for Comparison

**PRE-2 (GRG0013):** This monitoring site is located on Grave Run in Baltimore County, but with the majority of drainage area in Carroll County. The Baltimore County monitoring indicated that this site has displayed continuing improvement for both low flow and high flow on an annual and a seasonal basis. It met water quality standards for all flow conditions on an annual basis, and on for low flow on a seasonal basis. The MDE data for this site indicated a seasonal dry weather geometric mean of 134 MPN/100ml for this site. The previous six years of Baltimore County data resulted in a geometric mean of 155 MPN/100 ml for the dry weather seasonal data. This would indicate that there has been no change or slight improvement at this site. The TMDL indicated a reduction of 9.5% reduction necessary for meeting bacteria water quality standards in the drainage area to this site.
