**9.0 Permit Requirements**

**F. Discharge Characterization**

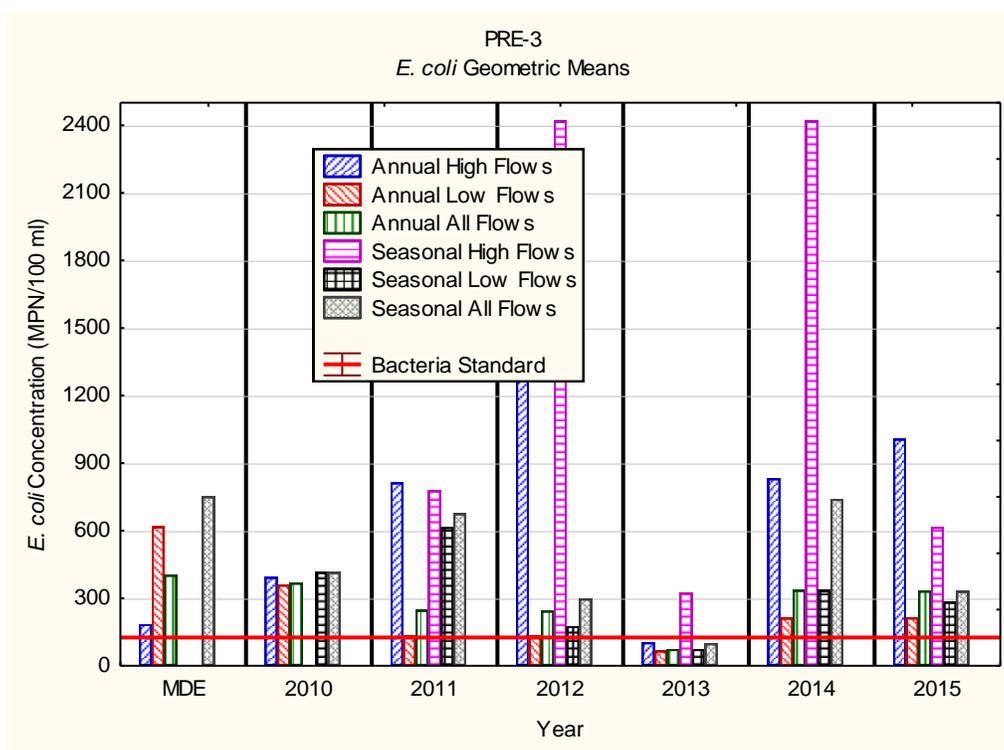
Figure 9-26: E. coli Geometric Mean Concentrations at Site PRE-3 for both Annual and Seasonal Flow Periods Stratified by Flow Condition, MDE Results Added for Comparison

**PRE-3 (GUN0476):** This site is located on the mainstem of Gunpowder Falls above the Prettyboy Reservoir. The Baltimore County monitoring data indicates variability in the geometric mean *E.coli* concentrations from year to year for both low flow and high flow conditions, but the data indicated a generally improving trend. The MDE data indicated a seasonal dry weather concentration of 751 MPN/100ml for this site, while the Baltimore County data indicate a concentration of 254 MPN/100ml, indicating improvement at this site. The

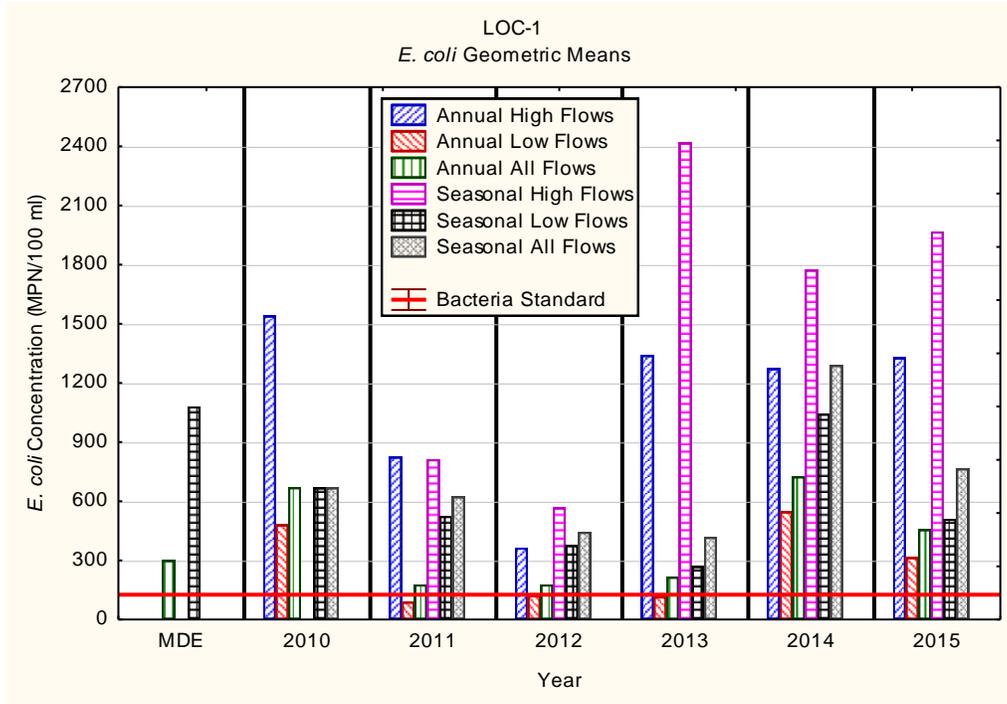
Figure 9-27: E. coli Geometric Mean Concentrations at Site LOC-1 for both Annual and Seasonal Flow Periods Stratified by Flow Condition, MDE Results Added for Comparison

Table 9-24 presents the number of samples and the geometric mean for high (wet) flow and low (dry) flow by year. It also presents the geometric mean of all samples by year regardless of condition. The table is stratified by annual data (includes all data collected for the year) and seasonal data (includes only those samples collected between May 1<sup>st</sup> and September 30<sup>th</sup> each year). Geometric means that met the water quality standard (126 MPN) are highlighted in green. These data are displayed graphically in Figure 9-27 through Figure 9-32.

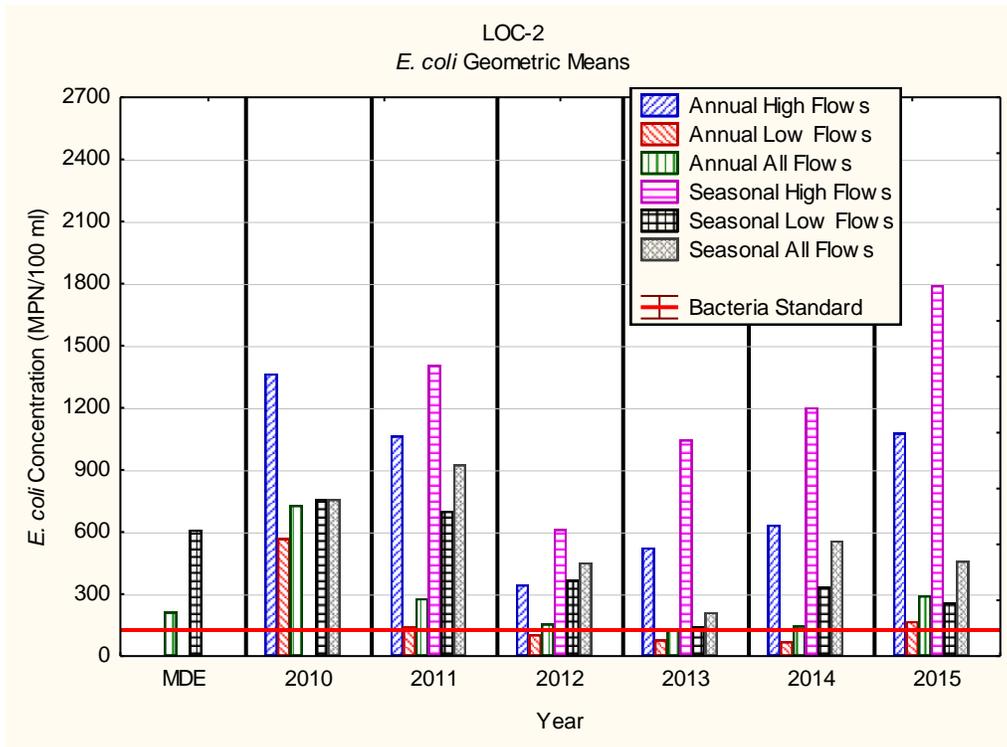
Figure 9-28: E. coli Geometric Mean Concentrations at Site LOC-2 for both Annual and Seasonal Flow Periods Stratified by Flow Condition, MDE Results Added for Comparison

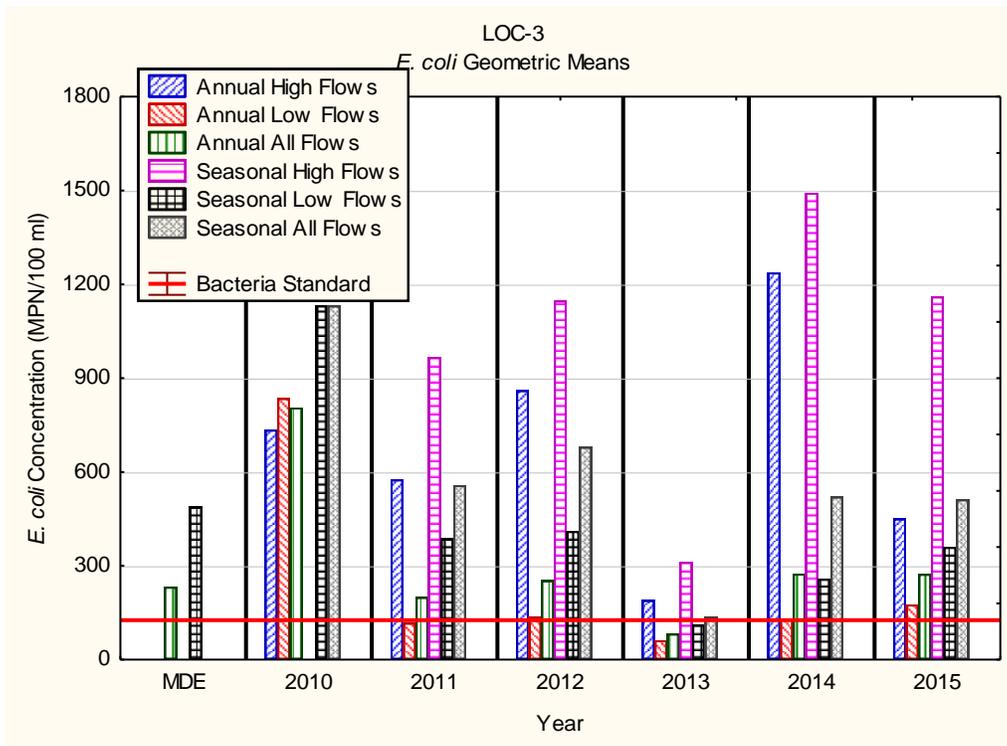
Figure 9-29: E. coli Geometric Mean Concentrations at Site LOC-3 for both Annual and Seasonal Flow Periods Stratified by Flow Condition, MDE Results Added for Comparison

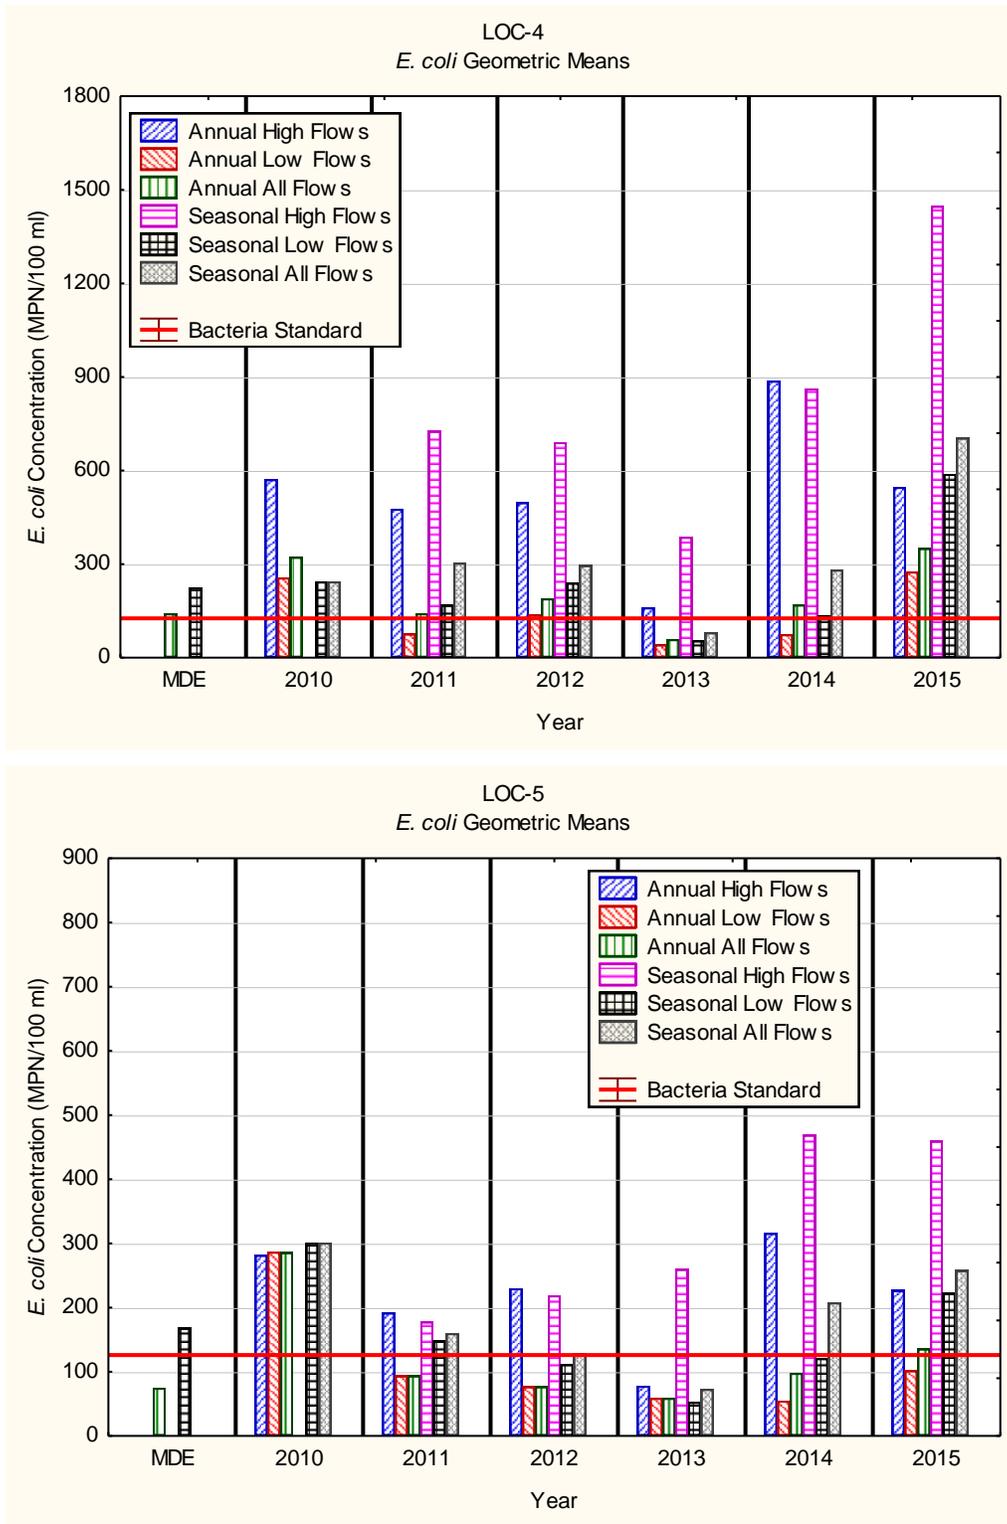
Figure 9-30: E. coli Geometric Mean Concentrations at Site LOC-5 for both Annual and Seasonal Flow Periods Stratified by Flow Condition, MDE Results Added for Comparison

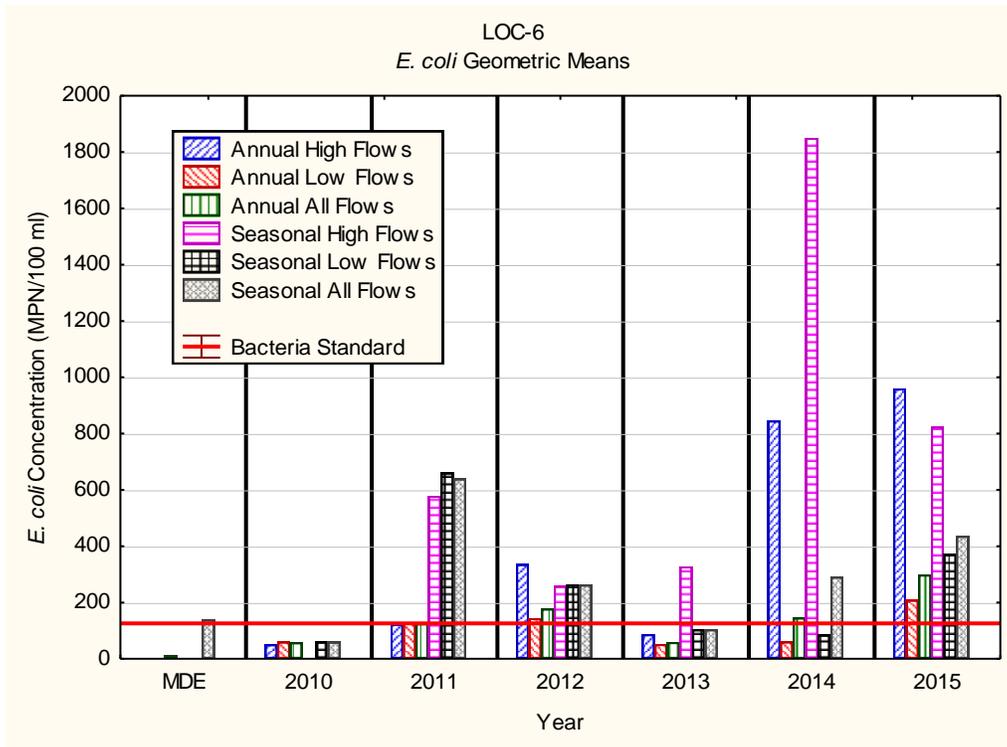
Figure 9-31: *E. coli* Geometric Mean Concentrations at Site LOC-6 for both Annual and Seasonal Flow Periods Stratified by Flow Condition, MDE Results Added for Comparison

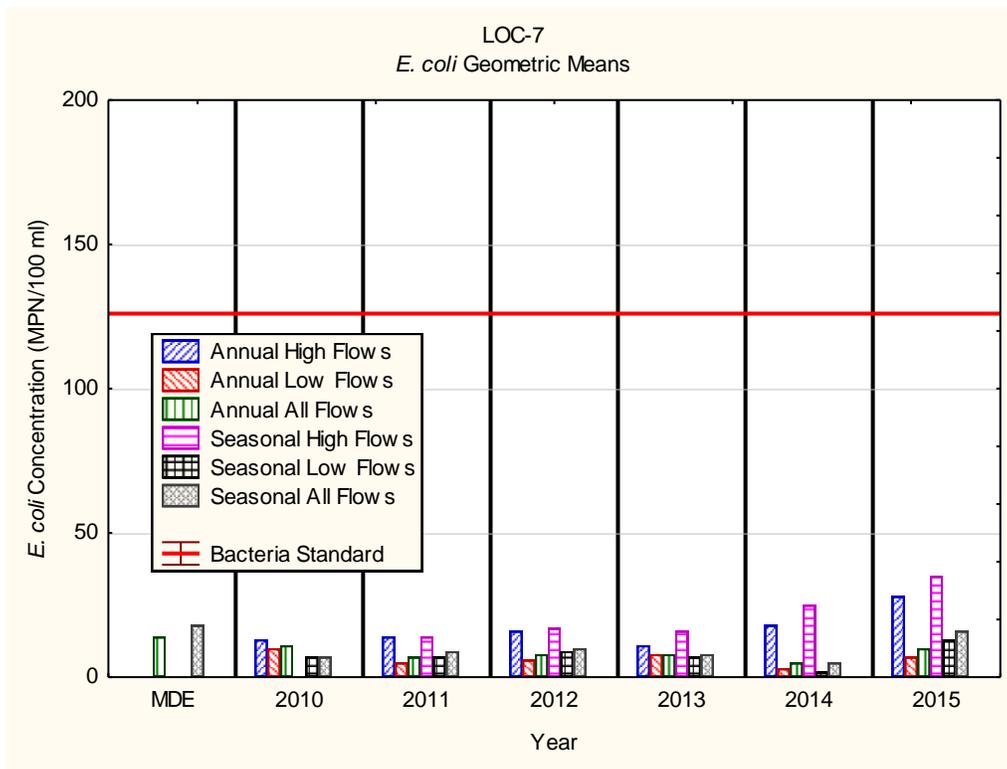
Figure 9-32: *E. coli* Geometric Mean Concentrations at Site LOC-7 for both Annual and Seasonal Flow Periods Stratified by Flow Condition, MDE Results Added for Comparison

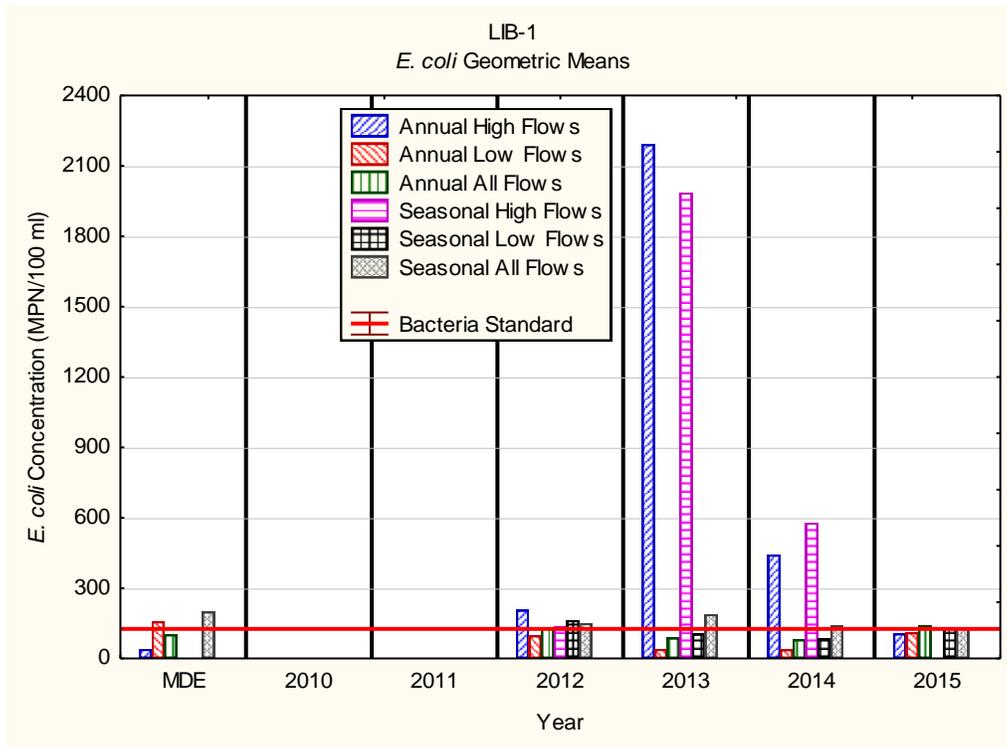
Figure 9-33: E. coli Geometric Mean Concentrations at Site LIB-1 for Both Annual and Seasonal Flow Periods Stratified by Flow Condition, MDE Results Added for Comparison. No data for 2010 and 2011.

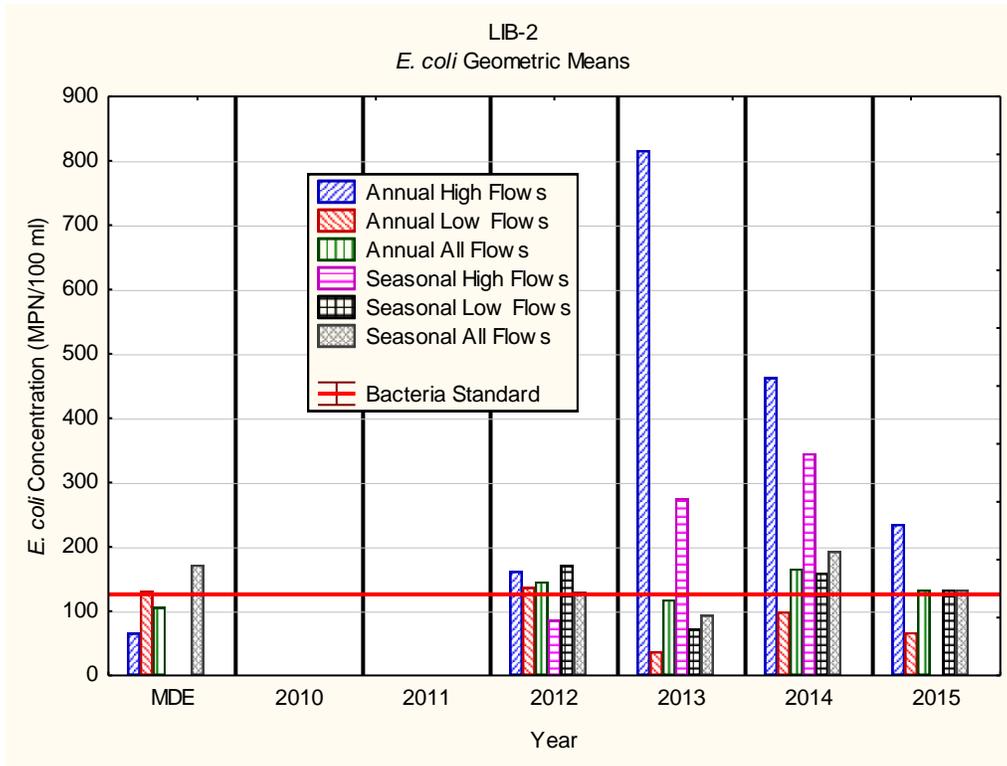
Figure 9-34: E. coli Geometric Mean Concentrations at Site LIB-2 for Both Annual and Seasonal Flow Periods Stratified by Flow Condition, MDE Results Added for Comparison. No data for 2010 and 2011.

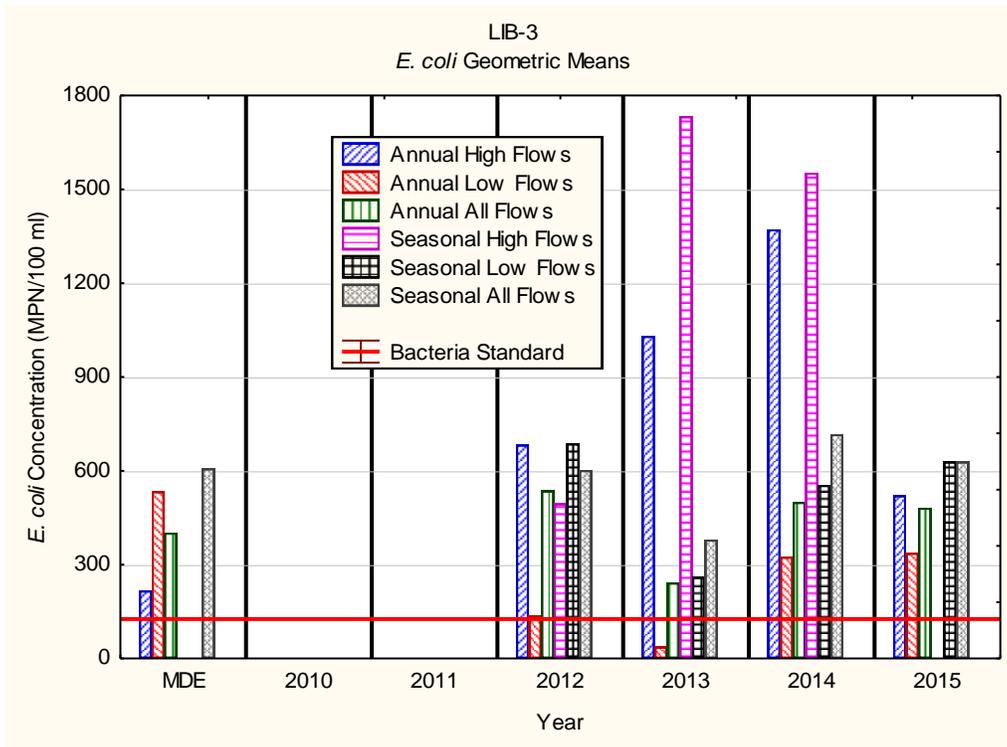
Figure 9-35: E. coli Geometric Mean Concentrations at Site LIB-3 for Both Annual and Seasonal Flow Periods Stratified by Flow Condition, MDE Results Added for Comparison. No data for 2010 and 2011.

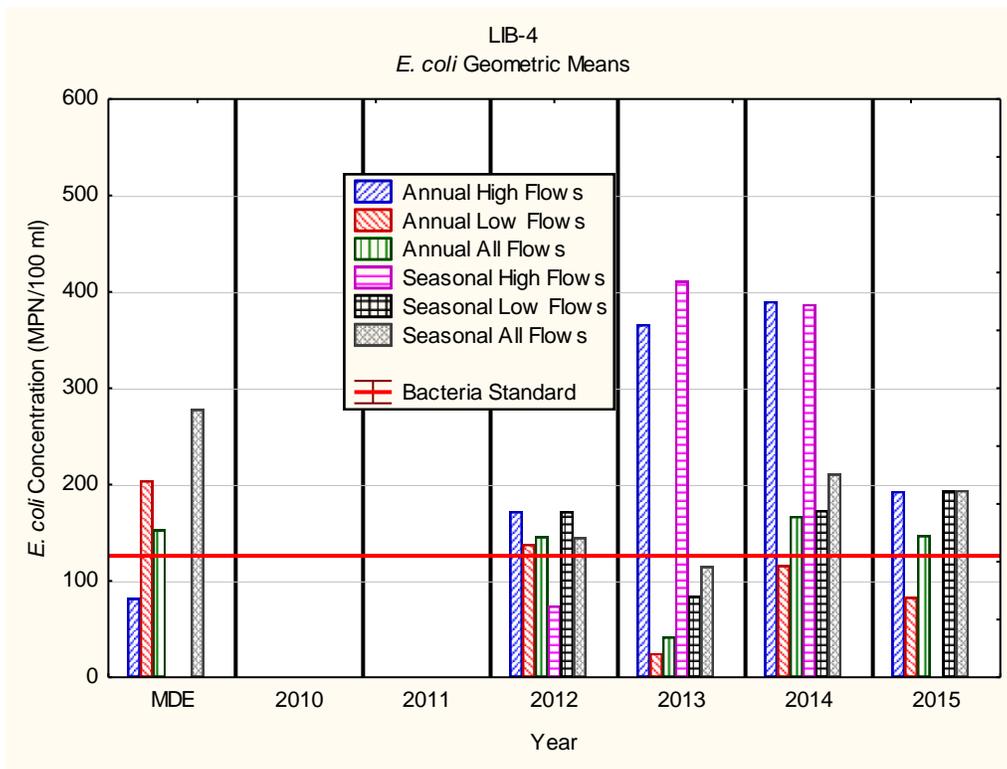
Figure 9-36: E. coli Geometric Mean Concentrations at Site LIB-4 for Both Annual and Seasonal Flow Periods Stratified by Flow Condition, MDE Results Added for Comparison. No data for 2010 and 2011.

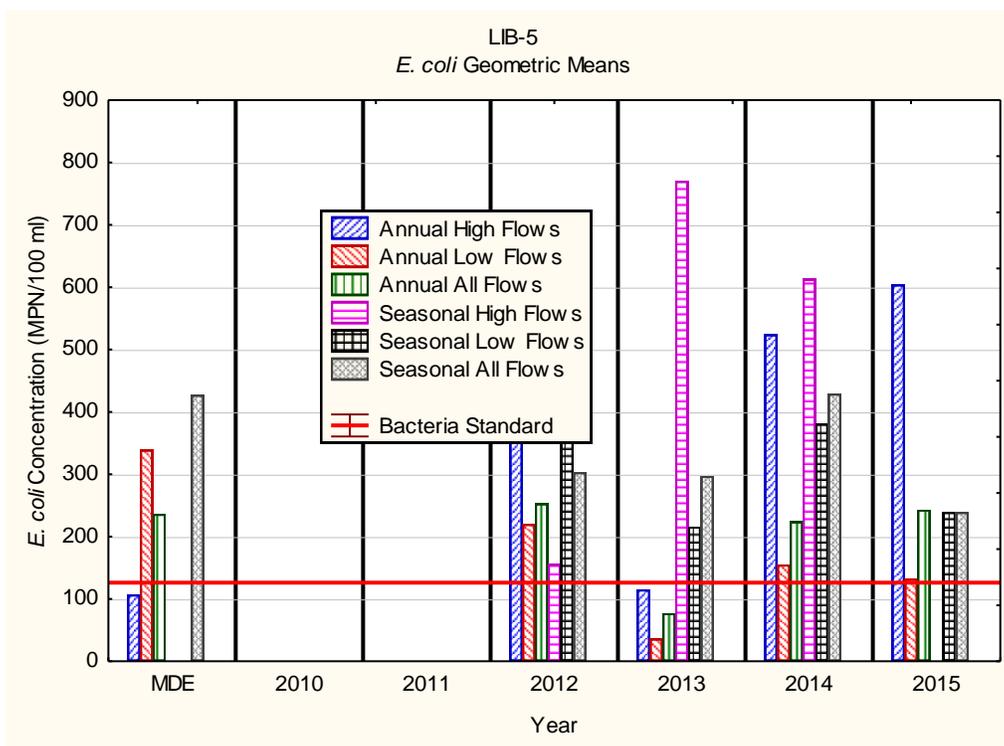
Figure 9-37: E. coli Geometric Mean Concentrations at Site LIB-5 for Both Annual and Seasonal Flow Periods Stratified by Flow Condition, MDE Results Added for Comparison. No data for 2010 and 2011.

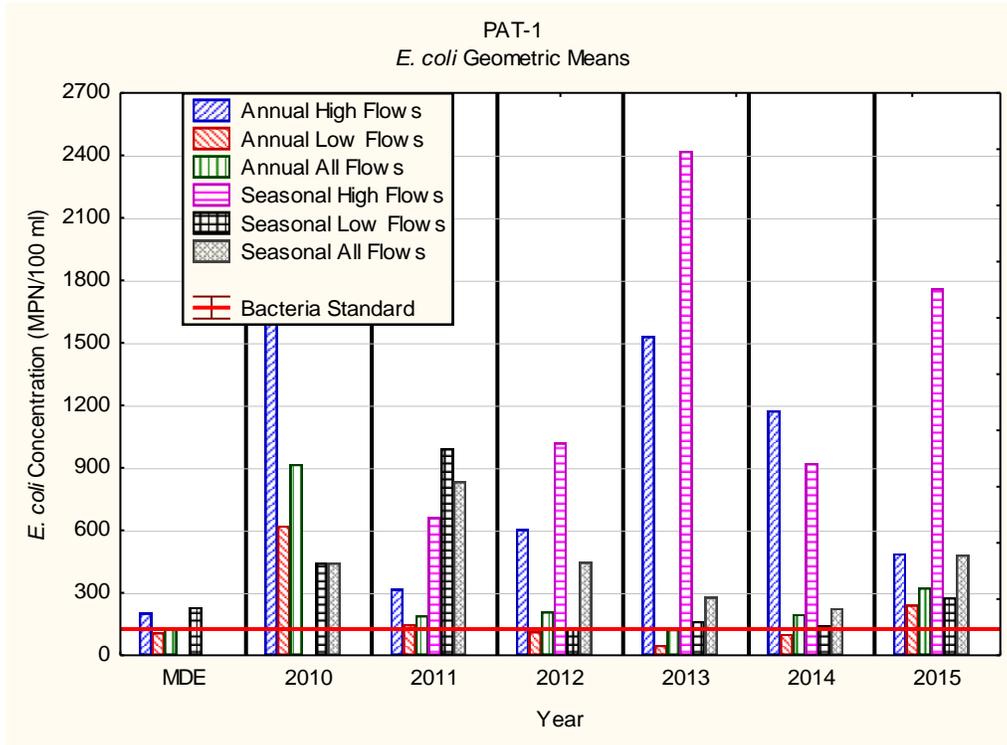
Figure 9-38: E. coli Geometric Mean Concentrations at Site PAT-1 for Annual and Seasonal Flow Periods Stratified by Flow Condition, MDE Results Added for Comparison

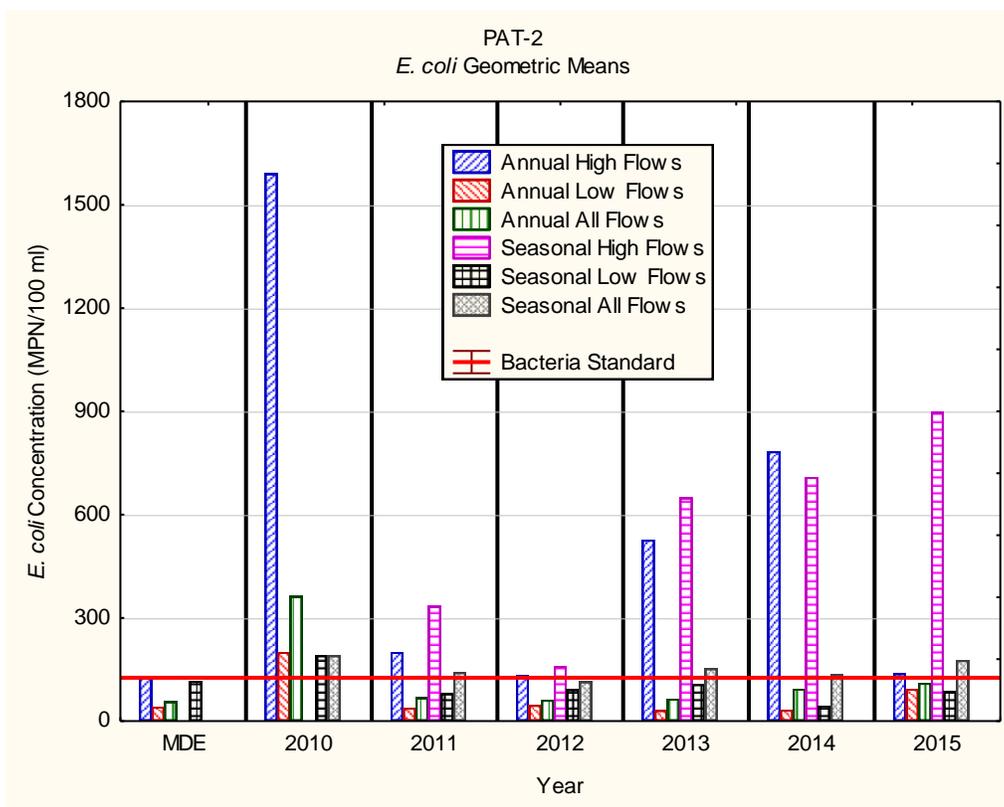
Figure 9-39: E. coli Geometric Mean Concentrations at Site PAT-2 for Annual and Seasonal Flow Periods Stratified by Flow Condition, MDE Results Added for Comparison

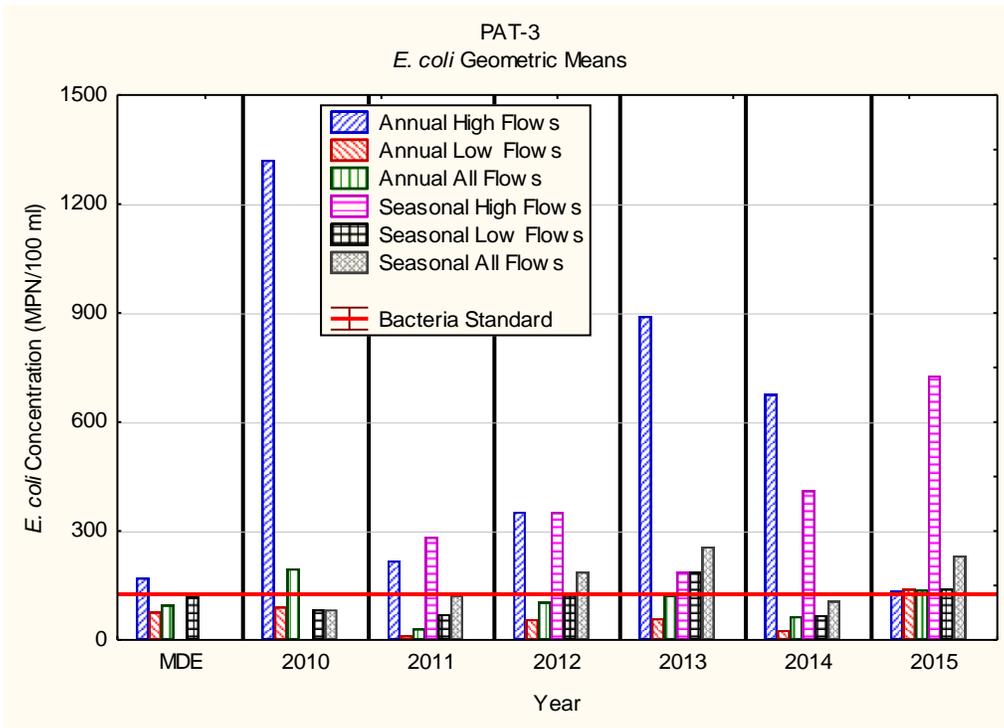
Figure 9-40: E. coli Geometric Mean Concentrations at Site PAT-3 for Annual and Seasonal Flow Periods Stratified by Flow Condition, MDE Results Added for Comparison

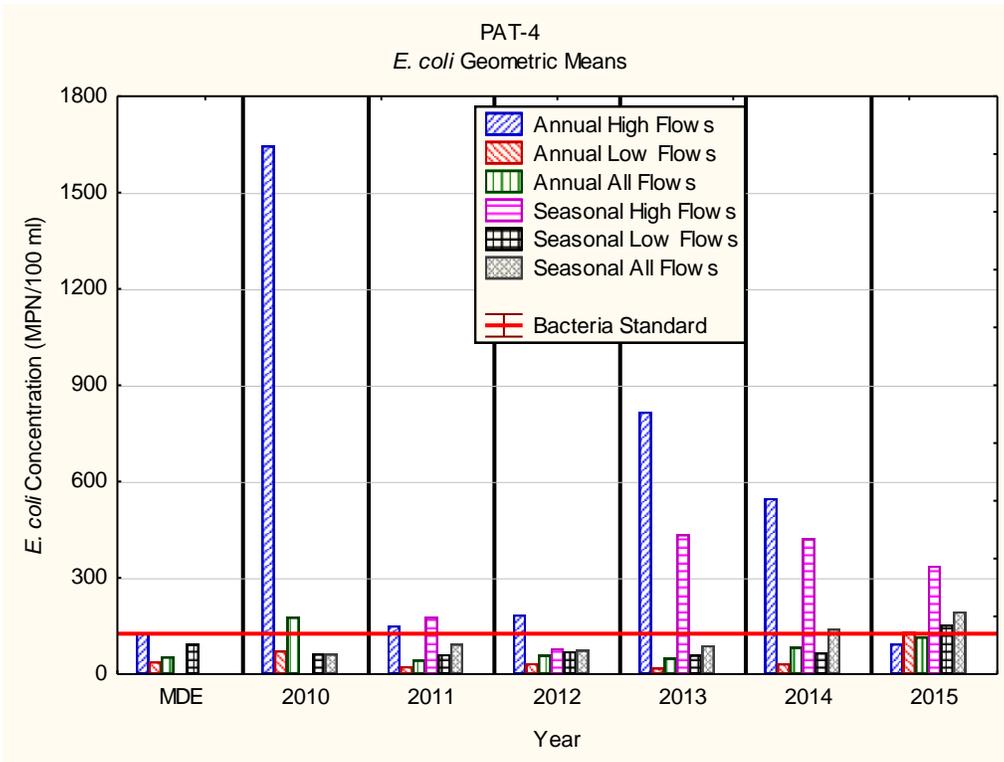
Figure 9-41: E. coli Geometric Mean Concentrations at Site PAT-4 for Annual and Seasonal Flow Periods Stratified by Flow Condition, MDE Results Added for Comparison

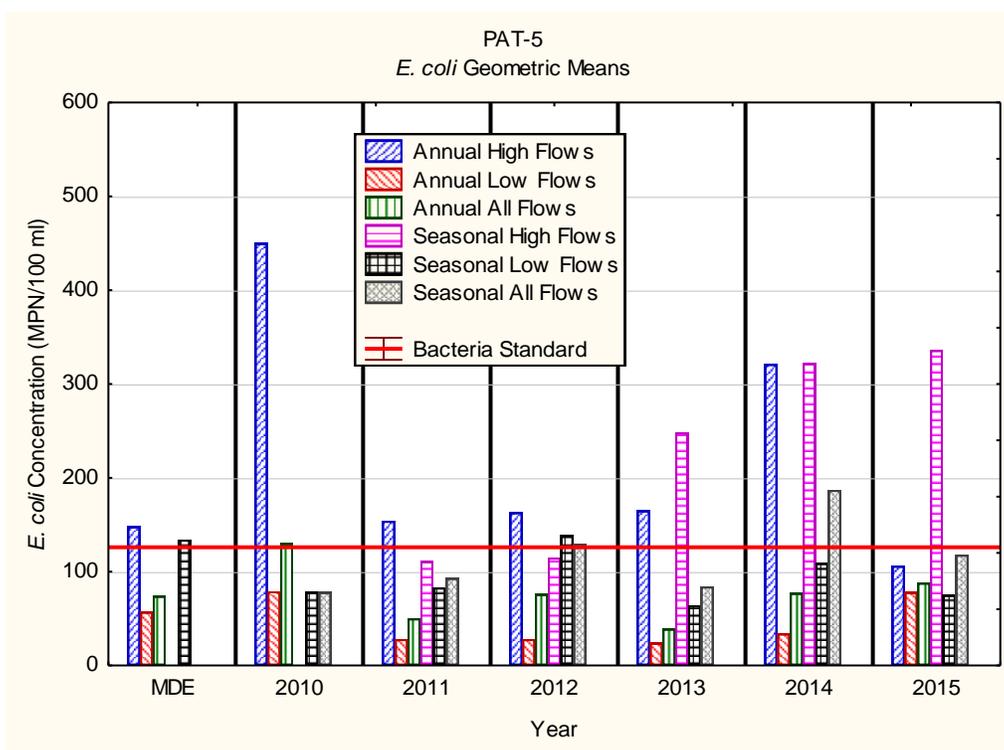
Figure 9-42: E. coli Geometric Mean Concentrations at Site PAT-5 for Annual and Seasonal Flow Periods Stratified by Flow Condition, MDE Results Added for Comparison

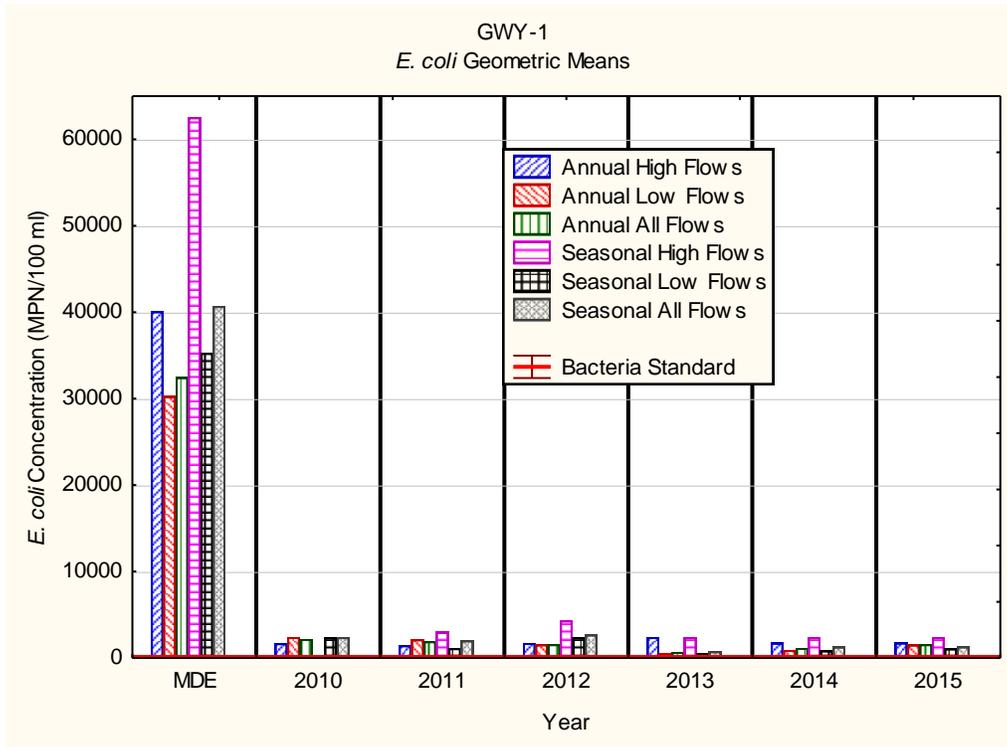
Figure 9-43: *E. coli* Geometric Mean Concentrations at Site GWY-1 for both Annual and Seasonal Flow Periods Stratified by Flow Condition, MDE Results Added for Comparison

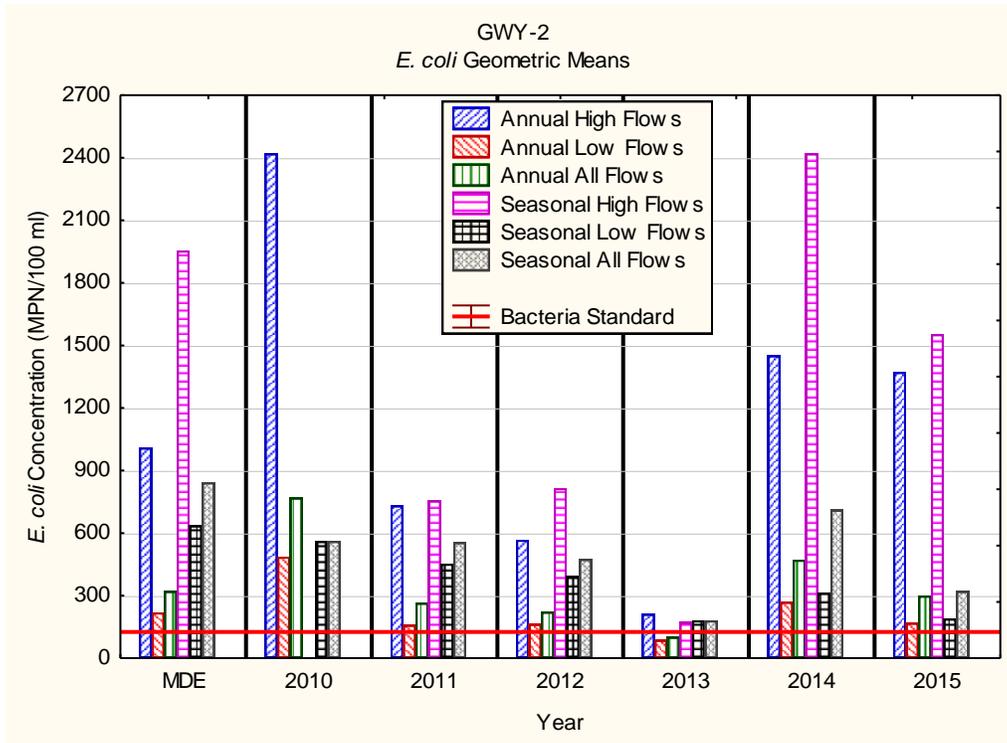
Figure 9-44: *E. coli* Geometric Mean Concentrations at Site GWY-2 for both Annual and Seasonal Flow Periods Stratified by Flow Condition, MDE Results Added for Comparison

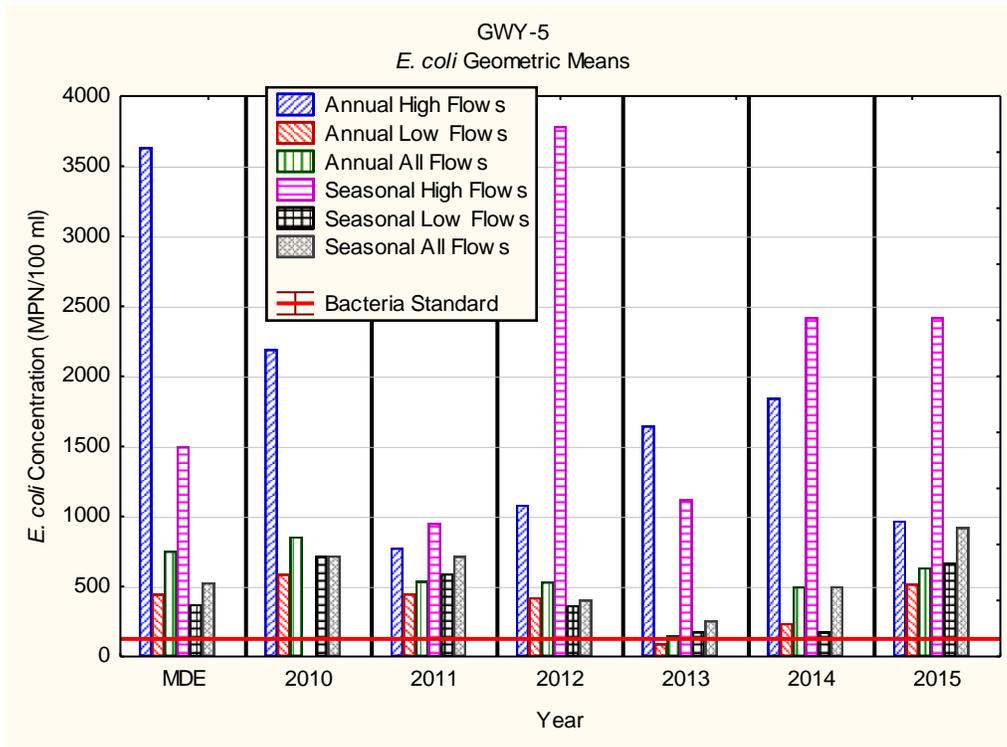
Figure 9-45: *E. coli* Geometric Mean Concentrations at Site GWY-5 for both Annual and Seasonal Flow Periods Stratified by Flow Condition, MDE Results Added for Comparison

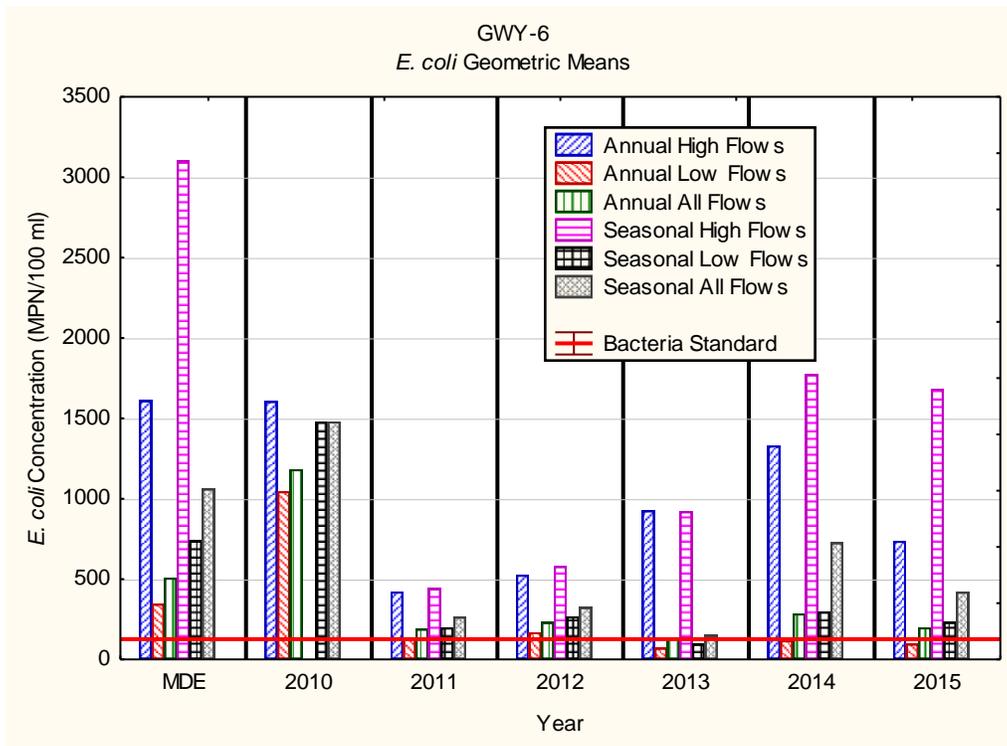
Figure 9-46: *E. coli* Geometric Mean Concentrations at Site GWY-6 for both Annual and Seasonal Flow Periods Stratified by Flow Condition, MDE Results Added for Comparison

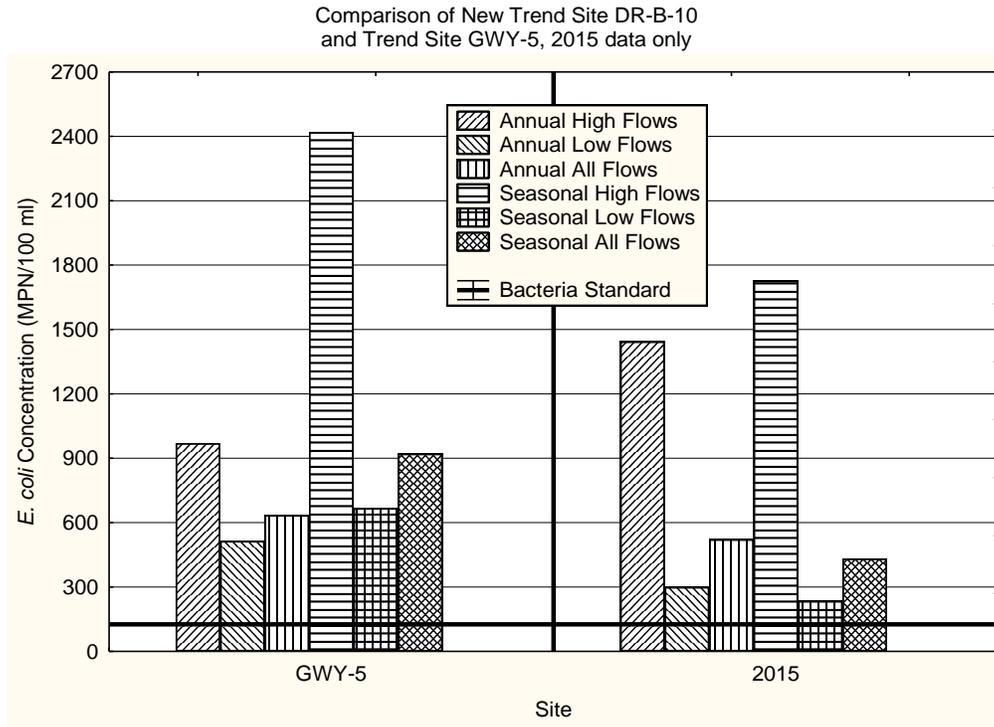
Figure 9-47: E. coli Geometric Mean Concentrations at Site DR-B-10 for both Annual and Seasonal Flow Periods Stratified by Flow Condition for first year of sampling, with GWY-5 for comparison

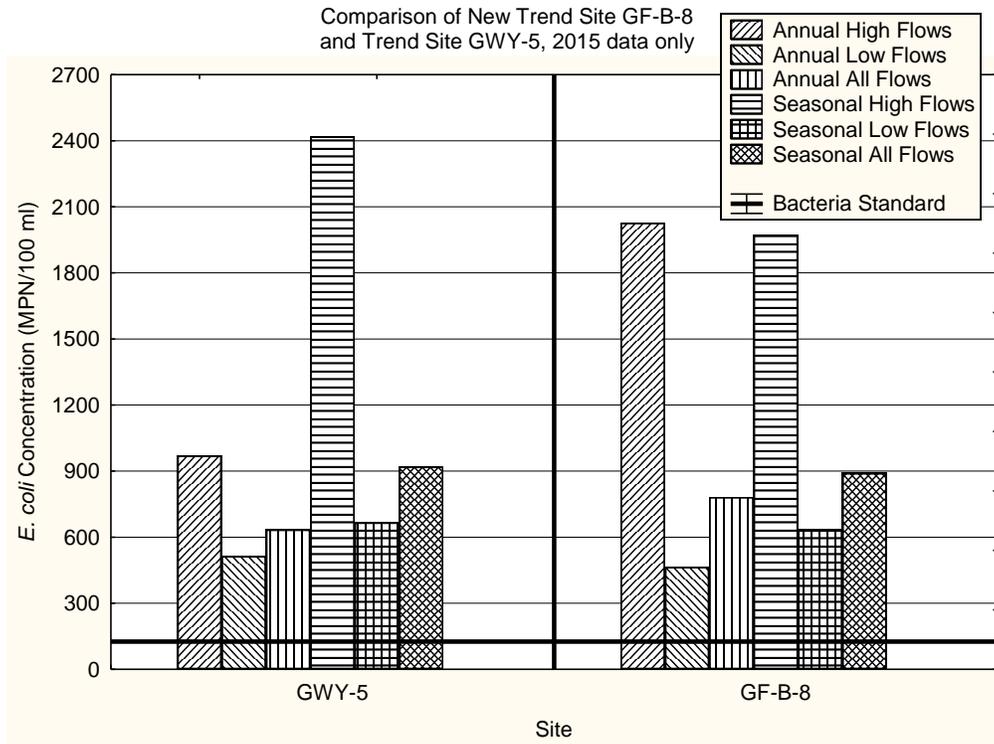
Figure 9-48: E. coli Geometric Mean Concentrations at Site GF-B-8 for both Annual and Seasonal Flow Periods Stratified by Flow Condition for first year of sampling, with GWY-5 for comparison

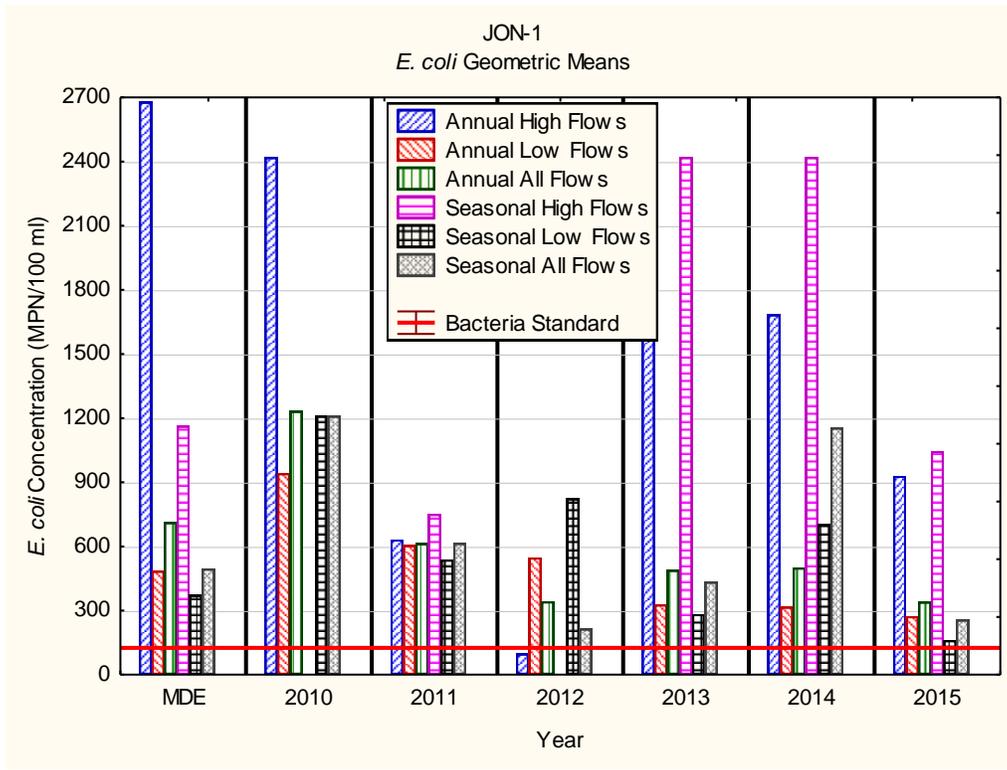
Figure 9-49: E. coli Geometric Mean Concentrations at Site JON-1 for both Annual and Seasonal Flow Periods Stratified by Flow Condition, MDE Results Added for Comparison

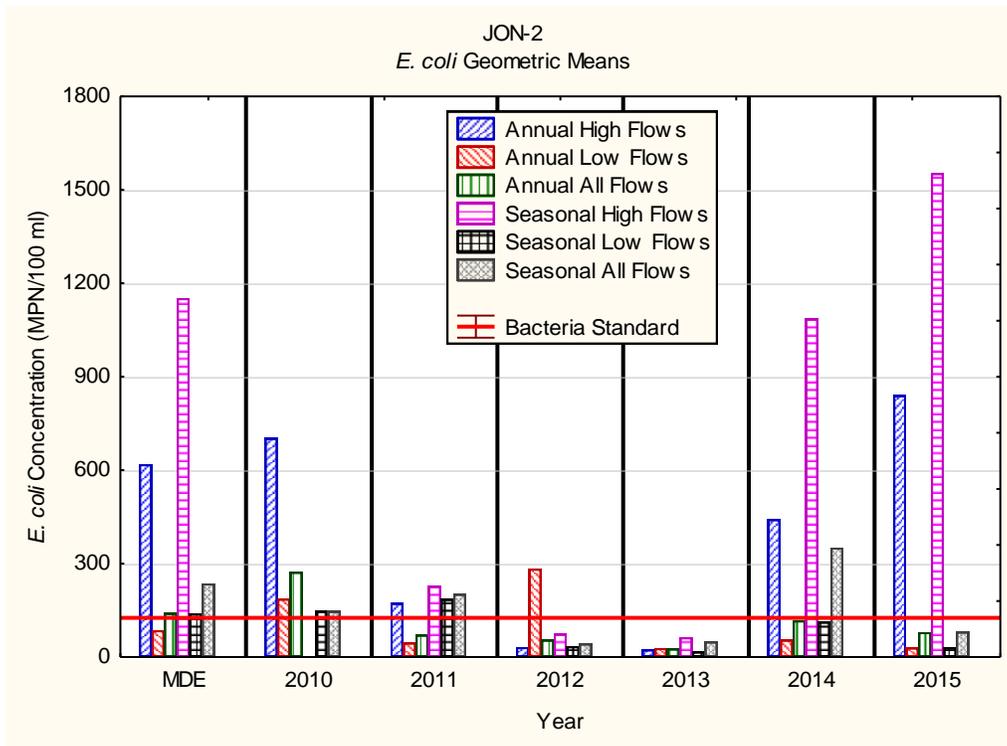
Figure 9-50: E. coli Geometric Mean Concentrations at Site JON-2 for both Annual and Seasonal Flow Periods Stratified by Flow Condition, MDE Results Added for Comparison

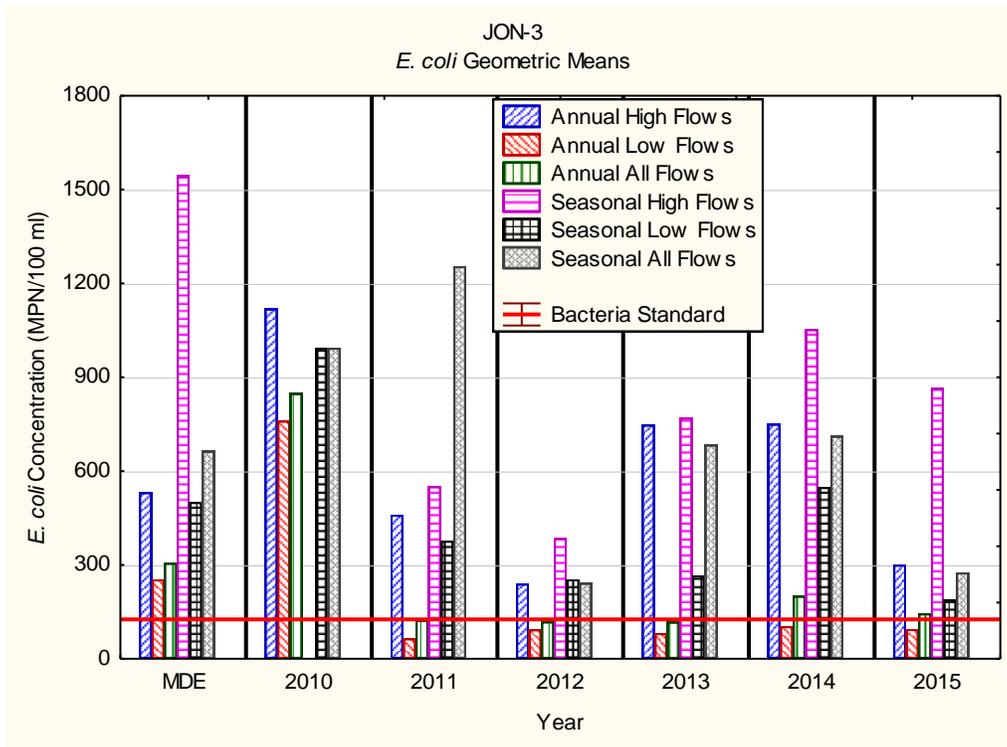
Figure 9-51: *E. coli* Geometric Mean Concentrations at Site JON-3 for both Annual and Seasonal Flow Periods Stratified by Flow Condition, MDE Results Added for Comparison

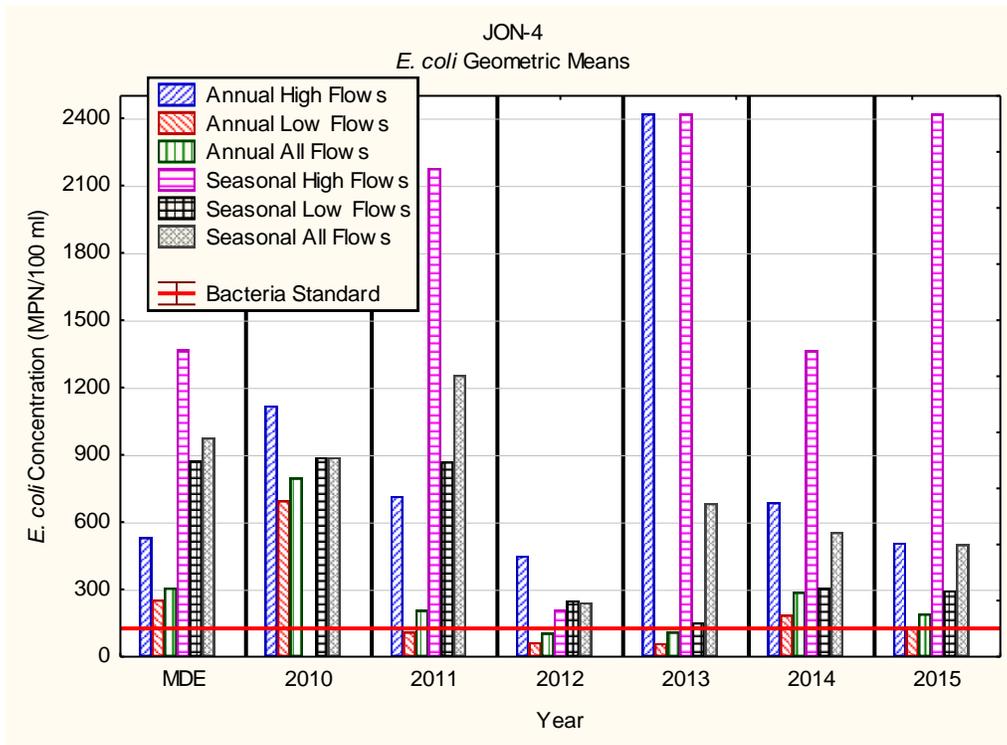
Figure 9-52: *E. coli* Geometric Mean Concentrations at Site JON-4 for both Annual and Seasonal Flow Periods Stratified by Flow Condition, MDE Results Added for Comparison
