**9.0 Permit Requirements**

**F. Discharge Characterization**

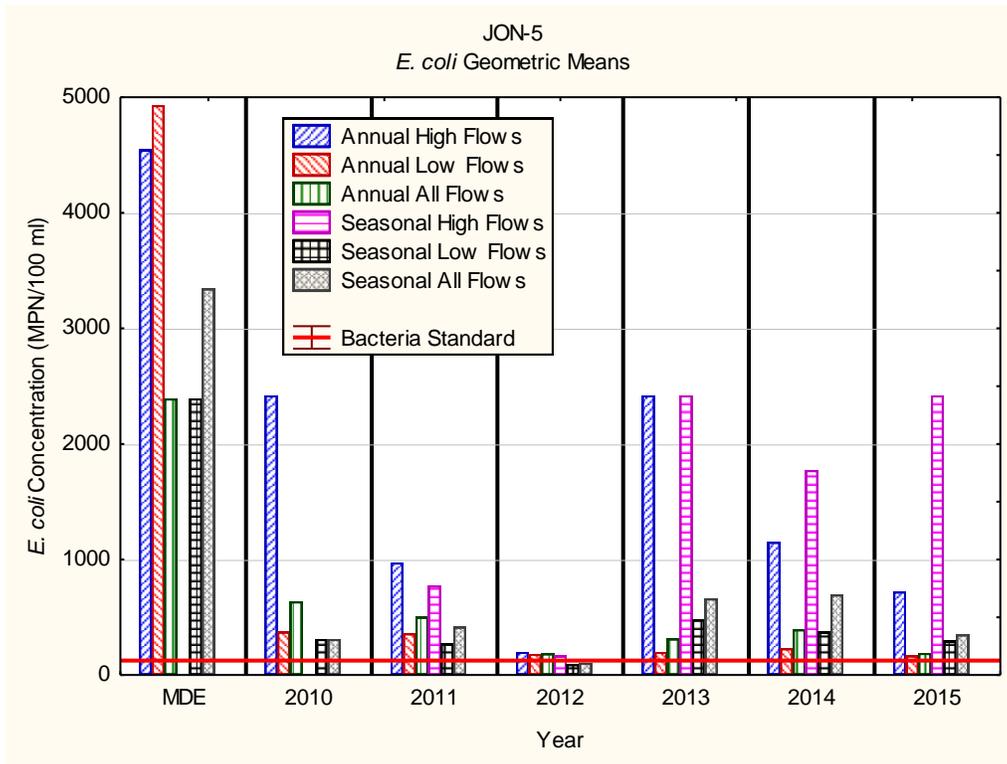
Figure 9-53: E. coli Geometric Mean Concentrations at Site JON-5 for both Annual and Seasonal Flow Periods Stratified by Flow Condition, MDE Results Added for Comparison

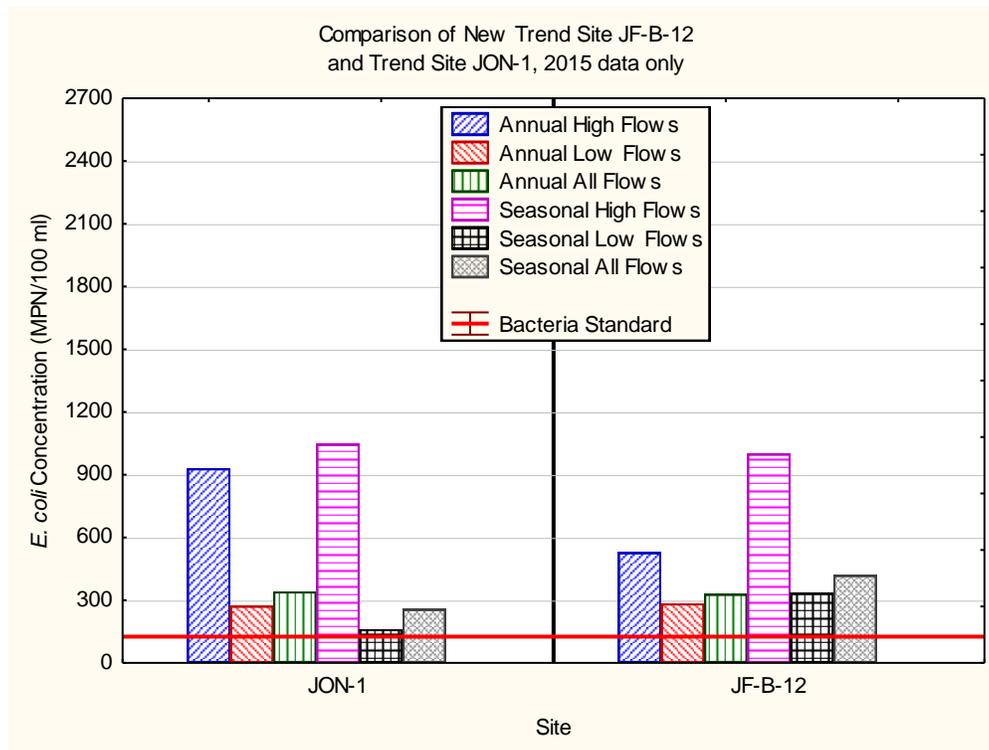
Figure 9-54: E. coli Geometric Mean Concentrations at Site JF-B-12 for both Annual and Seasonal Flow Periods Stratified by Flow Condition for first year of sampling, with JON-1 for comparison

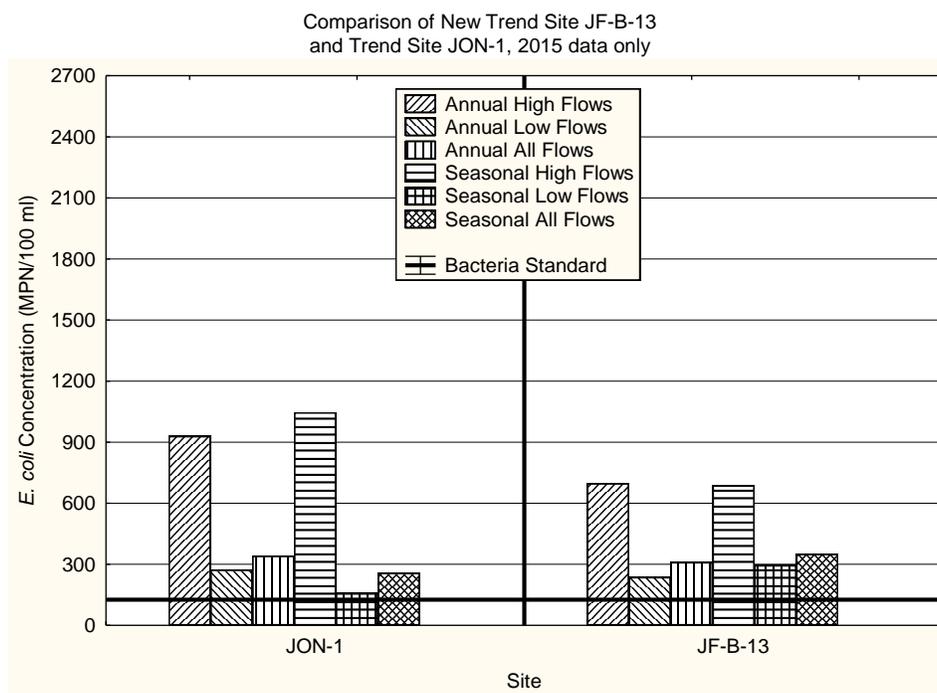
**Figure 9-55: E. coli Geometric Mean Concentrations at Site JF-B-13 for both Annual and Seasonal Flow Periods Stratified by Flow Condition for first year of sampling, with JON-1 for comparison**

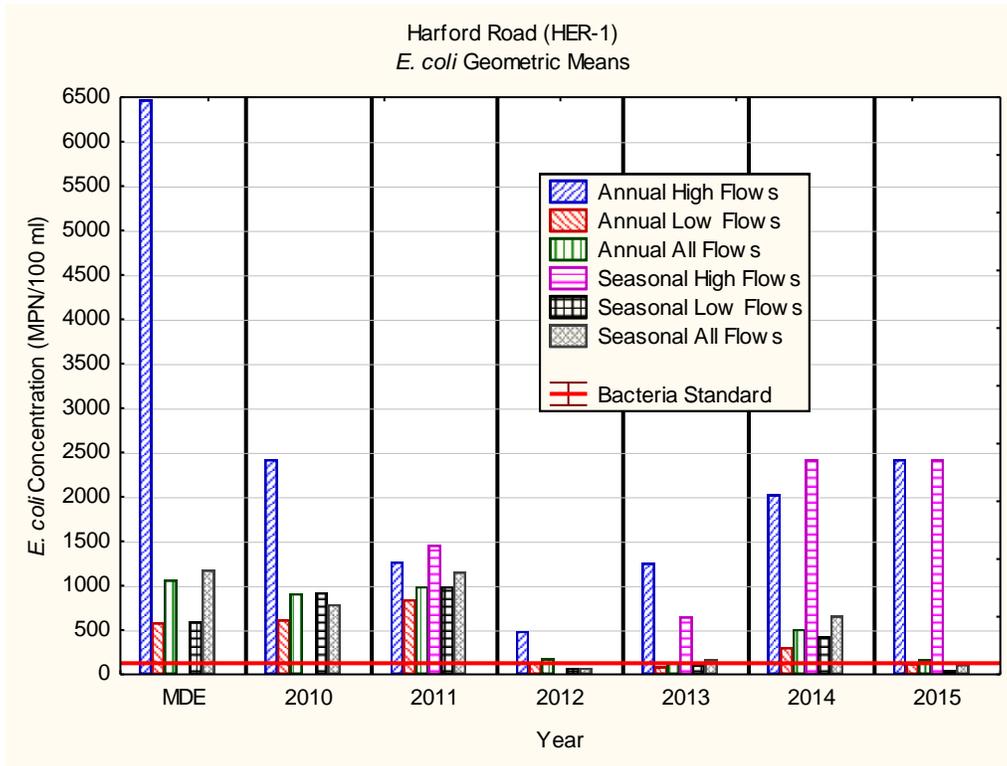
Figure 9-56: E. coli Geometric Mean Concentrations at the Harford Road Site (HER-1) for both Annual and Seasonal Flow Periods Stratified by Flow Condition, MDE Results Added for Comparison

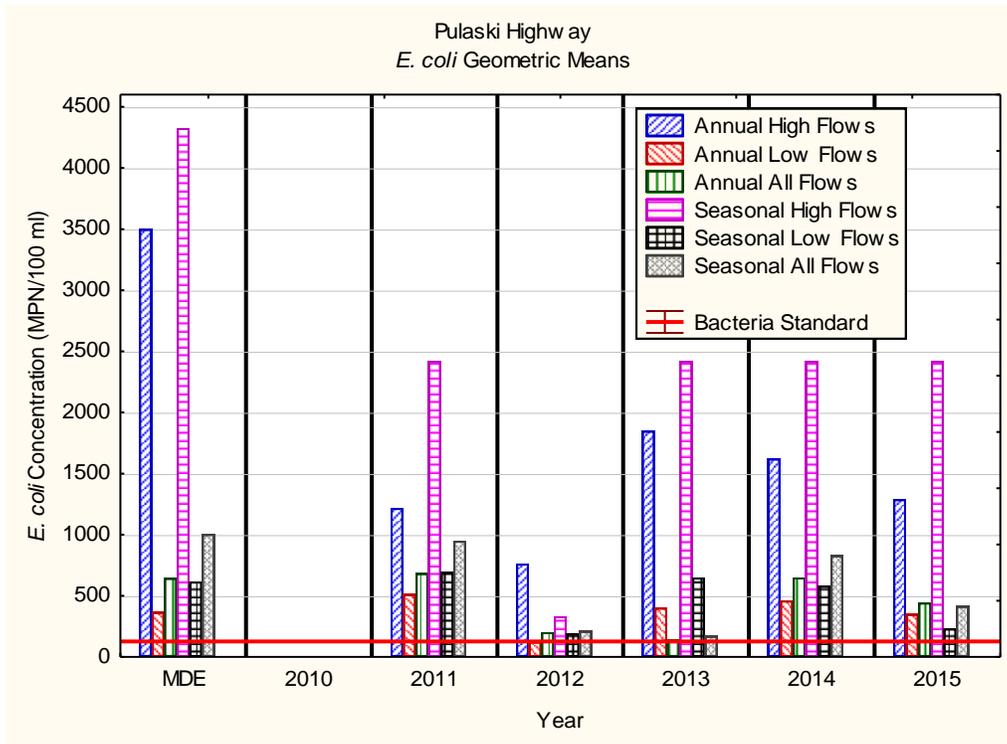
Figure 9-57: E. coli Geometric Mean Concentrations at the Pulaski Highway Site for both Annual and Seasonal Flow Periods Stratified by Flow Condition, MDE Results Added for Comparison. No Samples Collected in 2010

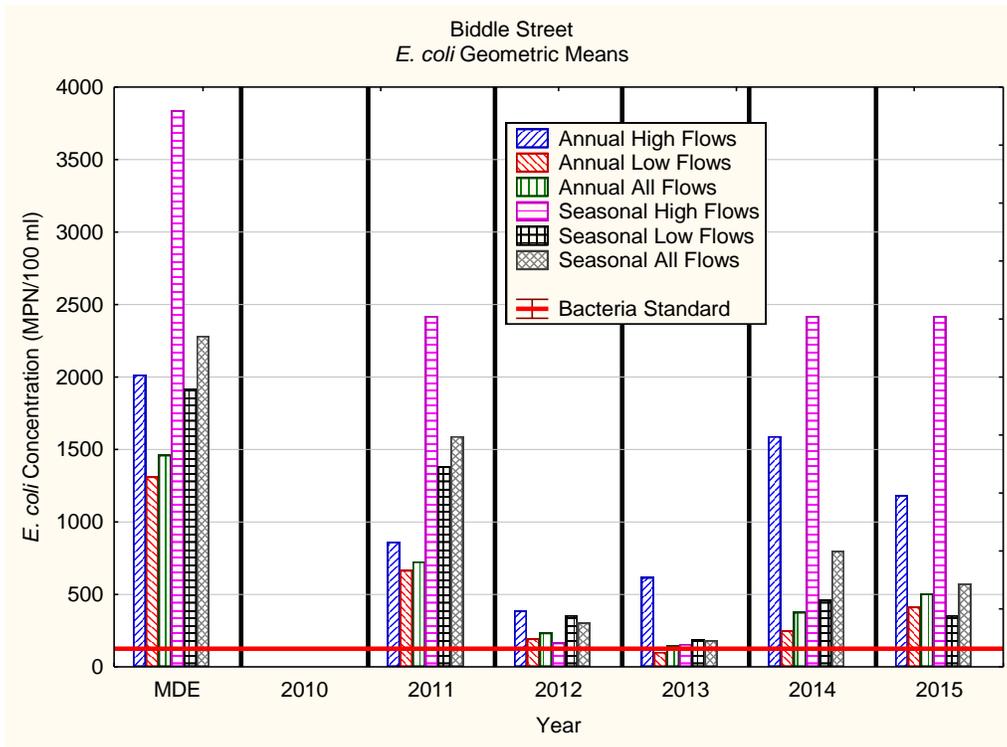
Figure 9-58: E. coli Geometric Mean Concentrations at the Biddle Street Site for both Annual and Seasonal Flow Periods Stratified by Flow Condition, MDE Results Added for Comparison. No Samples Collected in 2010

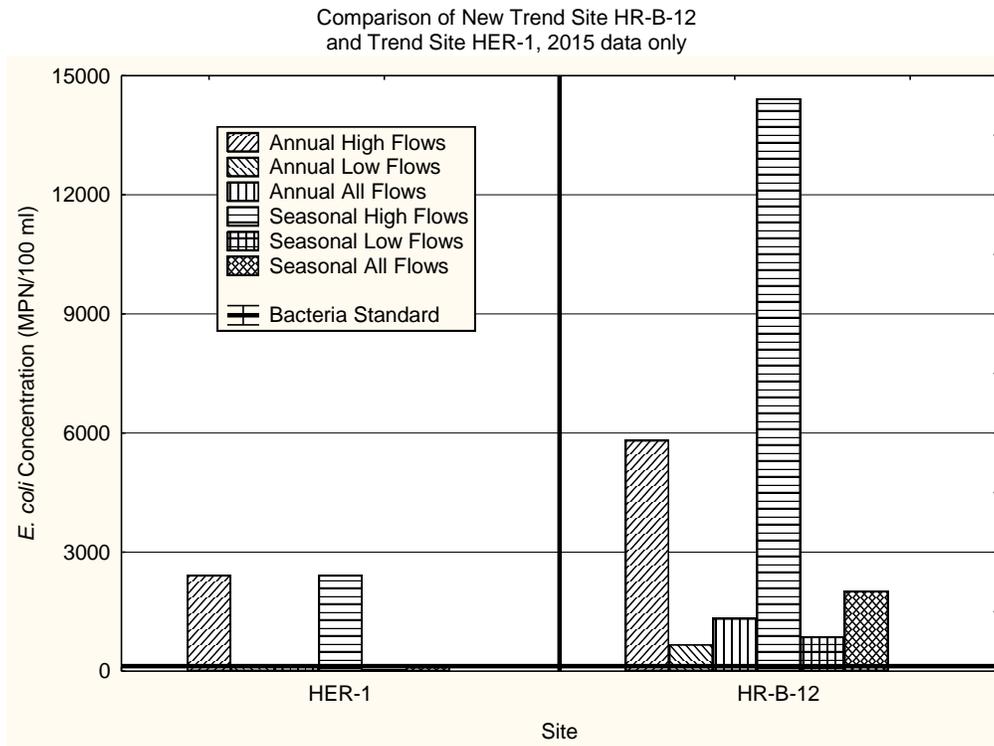
Figure 9-59: E. coli Geometric Mean Concentrations at Site HR-B-12 for both Annual and Seasonal Flow Periods Stratified by Flow Condition, HER-1 Results Added for Comparison.

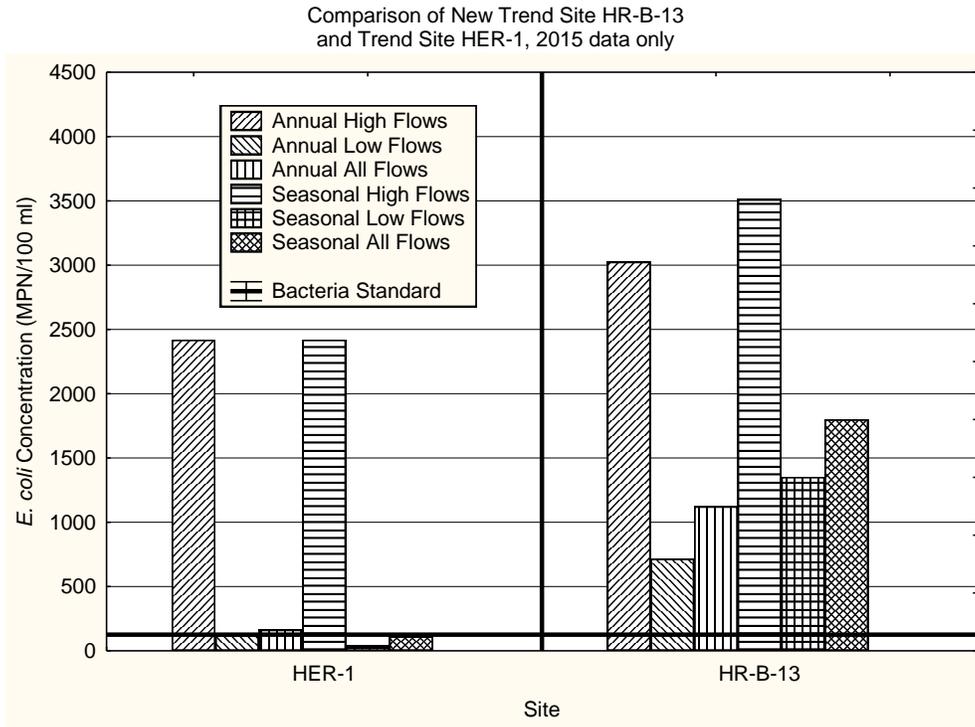
Figure 9-60: E. coli Geometric Mean Concentrations at Site HR-B-13 for both Annual and Seasonal Flow Periods Stratified by Flow Condition, HER-1 Results Added for Comparison.

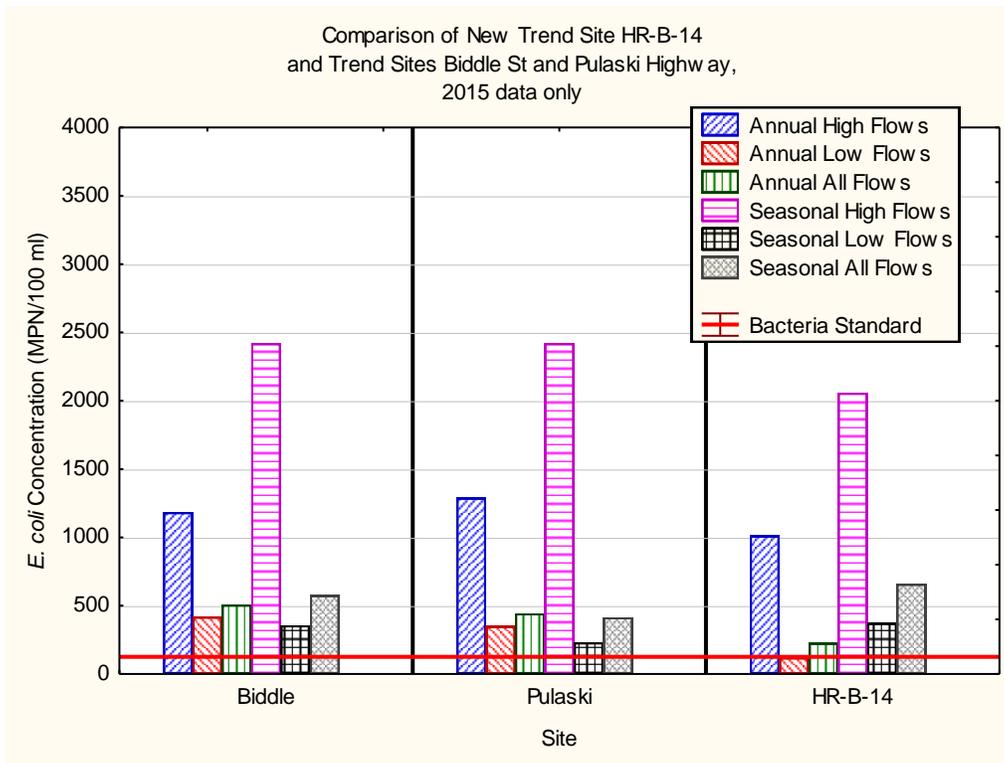
Figure 9-61: E. coli Geometric Mean Concentrations at Site HR-B-14 for both Annual and Seasonal Flow Periods Stratified by Flow Condition, Biddle and Pulaski Results Added for Comparison.

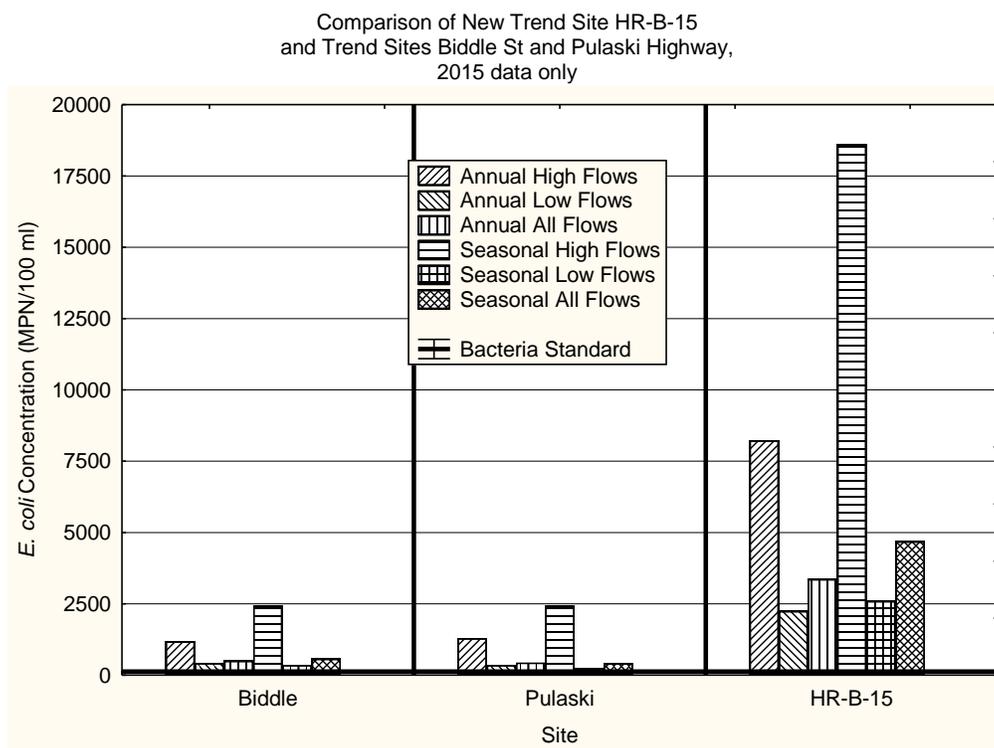
**Figure 9-62: E. coli Geometric Mean Concentrations at Site HR-B-15 for both Annual and Seasonal Flow Periods Stratified by Flow Condition, Biddle and Pulaski Results Added for Comparison.**

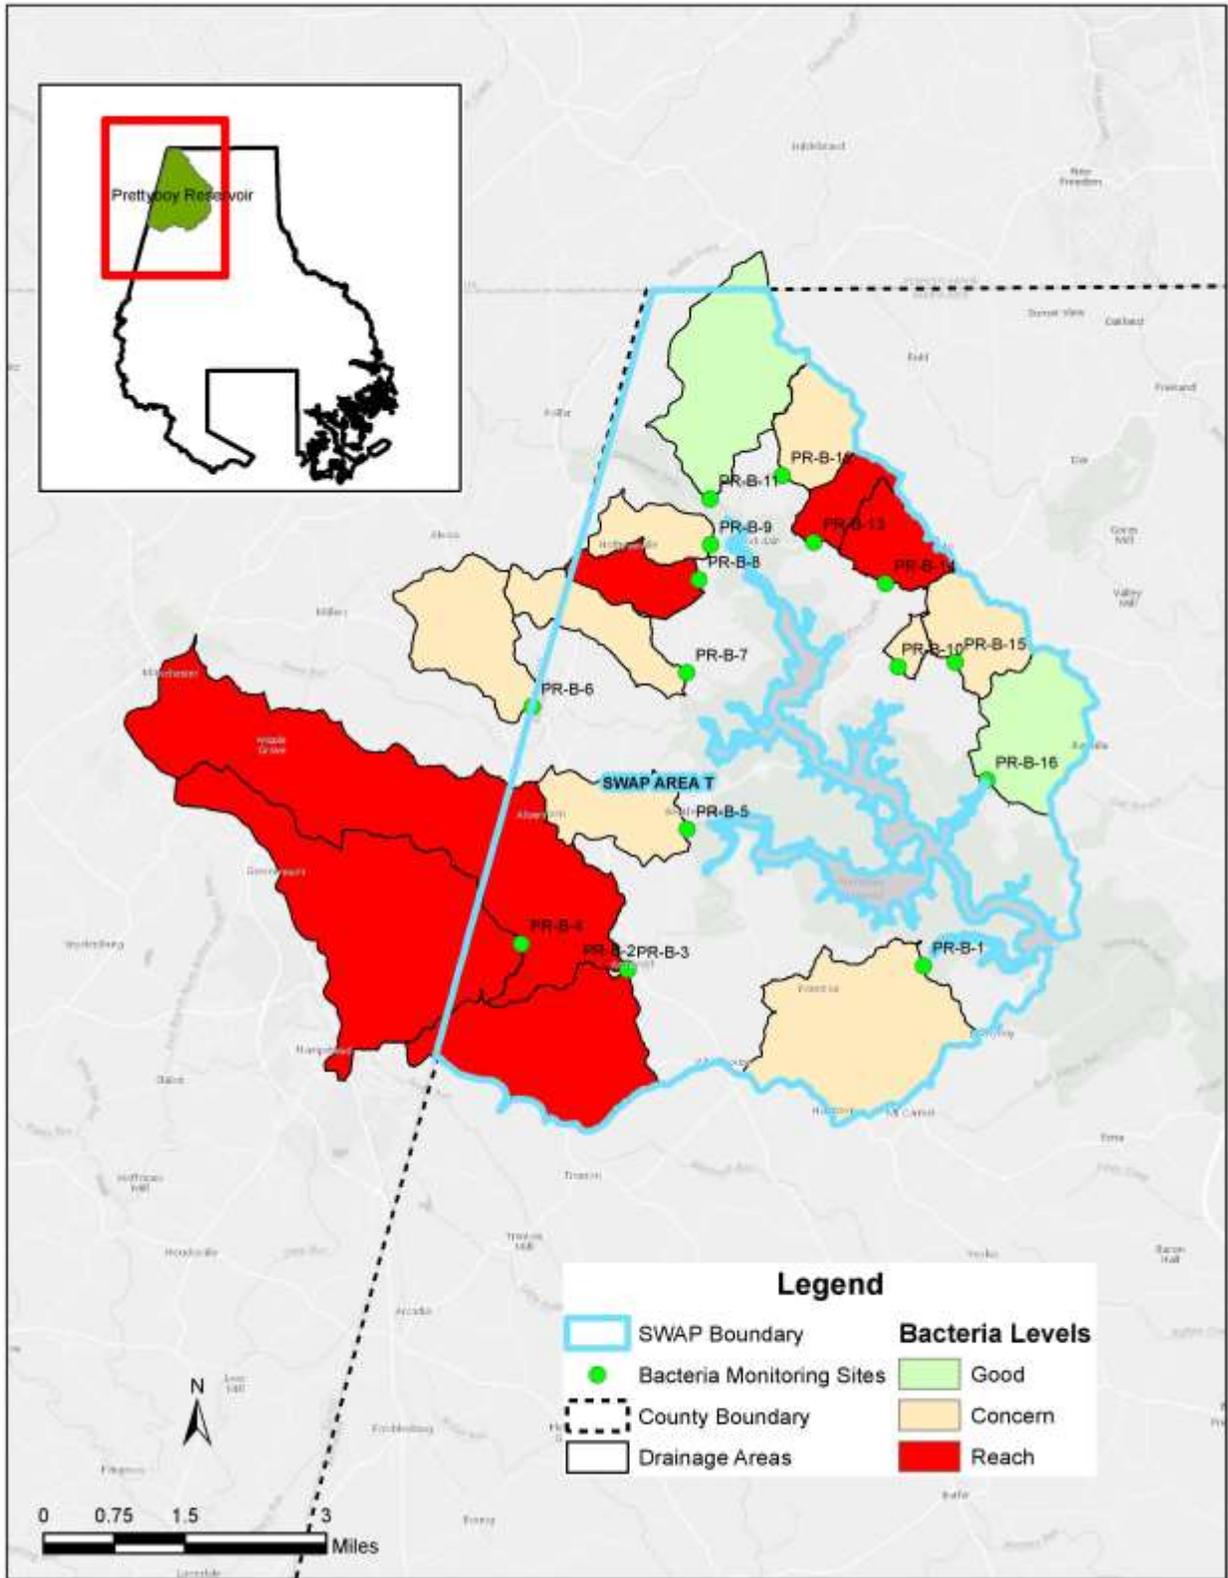
Figure 9-63: Prettyboy Reservoir Subwatershed Prioritization Site Results

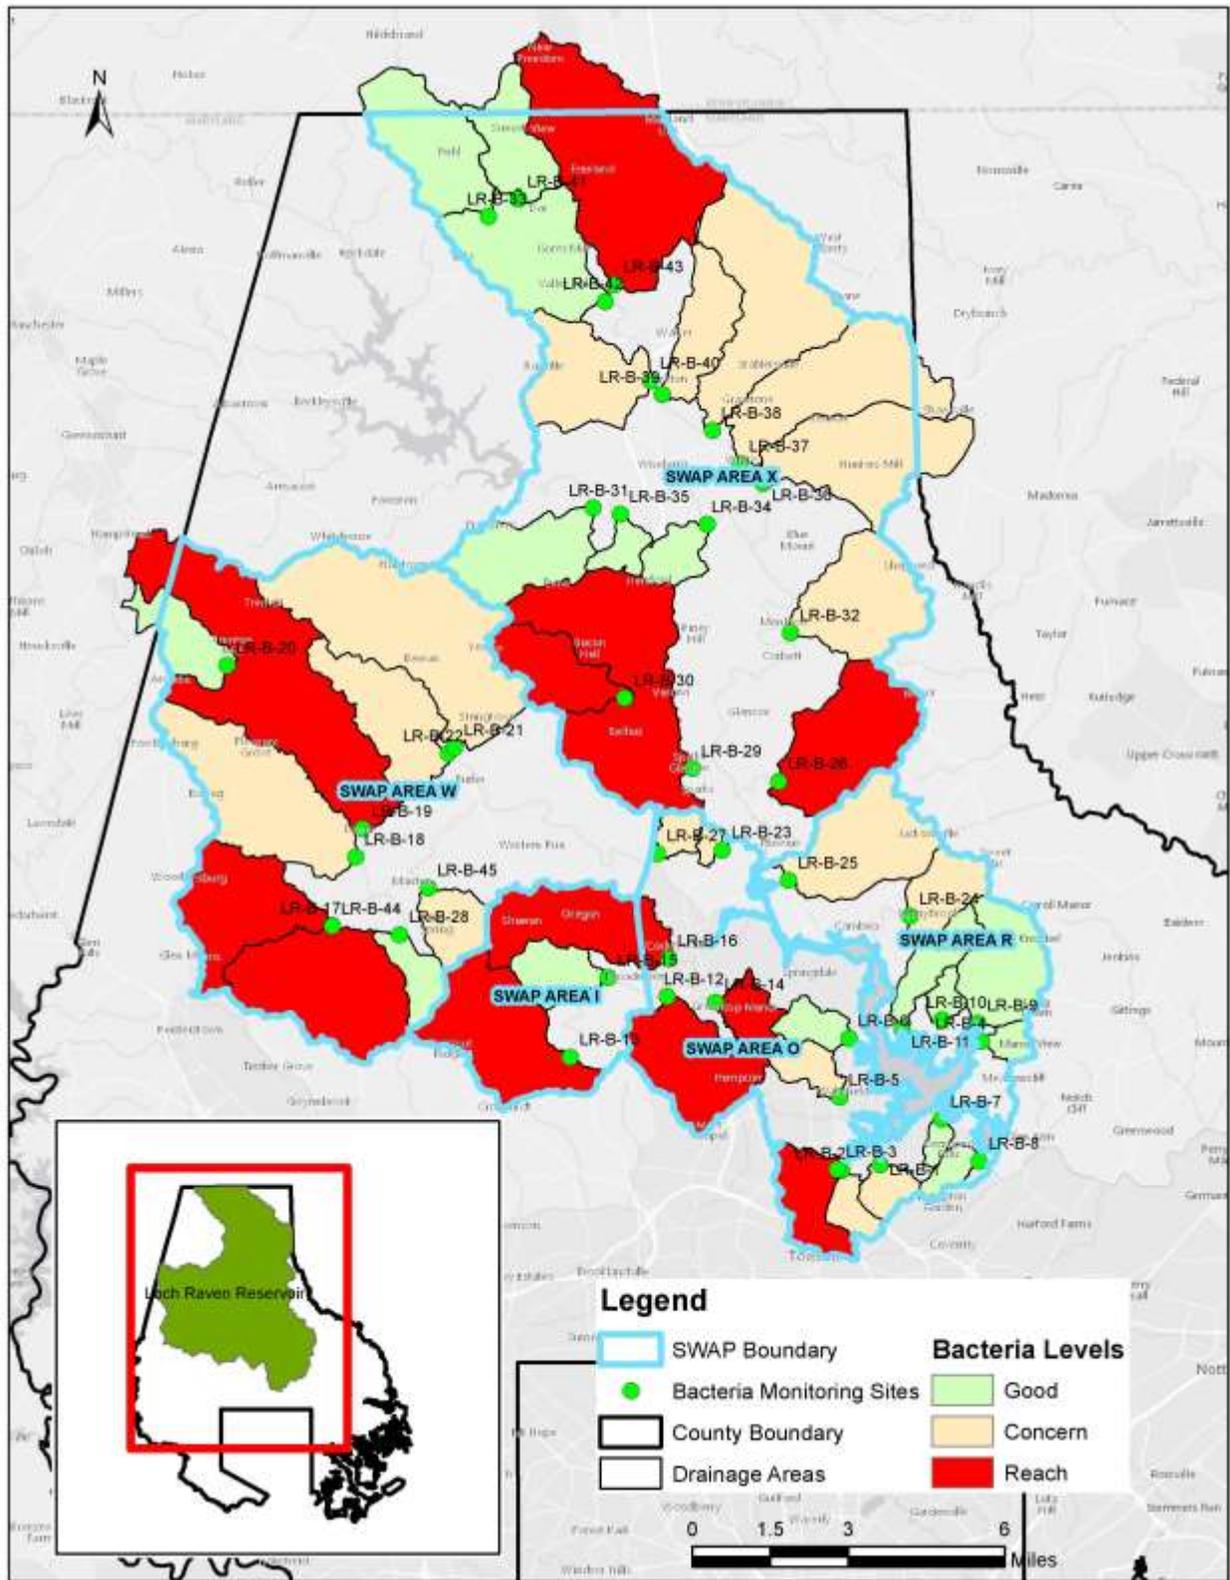
Figure 9-64: Loch Raven Reservoir Subwatershed Prioritization Site Results

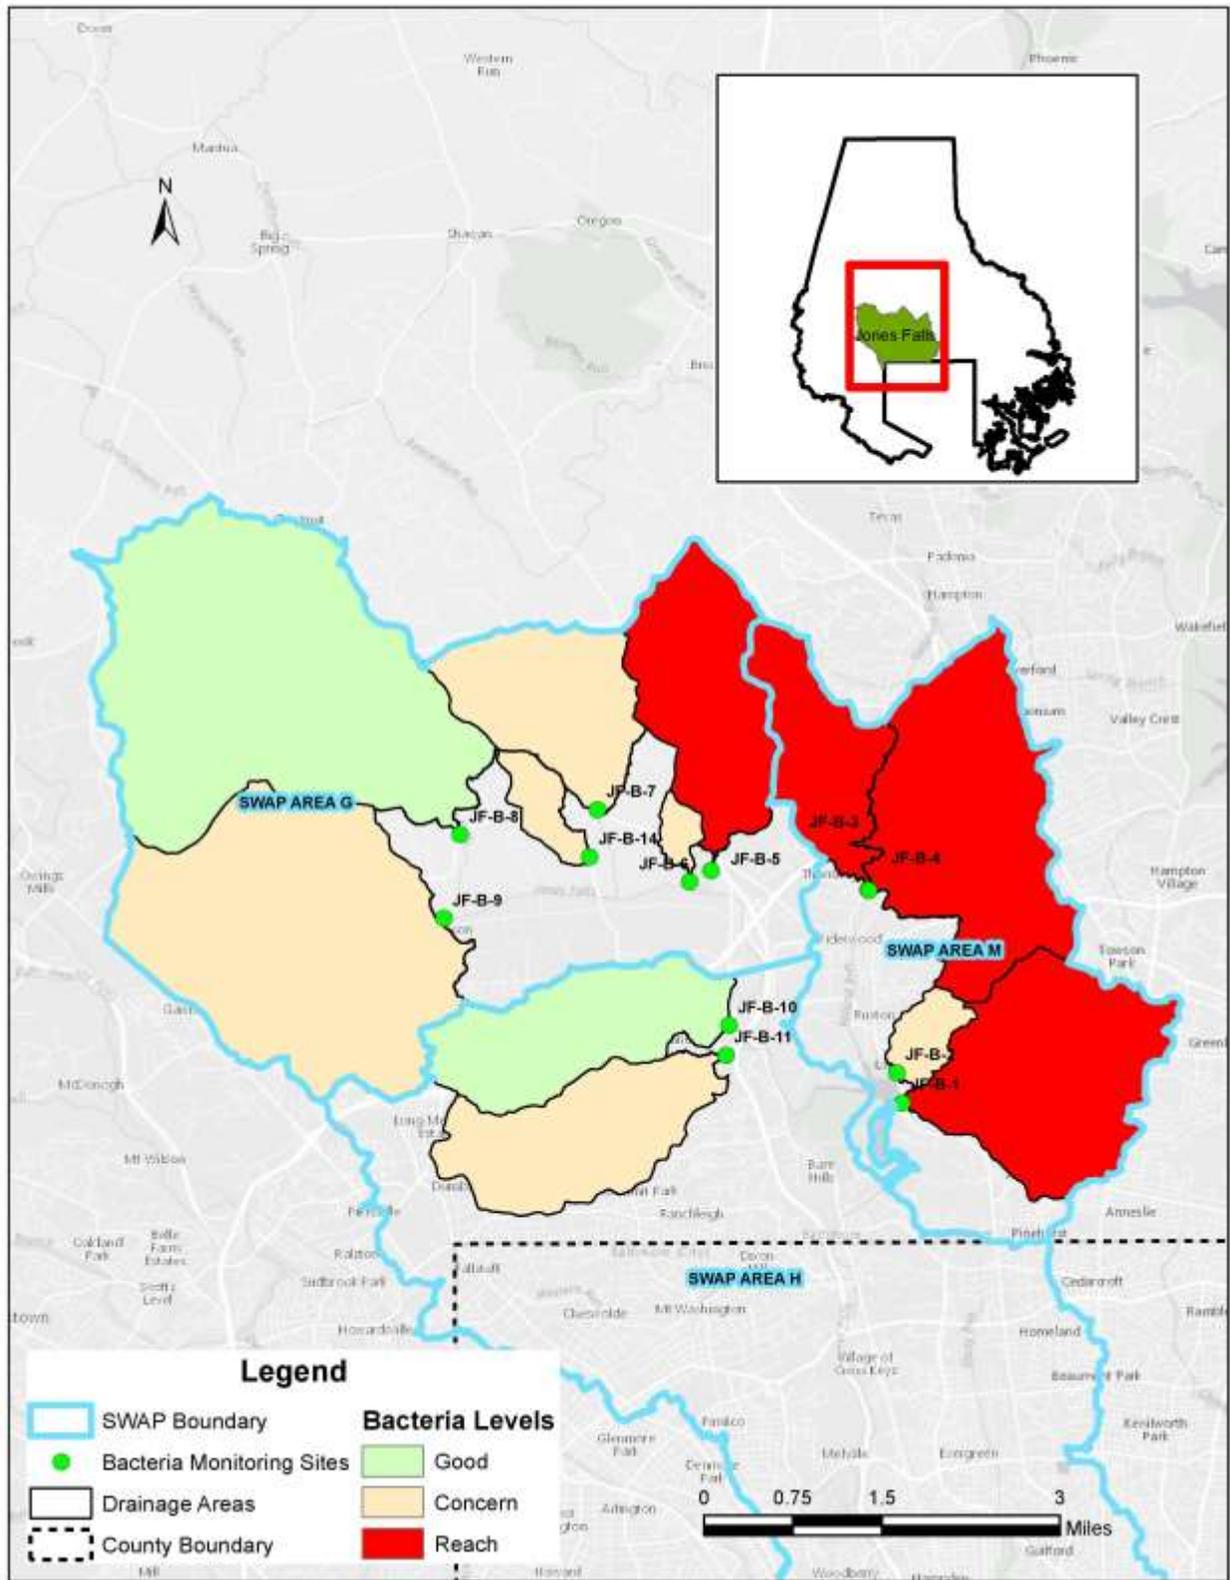
Figure 9-65: Jones Falls Subwatershed Prioritization Site Results

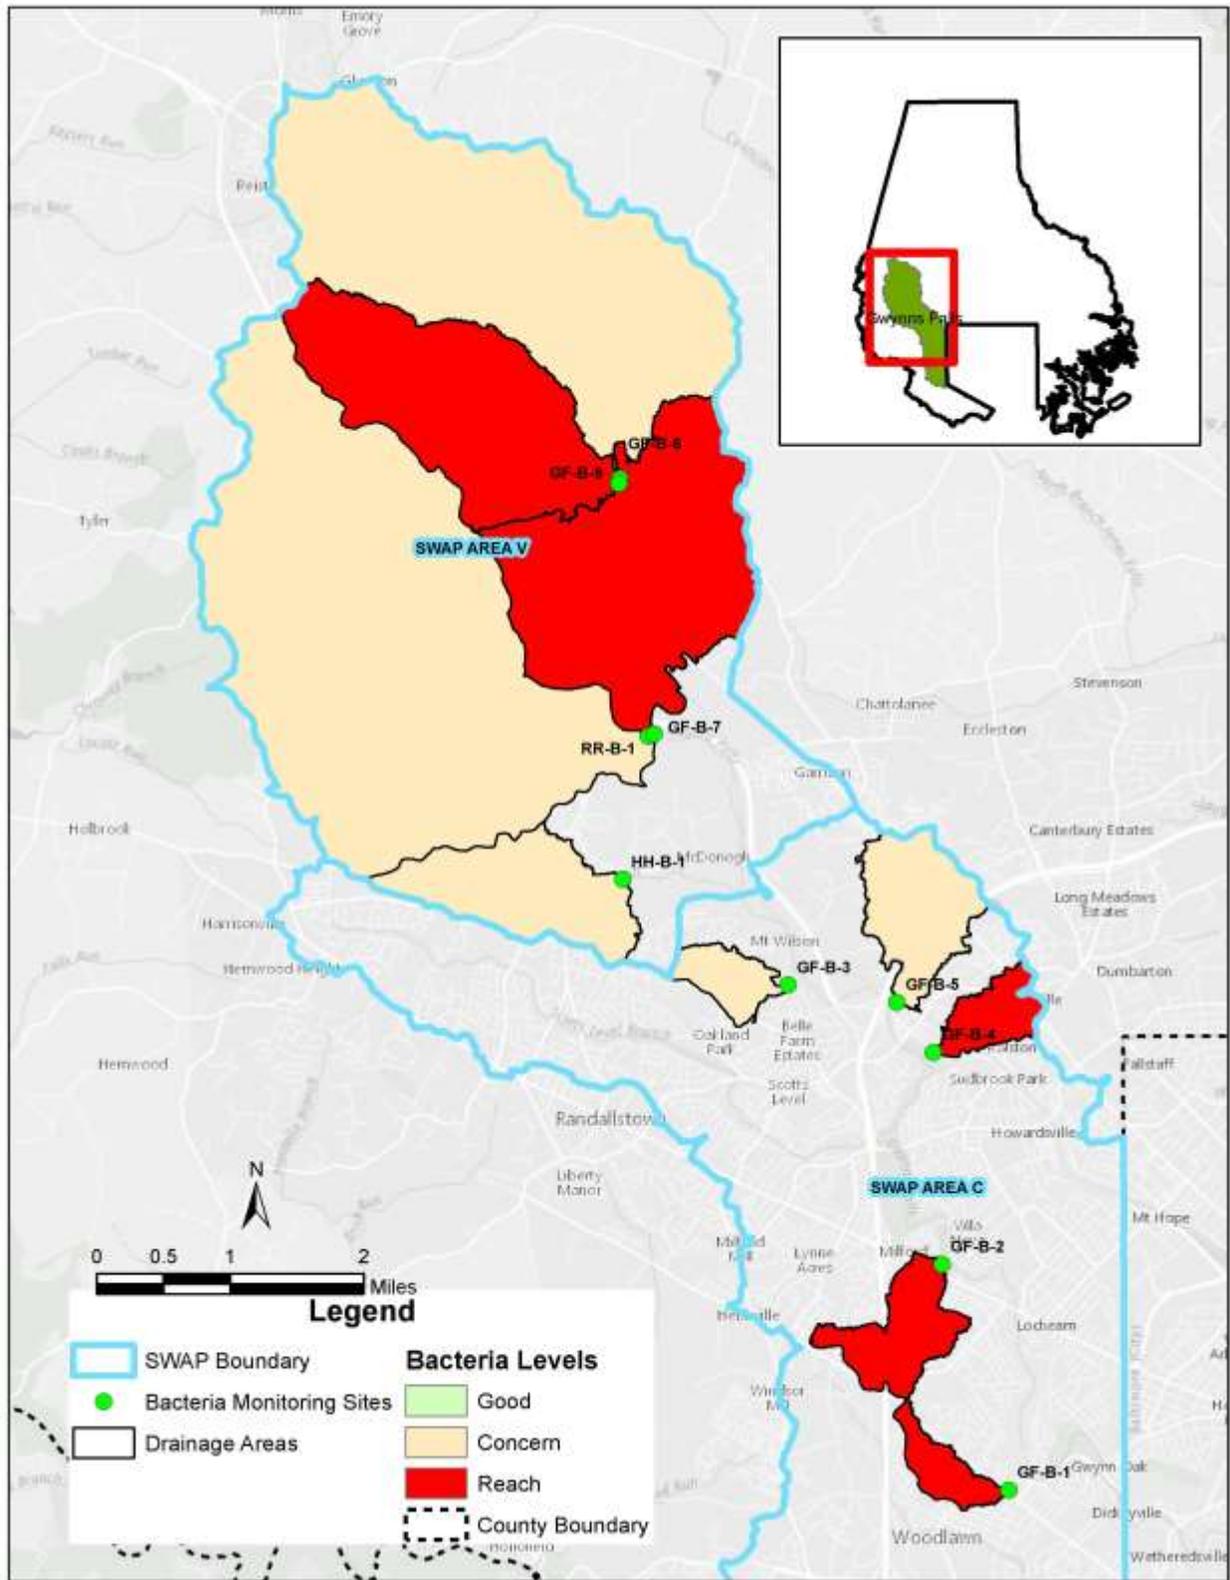
Figure 9-66: Gwynns Falls Subwatershed Prioritization Site Results

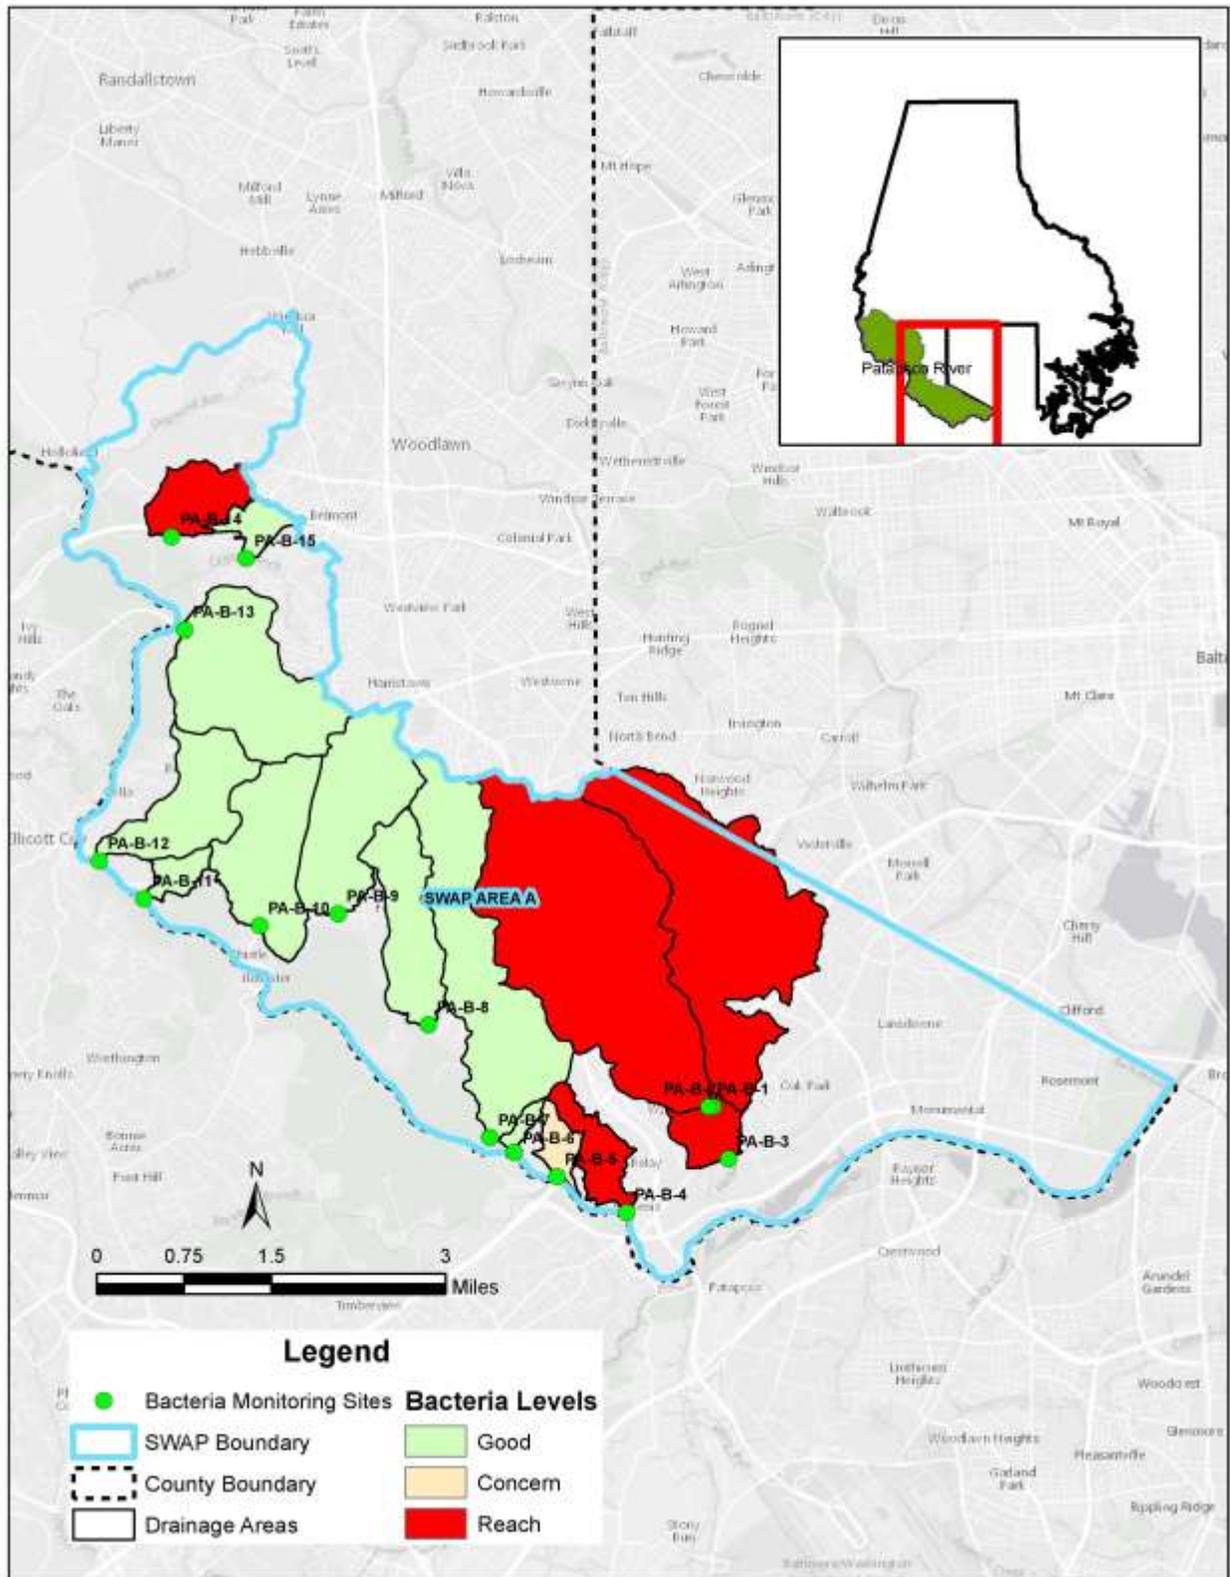
Figure 9-67: Patapsco Subwatershed Prioritization Site Results

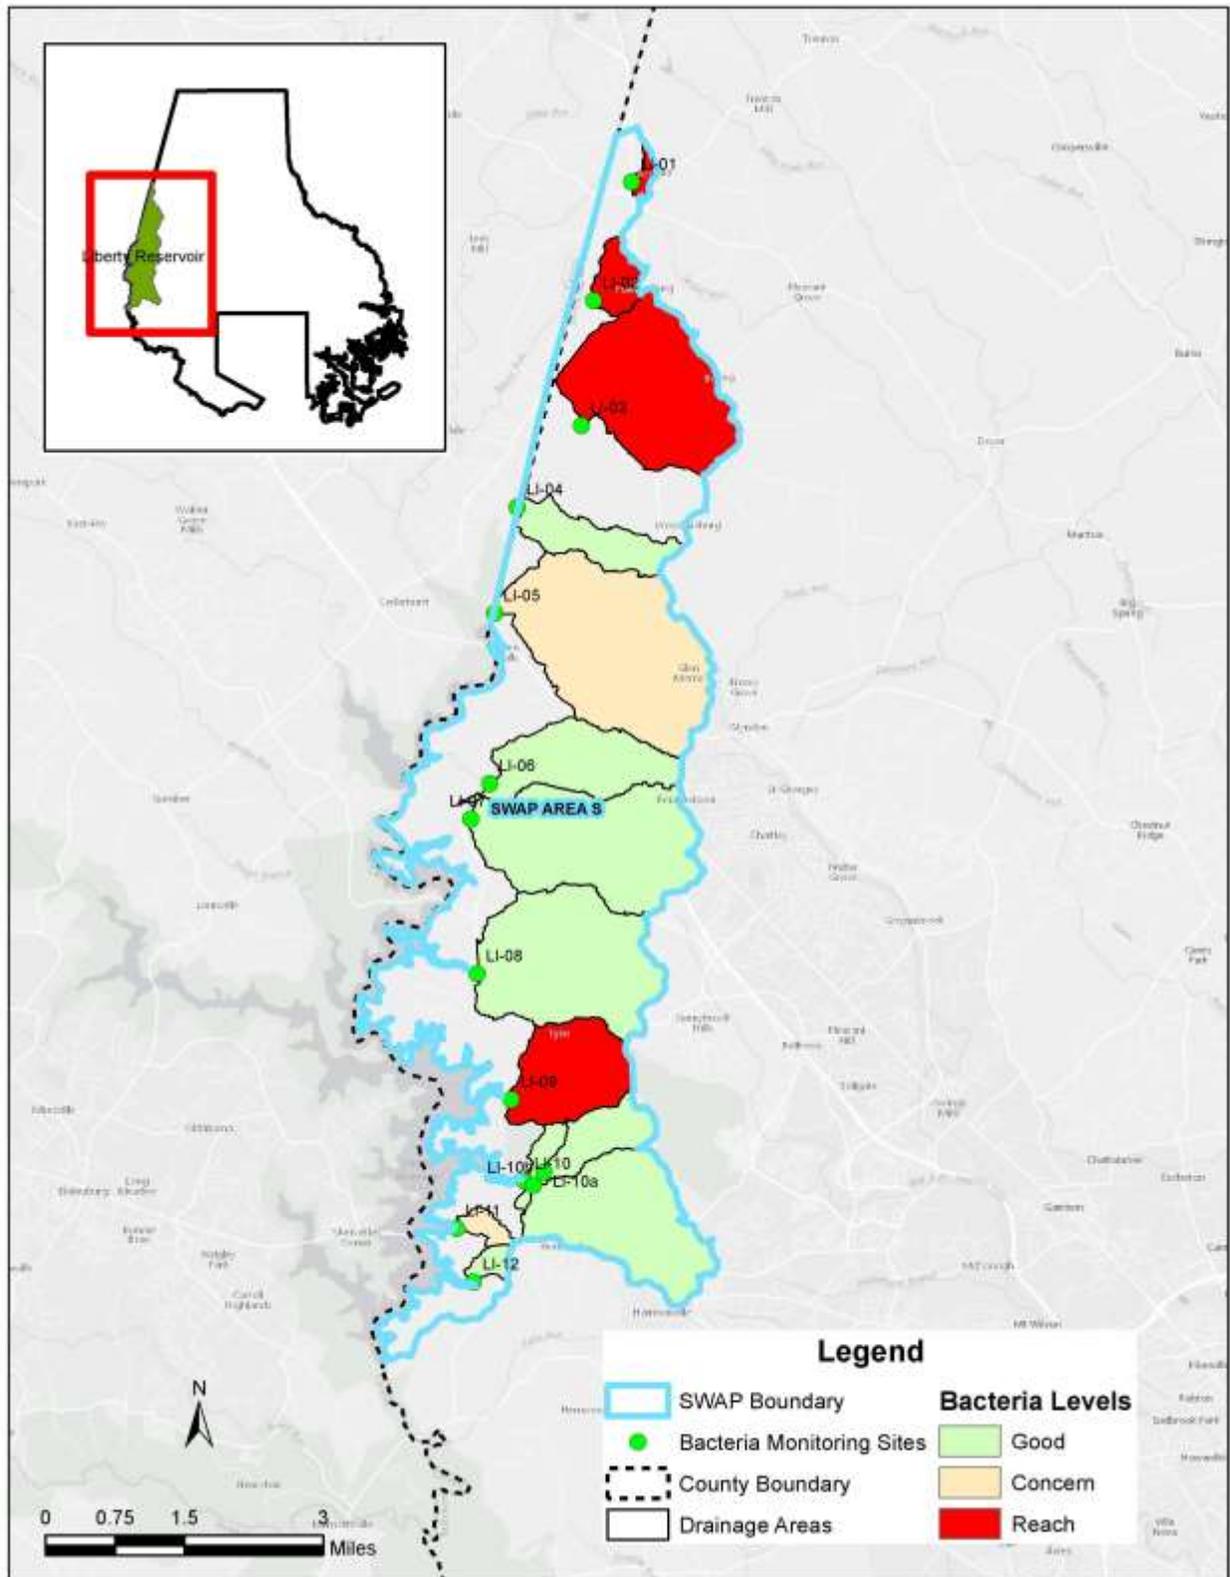
Figure 9-68: Liberty Subwatershed Prioritization Site Results

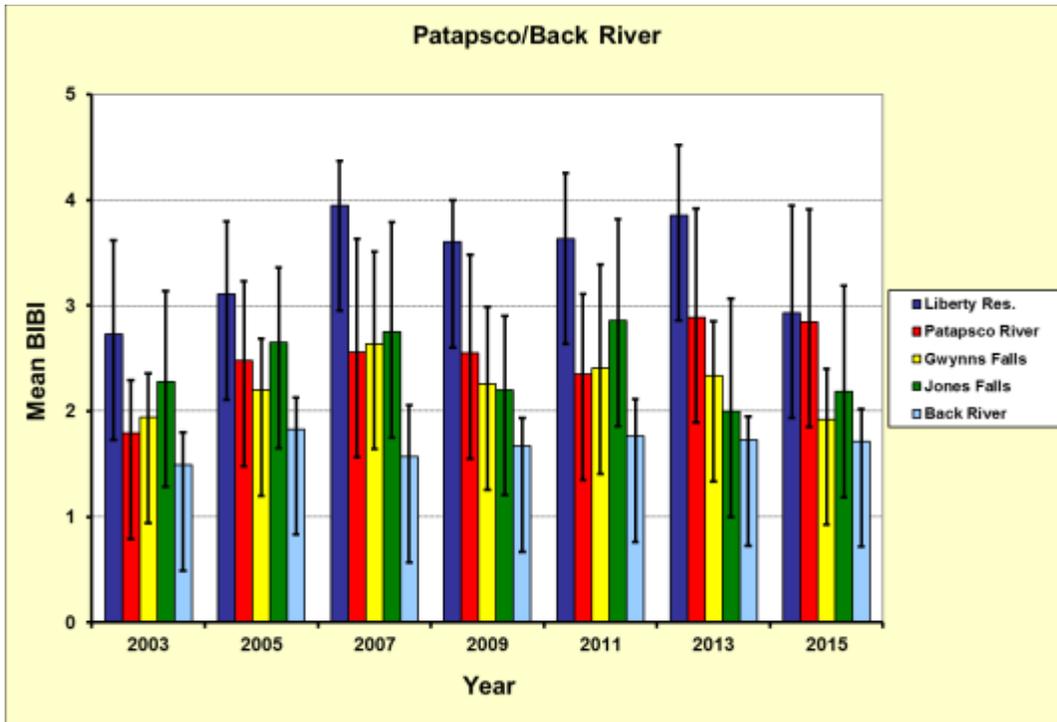
Figure 9-69: Means and one standard deviation of BIBI scores for Patapsco/Back River watersheds between 2003 and 2013.

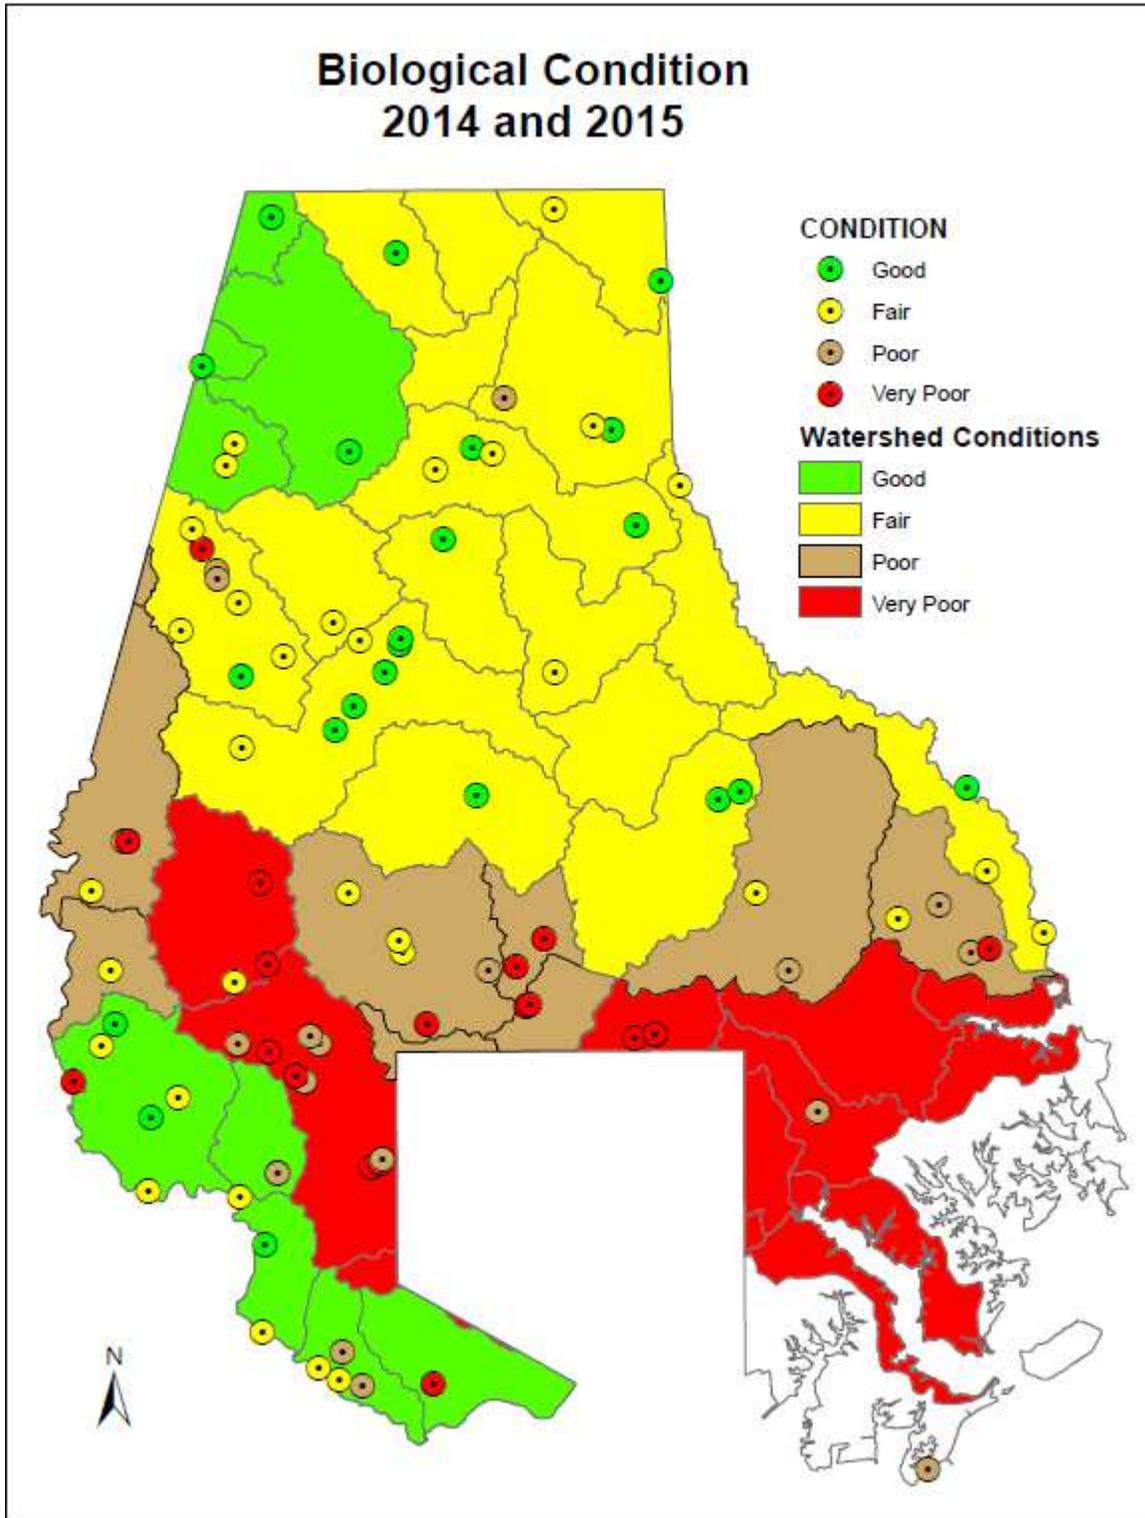
Figure 9-71: Probabilistic Biological Monitoring results for 2014 and 2015. Sample points are superimposed on named Baltimore County subwatersheds.

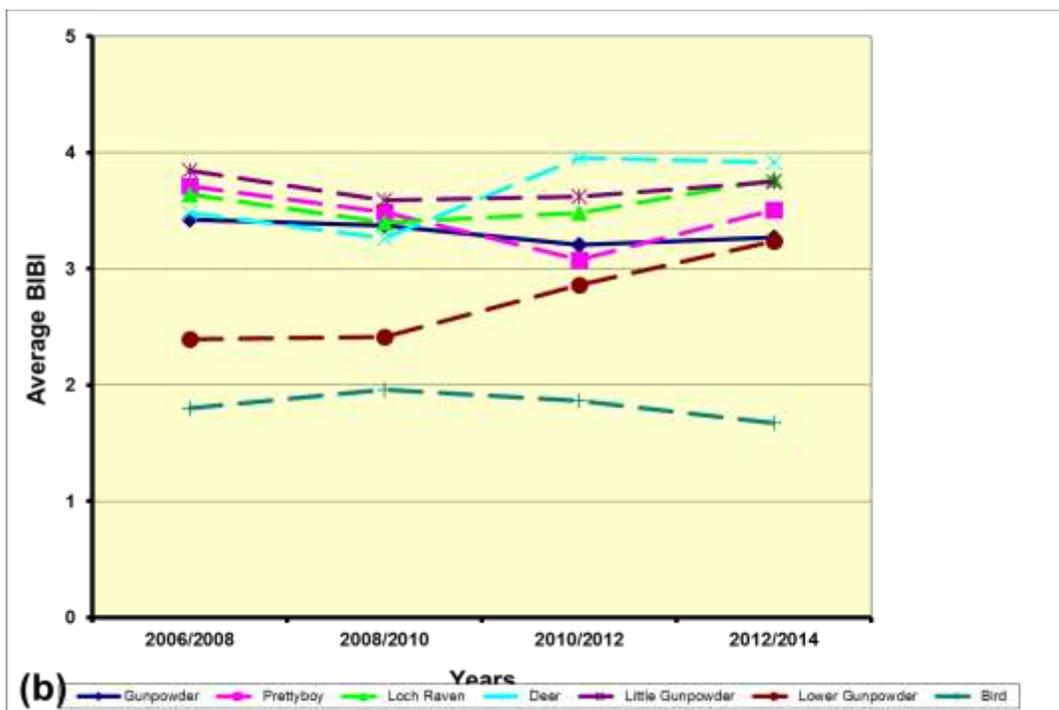
Figure 9-73: BIBI rolling averages for Gunpowder/Deer Creek probabilistic monitoring sites between 2006 and 2014.
