**9.0 Permit Requirements**

**F. Discharge Characterization**

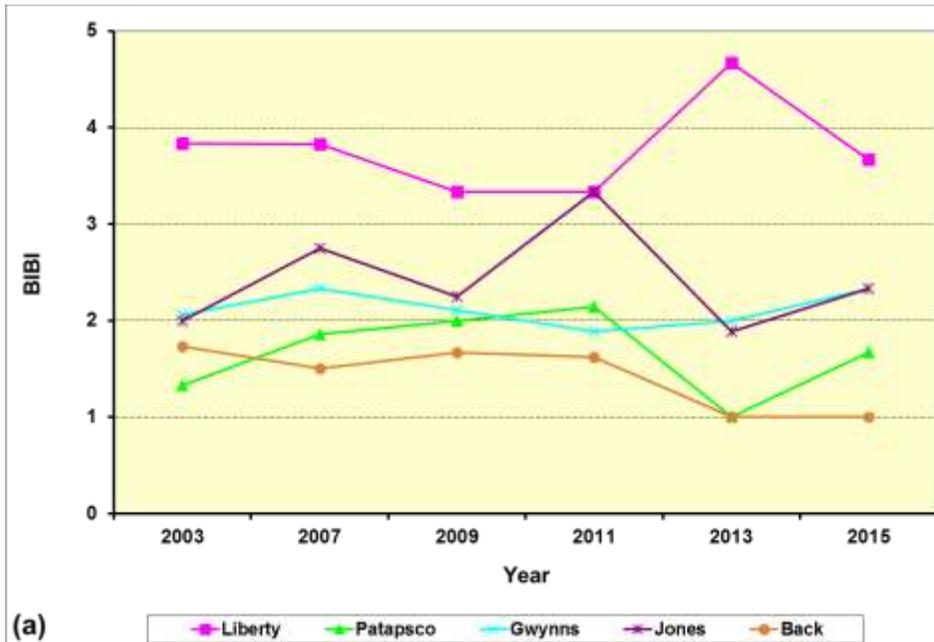
Figure 9-74: Mean BIBI scores for Patapsco/Back River Sentinel Sites between 2003 and 2015.

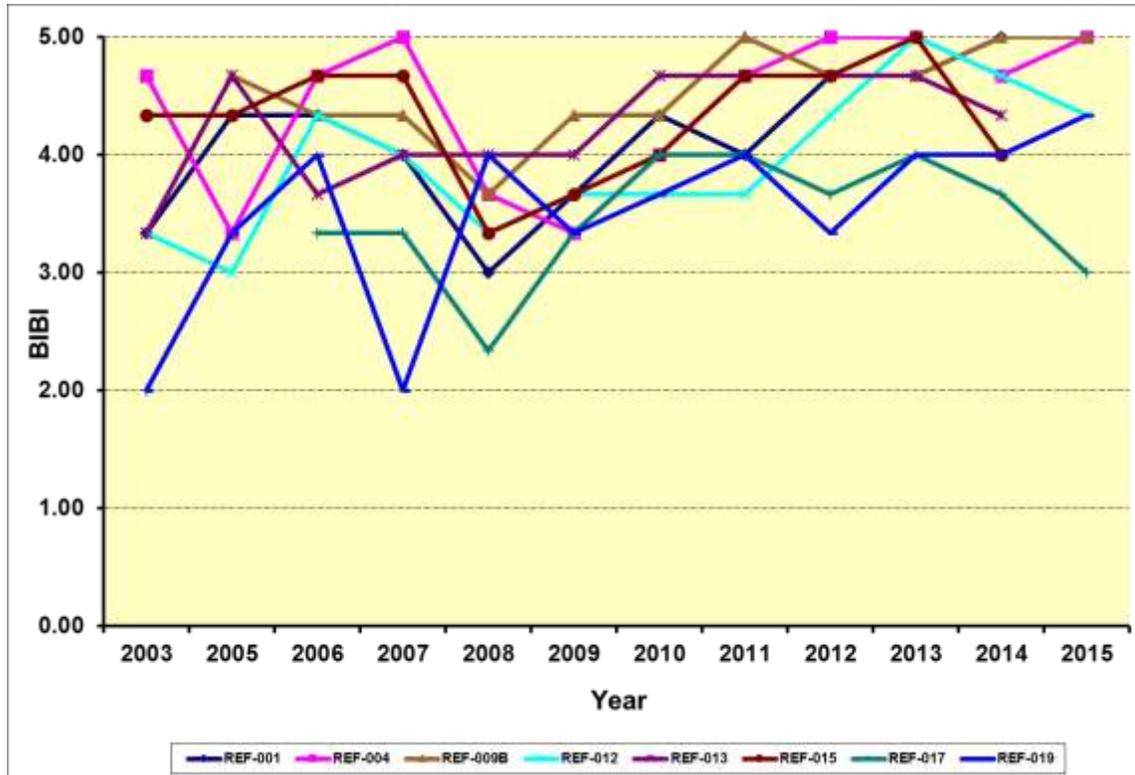
Figure 9-78: Benthic IBI values for Reference Sites, 2003-2015

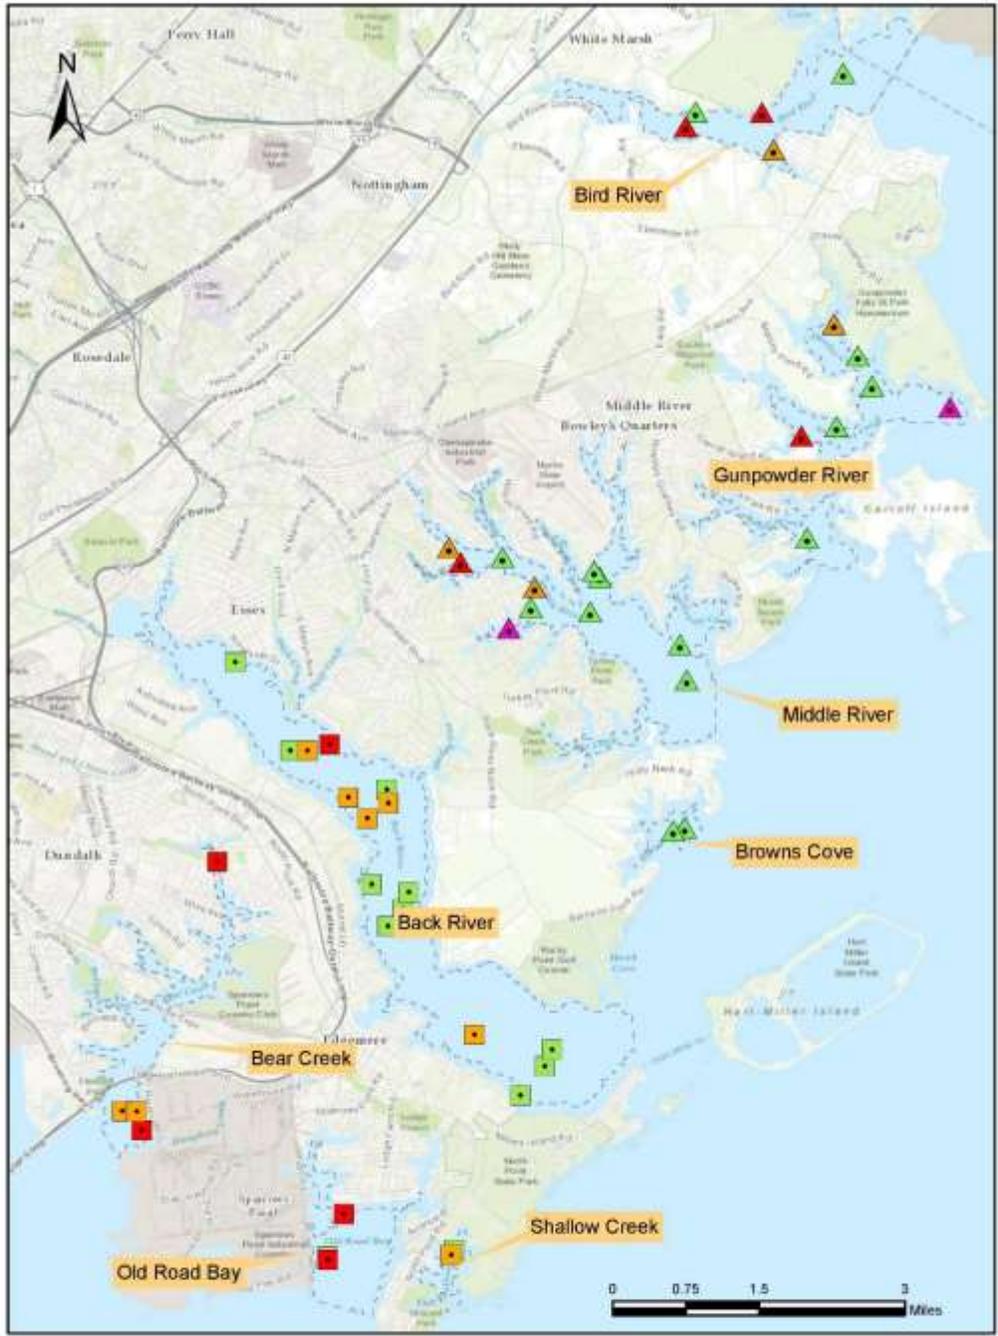
Baltimore County  
 2014 & 2015  
 Benthic BIBI Sampling Results

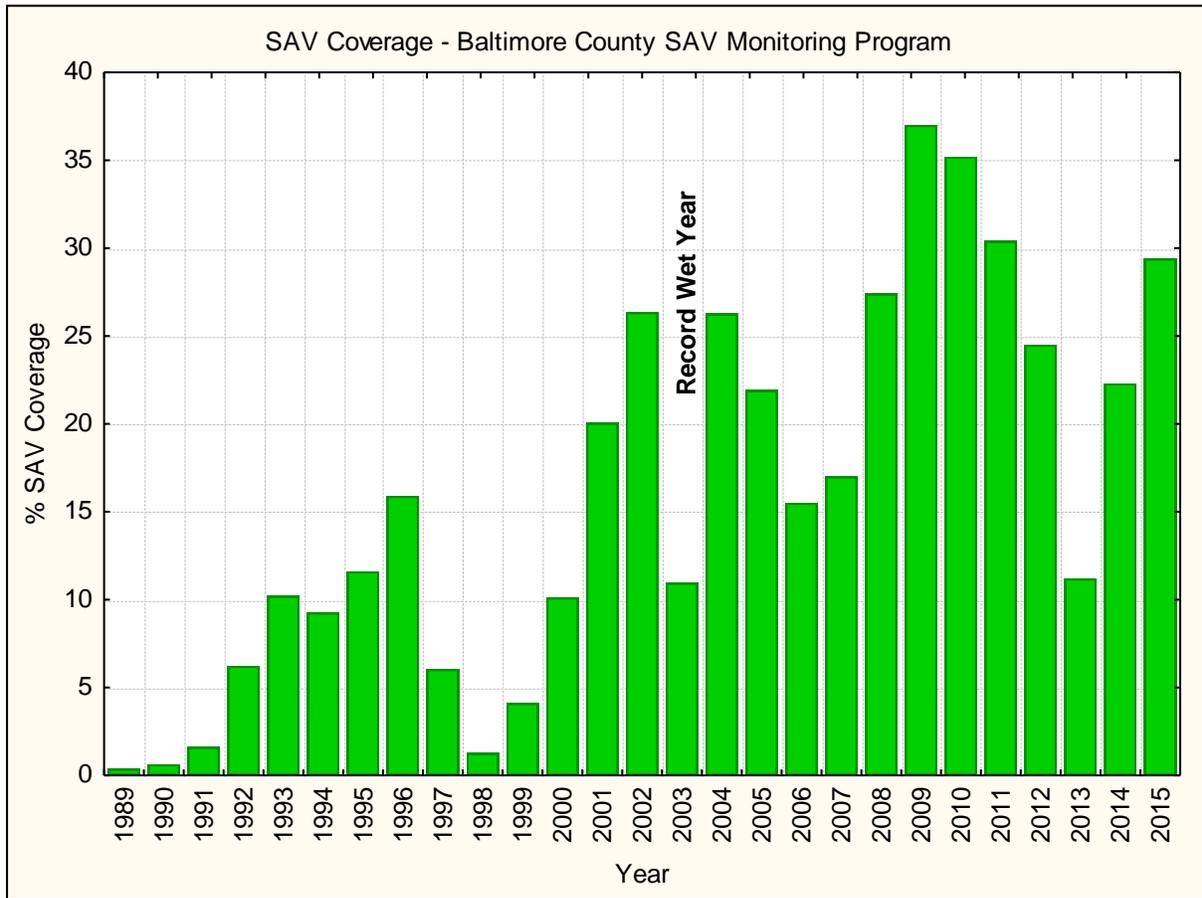
Figure 9-83: Baltimore County SAV Monitoring Program – Trends in % Coverage

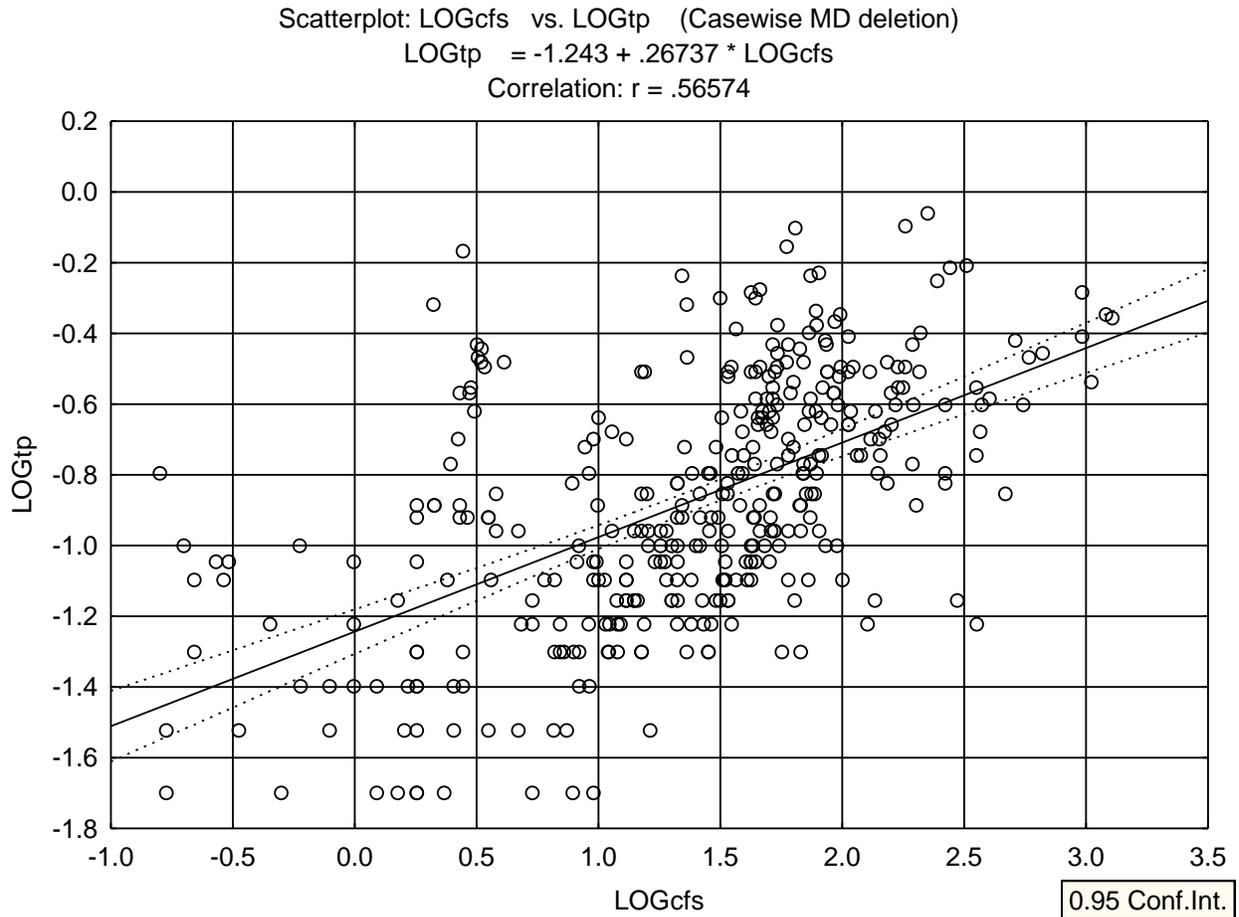
SL-01 Total Phosphorus Data and Regressions for 2005-2015.

The chemical results from the storm event monitoring at the Scotts Level Branch in-stream (SL-01) and outfall (SL-09) monitoring sites were analyzed in conjunction with the discharge data.. Eight storms were monitored for the instream site (SL-01) and twelve were monitored at the outfall site (SL-09). Baseflow conditions were monitored twice during 2015. Attachment A of this document contains a table of these storms with calculated EMCs. Fewer storms were captured at the instream site due to a variety of factors, including a more variable response to precipitation than the outfall monitoring site. The county’s laboratory also had intermittent availability and data issues, including being unavailable for the last two weeks of December 2015. Both the chemical and the discharge data were  $\log_{10}$  transformed before regression analysis and all available data were used to determine the regression equations. The data for the regression equations was censored by removing any chemical data that was below the detection limit for any constituent. The regression equations were used to calculate the chemical concentrations for each 15-minute interval for recorded discharge. Regression equations were determined for Total Suspended Solids, TKN, Nitrate/Nitrite, Total Nitrogen, and Total Phosphorus. The results are displayed in Table 9-1 and Table 9-2 and an example regression graph is shown in Appendix 9-3.
