CATONSVILLE ELEMENTARY SCHOOL EXISTING CONDITIONS ASSESSMENT REPORT

**615 Frederick Road
Catonsville, Maryland 21228**

Prepared For:
Baltimore County
Department of Property Management

Submitted:
September 1, 2016

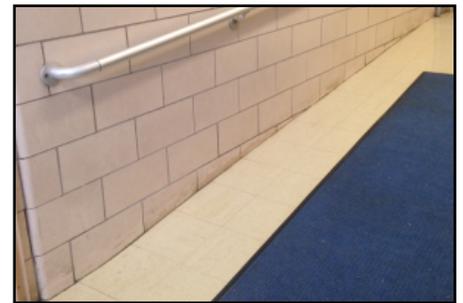
Ramp meets slope requirements.

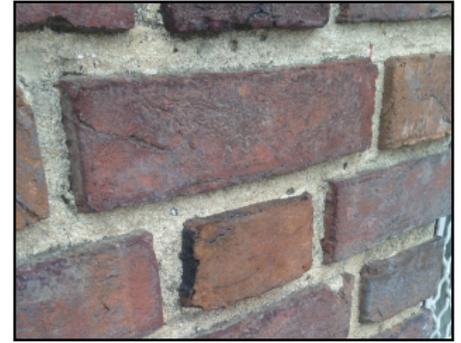
Weathered brick joints.

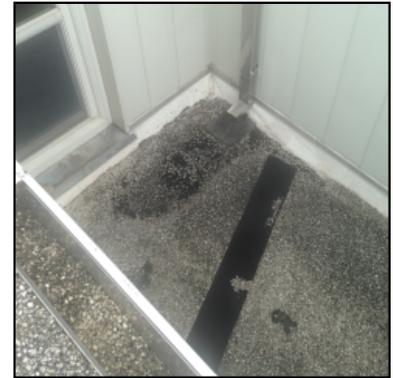
Gutter clogged with ballast.

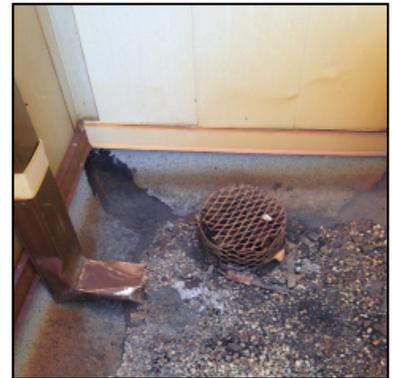
Roof drain, no over-flow drain.

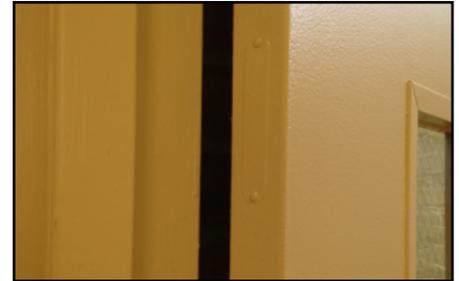
Fire rating tag covered over.

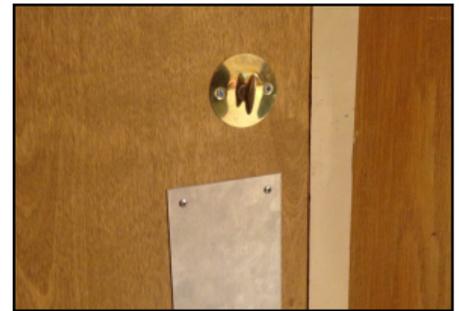
Thumb lock prohibited by code.

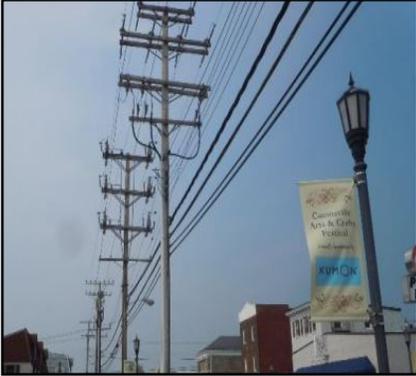
The existing facility is served from a 480/277VAC three phase, four wire utility service lateral which originates from a power pole located on Frederick Road (See photograph #1) and terminates in an utility CT meter cabinet located in the basement mechanical room (See photographs #2 and 3). The service lateral feeds a double section distribution panel which provides the service disconnecting means. The main circuit breaker of the distribution panel provides the service disconnecting means for the building service. The main circuit breaker is of the molded case, thermal magnetic type, with a current sensor rated for 600A trip and has a symmetrical short circuit rating of 30,000A (See photograph #4). The distribution panel provides 480/277VAC feeder circuits for feeder and branch circuit panelboards and HVAC equipment (See photographs #5 and 6). The distribution panel is manufactured by General Electric, type CCB, and is designed for group-mounted bolted circuit breakers. General Electric no longer manufactures this type of panelboard assembly and an estimate for the age of this panelboard is approximately forty years old.

Photograph 1 - Utility power pole located on Frederick Road.

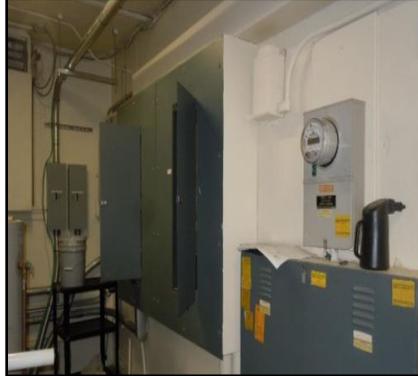
Photograph 2 - Service entrance distribution panelboard.

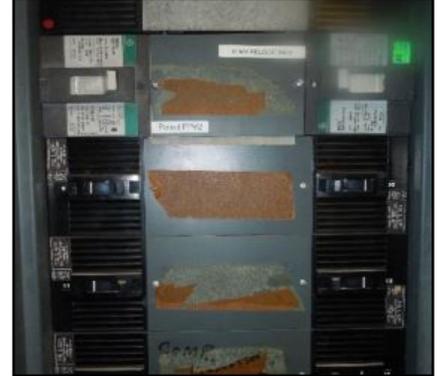
Photograph 3 - 800A, 277/480VAC, 3 phase, 4 wire distribution section.

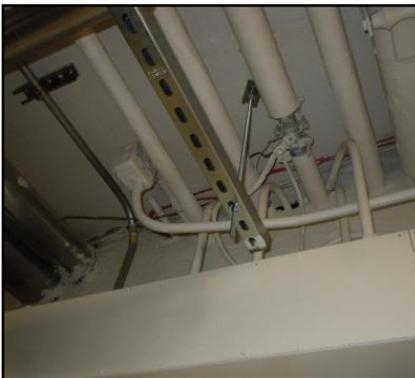
The electrical service is of the solidly grounded type (See photograph #7).

Photograph 7 - Grounding electrode conductor connection to domestic water service (Electrode).

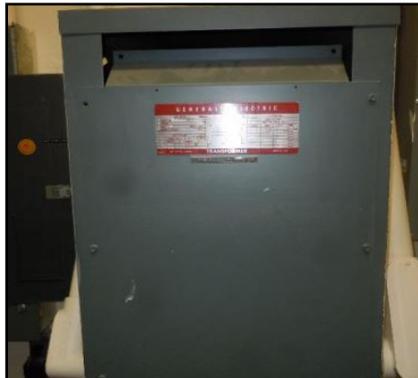
Through step-down dry-type transformers, 120/208VAC panelboards provide power for lighting, equipment and receptacle branch circuits (See photographs #8 and 9).

Photograph 8 - Dry-type general purpose step-down transformer.

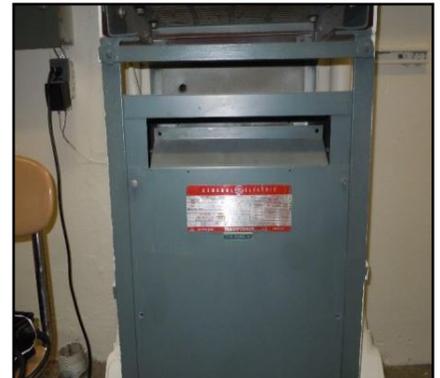
Photograph 9 - Dry-type general purpose step-down transformer.

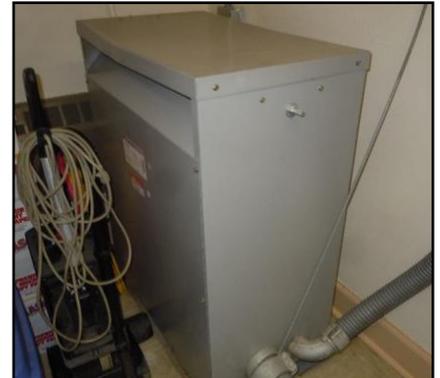
The new distribution panel is located in the basement mechanical room along with the 120/208VAC feeder panelboard and the branch circuit panelboard for the basement branch circuits. The new distribution equipment is as manufactured by General Electric. The distribution panel is a Spectra series type and all branch circuit panelboards are AQ series (See Photographs #34-41). The new step-down transformer is K-rated for non-linear loading and is located in a passage area adjacent to the basement mechanical room (See photograph #42).

Photograph 42 - K-rated step-down transformer for panelboard DPA.

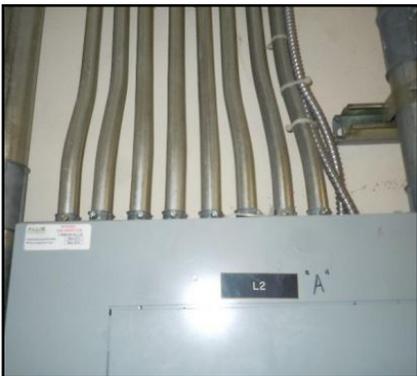
The building wiring method is of the pipe and wire type (See photographs #43 and 44). Where possible, all branch circuit raceways were concealed. Most of the exposed conduit is of the thin-wall construction with set-screw couplings.

Photograph 43 - Feeder and branch circuit EMT conduit with set-screw fittings.

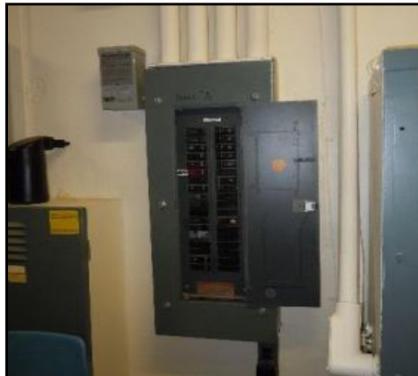
Photograph 44 - Feeder and branch circuit conduit with set-screw fittings.

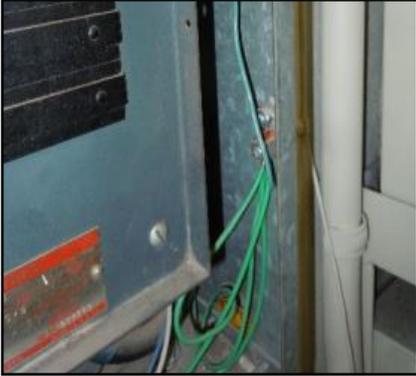
All feeder and branch circuit wiring installed under the 1970 renovation is copper with THW insulation (See photograph #45). THW insulation is of the PVC thermoset type suitable for dry/wet, commercial applications at 75 degree C. The metal conduit system was utilized as the equipment ground conductor for the branch circuits installed during the 1970 renovation. Panelboards were not provided with equipment ground bus. When branch circuits with equipment grounding conductors were added, the equipment grounding conductor was attached to the panelboard back box (See photographs #46).

Photograph 46 - Equipment grounding conductors bolted to panelboard back box.

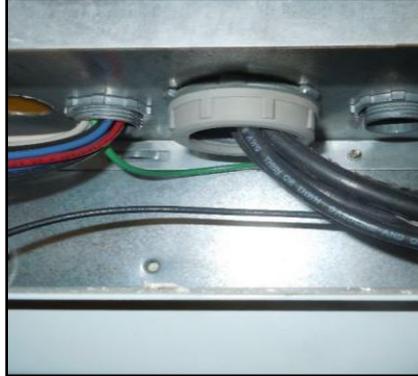
All feeder and branch circuit wiring installed under the 2000 renovation is copper with THHN/THWN insulation (See photograph #47). THHN/THWN insulation is of the thermoplastic type suitable for dry/wet, commercial applications at 75 degree C. Panelboards were provided with equipment ground bus. All feeder and branch circuits include an insulation equipment grounding conductor which terminates to an equipment ground bus (See photograph #48).

Photograph 47 - THHN/THWN insulated copper building wiring.

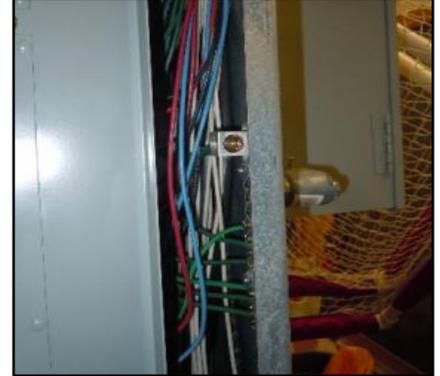
Photograph 48 - Panelboard equipment ground bus.

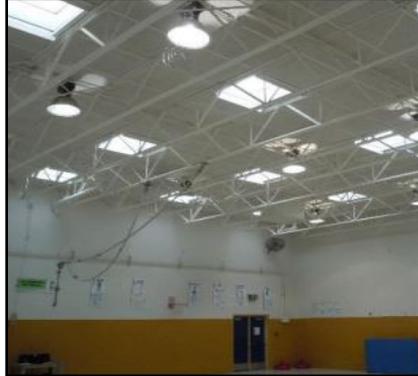
Most of the interior lighting is provided as light fixtures which utilize fluorescent arc-tubes and rapid start solid state ballast. Most fluorescent lamps are tubular type, T-8 with 4100K color temperature. Most interior lighting is surface-mounted. Corridors, stairwells, dining, utility spaces, and toilet rooms utilize surface-mounted lights. (See photographs #50-54). Classrooms utilize pendant-mounted lights (See photograph #49). The auditorium utilizes recessed lights (See photograph #55). The estimated age of the interior lighting is approximately fifteen years old. The gymnasium lighting is provided with pendant-mounted HID high bay light fixtures. There was no as-built documentation for the gymnasium lighting, however, the lighting fixtures appear to be in good shape and, thus, it was concluded that the gymnasium lighting was recently replaced (See photograph #56).

Photograph 56 - HID high bay light fixtures for gymnasium illumination.

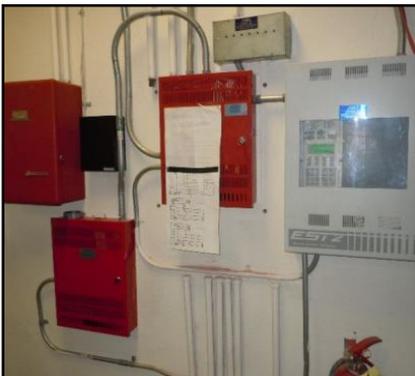
During or after the 2000 renovation, the building fire alarm system was replaced; however, the building is not fully sprinkled. The building fire alarm control panel is an Edwards EST2 and is supplemented with two notification appliance circuit panels (See photograph #70). The building was provided with new audible and visual indicating devices which are ADA compliant (See photograph #71). Automatic initiating devices were located in the kitchen, storage rooms, and rooms containing fire alarm control equipment (See photographs #72-74). New duct smoke detectors were added to each of the three air handling units (See photograph #75). A control switch was added at the main entrance for fire department use. The control switch provides shut-off for the three building air handling units. Manual pull stations were provided for manual trip of fire alarm systems (See photograph #76). There was no review of the fire alarm wiring. The system and equipment appears to be in working condition. This fire alarm system analysis did not review issues regarding compliance with codes for installation of fire alarm systems.

Photograph 70 - Fire alarm system control and notification appliance panels.

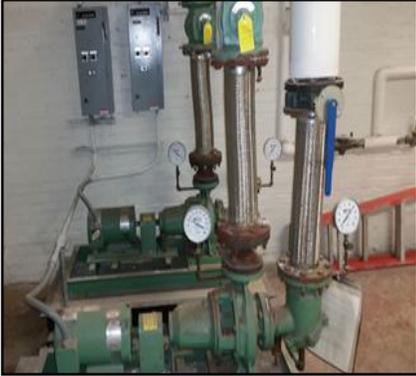
- There was no damage observed on the insulation on the heating water piping connecting the air handler in the boiler room. The supply pumps were in good operational condition (See Photograph #1).

Photograph 1 - Heating water pumps.

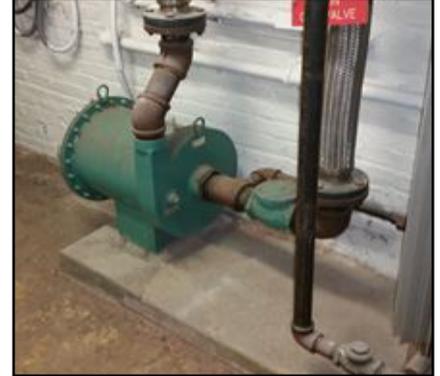
- The fuel pumps on site were operating within their expected design parameters (See Photograph #3).

Photograph 3 - Gas booster pump in boiler room.

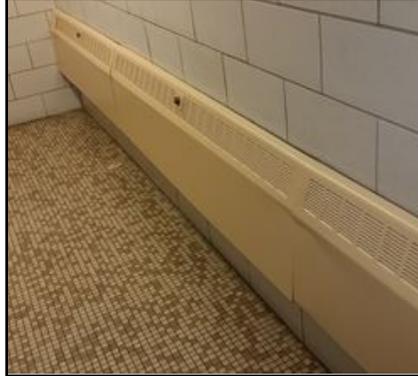
- Baseboard fin tube heaters line the perimeter wall in the offices and classrooms throughout the building (See Photograph #11). All the baseboards fin tubes were observed to be in physically good condition. Personnel reported that the baseboard operated adequately during heating season when they are being used.

Photograph 11 - Fin tube heaters in bathroom.

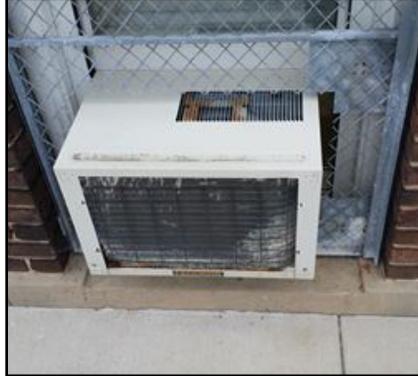
- A number of window A/C units are being used in offices (See Photographs #20 & 34). The areas served by these units were not receiving adequate cooling by the unit ventilators in these spaces. Further investigation is needed to determine the cause of this problem and eliminate the need for the window unit.

Photograph 20 - Window AC unit.

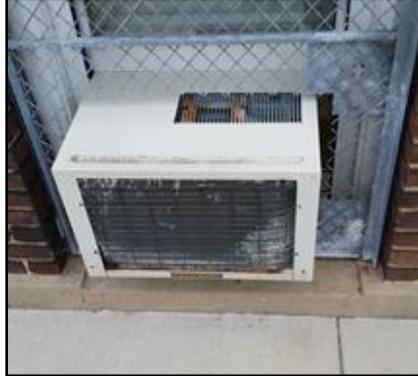
Photograph 29 - Window AC unit serving teachers' lounge.

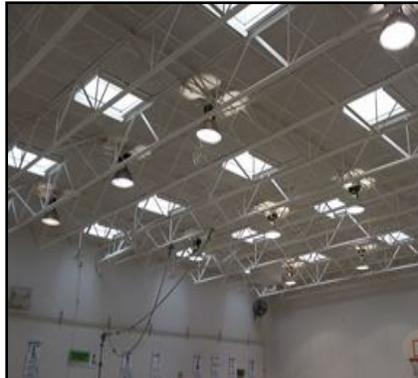
Photograph 32 - Ceiling of gymnasium. No downward diffusers.

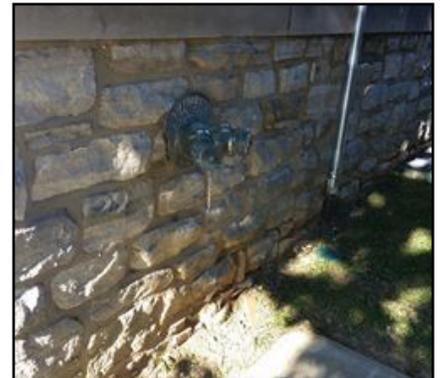
Photograph 36 - Fire department siamese connection.

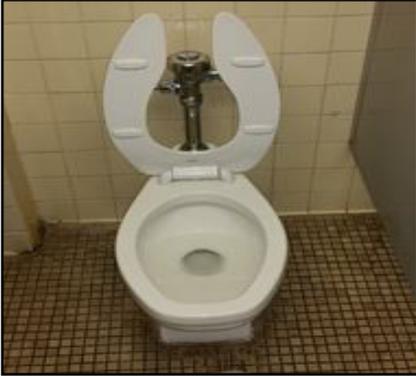
- Lavatory Faucets: The faucets were tested using normal operating controls and were generally in satisfactory condition (See Photograph #12).
- Water Closets: The water closets were tested using normal operator controls and were generally in satisfactory condition (See Photograph #37).
- Urinals: The urinals were tested using normal operator controls and were generally in satisfactory condition (See Photograph #6). Some fixtures observed were in need of repair.
- Drinking Fountains: The drinking fountains were tested using normal operator controls and were generally in satisfactory condition (See Photograph #9).

Photograph 37 - Water closet.

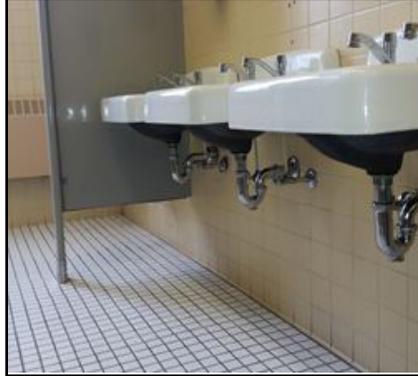
Photograph 38 - Lavatories needing pipe guards.

Install vinyl PVC under sink pipe guards on all exposed lavatory waste piping per plumbing code. None were observed as seen in Photograph #38. A sample is shown to the right.

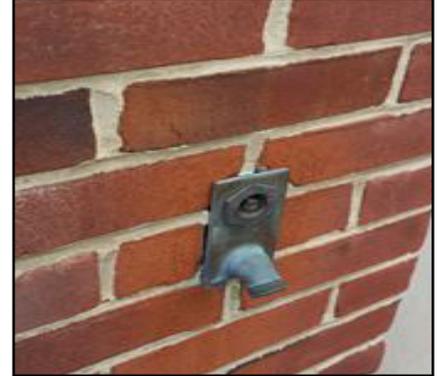
Photograph 39 - Hose bib needs updating.

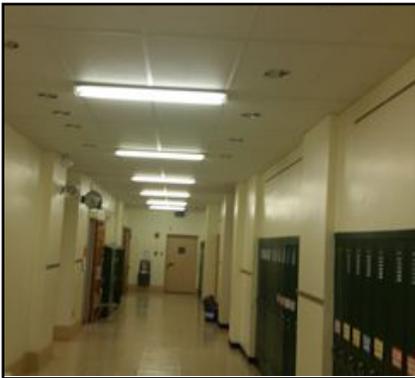
Photograph 40 - No air provided in corridors.

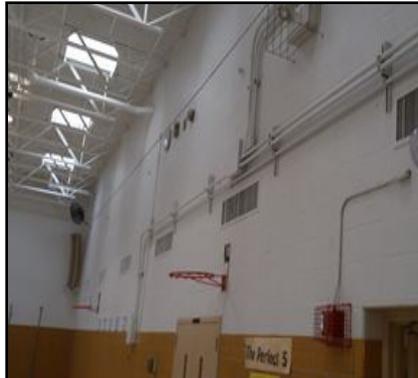
Photograph 41 - Supply air grille in gymnasium.

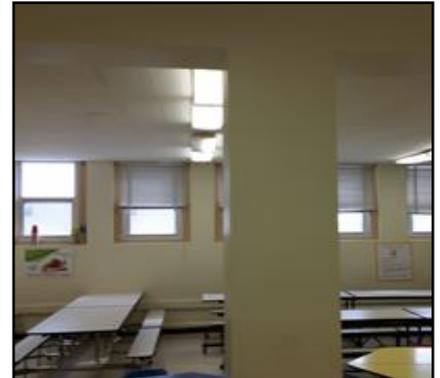
Photograph 42 - Wall-mounted fans in cafeteria.

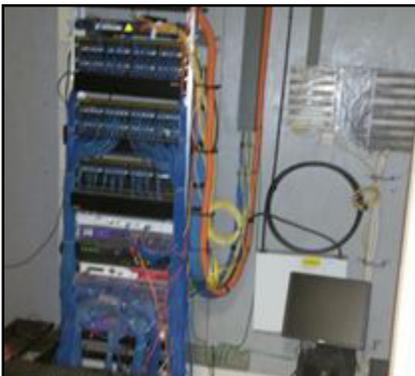
Photograph 43 - IT closet with no cooling.

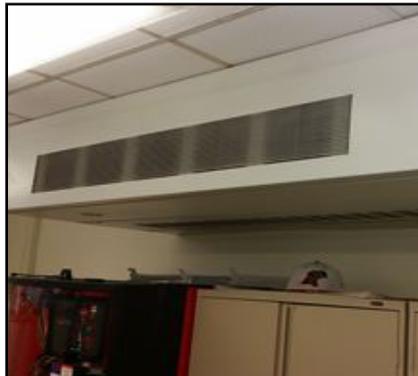
- The primary source of cooling throughout the classrooms and offices are unit ventilators (See Photograph #44). These units are located on the perimeter walls under the windows. These units are also the primary source of ventilated air provided to the classrooms. It was noted that these units were not providing adequate cooling on the day observed. Fans were often observed in use, in order to provide additional air flow to the space.

Photograph 44 - Ceiling-mounting unit ventilator.
